SOUTH DAKOTA STATE HISTORIC PRESERVATION OFFICE
HISTORIC SITES SURVEY STRUCTURE FORM

*ADDRESS: #1226 463rd Ave.

CURRENT FUNCTION: Vacant
 CURRENT SUBFUNCTION: Vacant
 HISTORIC FUNCTION: Livestock barn
 HISTORIC SUBFUNCTION: Hay storage

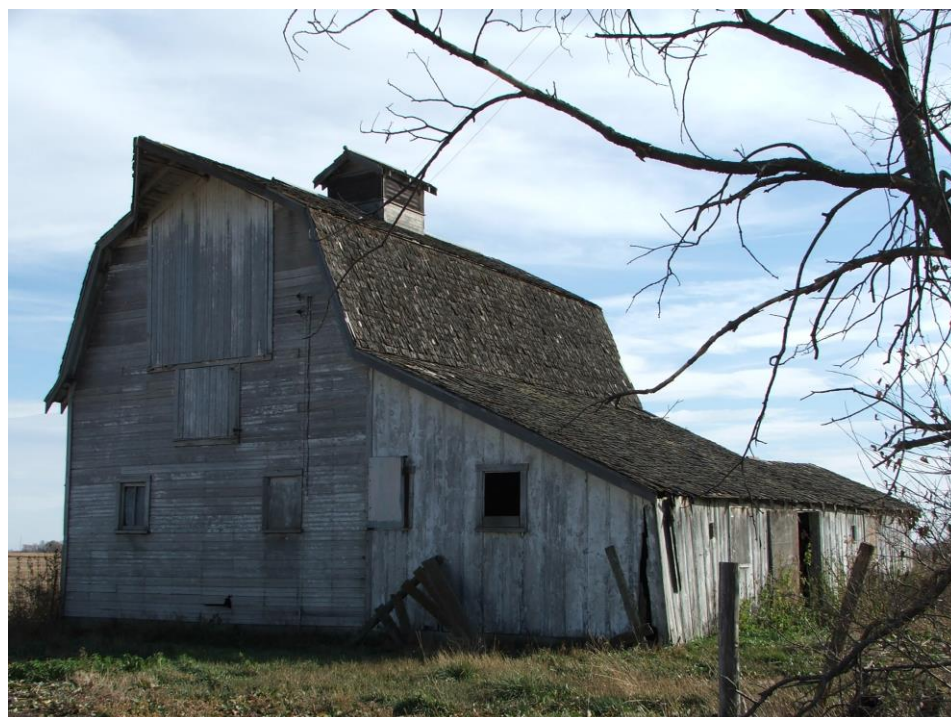
ROLL NUMBER: _____
PHOTO NUMBER: 4
CAMERA DIRECTION: Looking SE, NW corner

*PHYSICAL NOTES: Barn is in fair condition. Needs roofing now. Doors and windows need some repair. Concrete foundation is crumbling in North West corner.

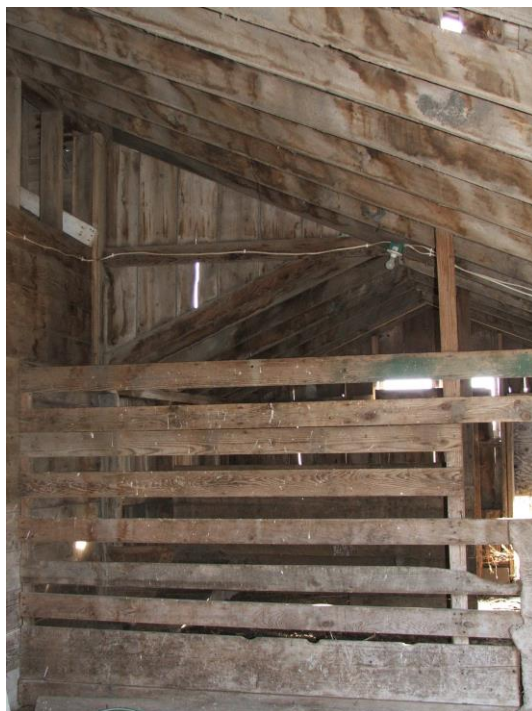
ROLL NUMBER: _____
PHOTO NUMBER: 5

CAMERA DIRECTION: First floor, looking
South, in West lean-to

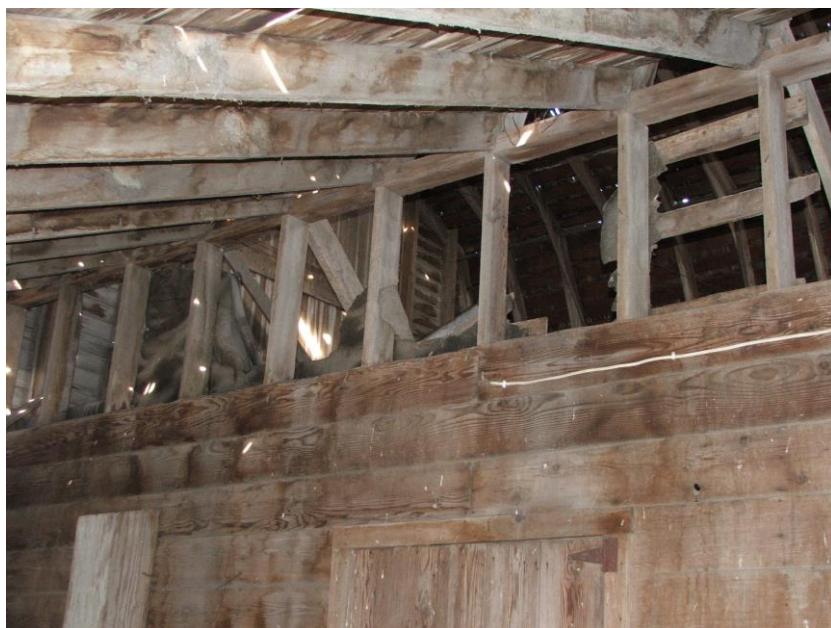
ROLL NUMBER: _____
PHOTO NUMBER: 6

CAMERA DIRECTION: First floor, looking NE, in
West lean-to, looking at
West wall of main barn
and into hayloft

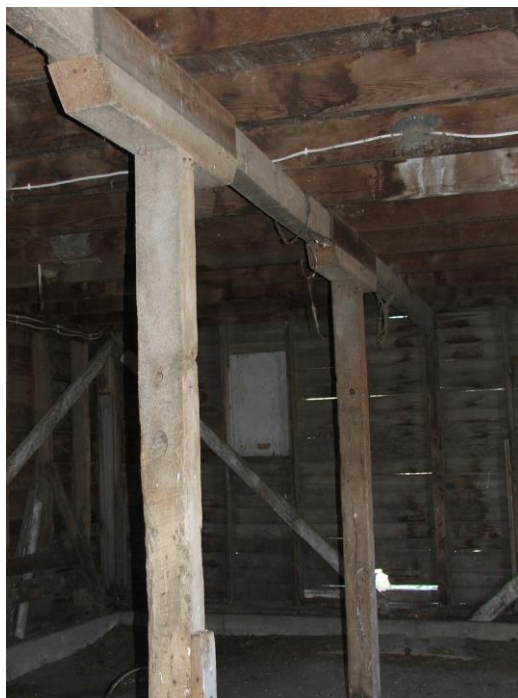
ROLL NUMBER: _____
PHOTO NUMBER: 7

CAMERA DIRECTION: First floor, looking North, posts and beam in main barn

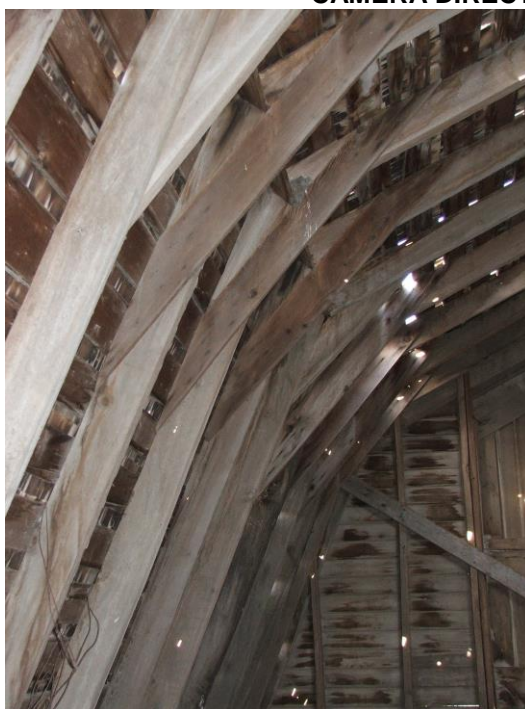
ROLL NUMBER: _____
PHOTO NUMBER: 8

CAMERA DIRECTION: Hayloft, looking North, rafter bracing at hip.
