SITE INFORMATION

*SURVEY DATE: <u>Aug. 20, 2012</u> *SURVEYOR: Jim Stone

*ADDRESS:	45589 Cottonwood Street
*COUNTY:	Clay
*CITY:	Meckling

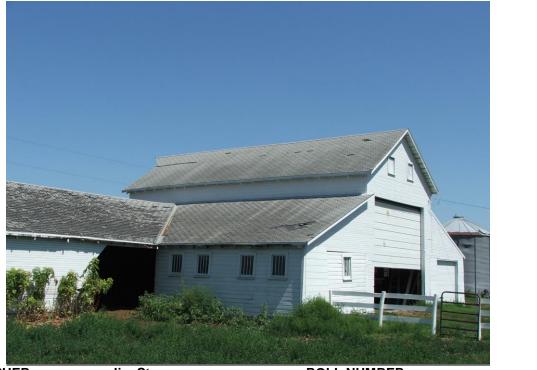
DATE OF PHOTO:
 Aug. 20, 2012
 PHOTO NUMBER:
 1

CAMERA DIRECTION:
 Looking NE, SW corner

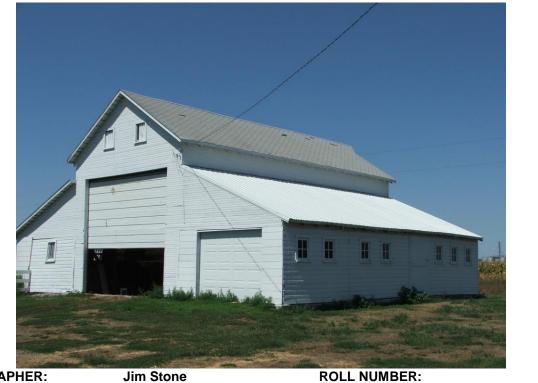
PHOTO NUMBER:
 2

CAMERA DIRECTION:
 Looking NW, SE corner

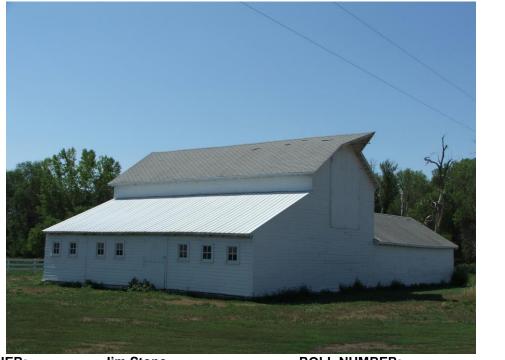
DATE OF PHOTO:
 Aug. 20, 2012
 PHOTO NUMBER:
 3

CAMERA DIRECTION:
 Looking SW, NE corner

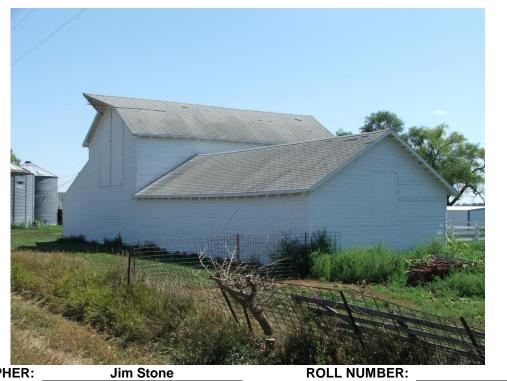
DATE OF PHOTO:
 Aug. 20, 2012
 PHOTO NUMBER:
 4

CAMERA DIRECTION:
 Looking SE, NW corner

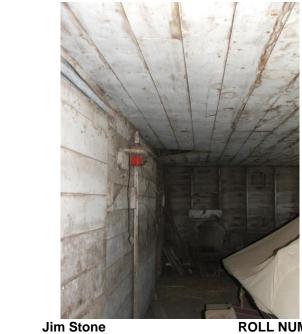
First floor, looking North, 4x6 post, 6' O.C. and CAMERA DIRECTION: bracing, East wall
