#### SITE INFORMATION

#### STRUCTURE DETAILS

#### SKETCH MAP

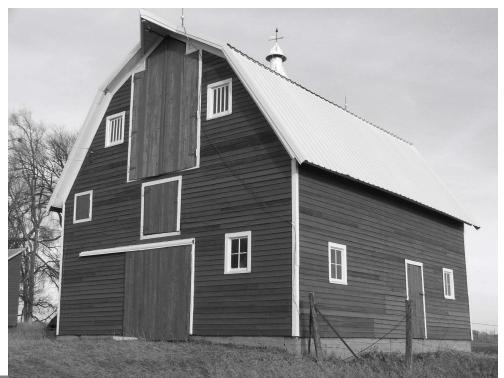
PHOTOGRAPHER: Jim Stone ROLL NUMBER: DATE OF PHOTO: December 5, 2012 PHOTO NUMBER: 1

CAMERA DIRECTION: Looking NE, SW corner

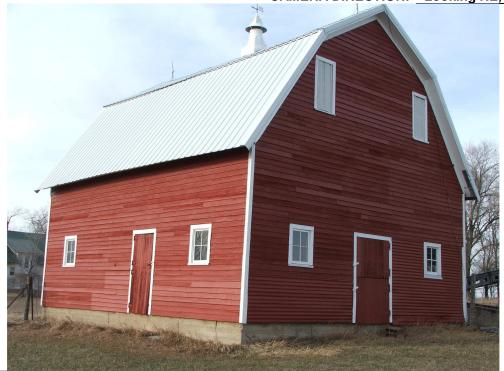
PHOTOGRAPHER: Jim Stone ROLL NUMBER: DATE OF PHOTO: December 5, 2012 PHOTO NUMBER: 2

CAMERA DIRECTION: Looking NW, SE corner

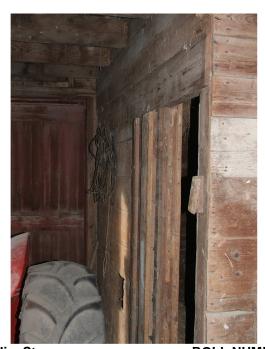
CAMERA DIRECTION: granary in NW corner

First floor, looking West,

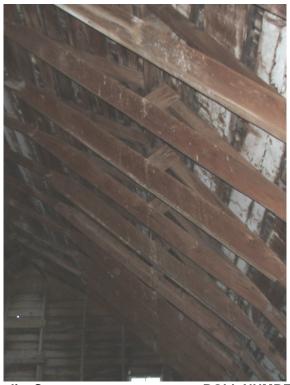
6

Hayloft, looking SE, 2x4lower bracing from rafters down to wall at

CAMERA DIRECTION: floor level

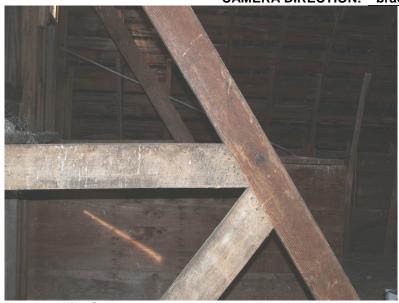
Hayloft, looking SE, 2x4

CAMERA DIRECTION: bracing at hip
