#### **SITE INFORMATION**

#### **SKETCH MAP**

### **History**

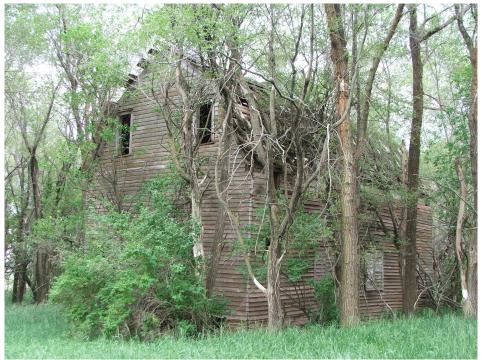
PHOTOGRAPHER: Jim Stone ROLL NUMBER: DATE OF PHOTO: May 23, 2012 PHOTO NUMBER: 3

CAMERA DIRECTION: Looking SE, NW corner

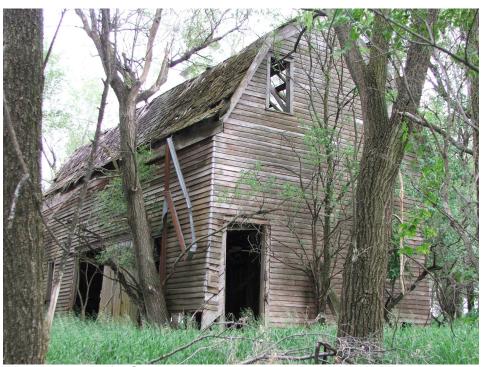
DATE OF PHOTO: May 23, 2012 PHOTO NUMBER: 4

CAMERA DIRECTION: Looking SW, NE corner

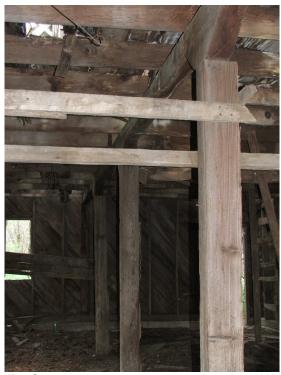
First floor, looking South, 6x8 posts & 6x6

CAMERA DIRECTION: beam

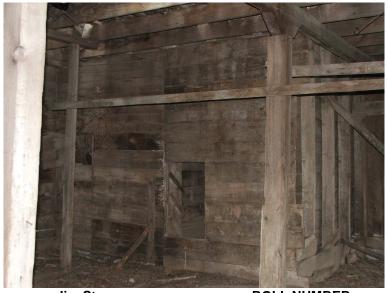
First floor, looking North, (2) 2x4's post & (2) 2x4's beam, granaries in NW

CAMERA DIRECTION: corner

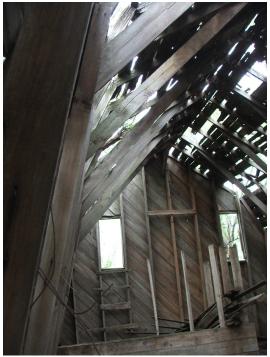
Hayloft, looking North,

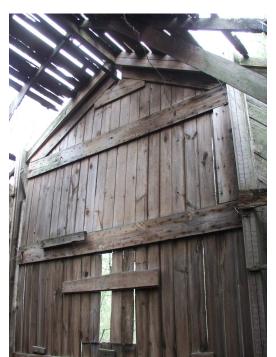
CAMERA DIRECTION: hayloft door

Hayloft, Looking South,
