**SOUTH DAKOTA STATE HISTORIC PRESERVATION OFFICE  
HISTORIC SITES SURVEY STRUCTURE FORM**

\*SURVEY DATE: March 10, 2014 \*ADDRESS: 30031 461<sup>st</sup> Ave.  
\*SURVEYOR: Jim Stone \*COUNTY: Clay  
\*CITY: Centerville

CURRENT FUNCTION: Vacant FOUNDATION: Poured Concrete  
 CURRENT SUBFUNCTION: Vacant ROOF MATERIAL: Steel roofing over cedar shingles  
 HISTORIC FUNCTION: Livestock barn ROOF SHAPE: Gable roof  
 HISTORIC SUBFUNCTION: Hay and grain storage STRUCTURAL SYSTEM: Balloon framing  
 OCCUPIED: no STYLE: Western feeder barn  
Yes with TYPE: Livestock barn  
 ACCESSIBLE: permission WALLS: 2x6 studs, 1x6 # 106 drop siding

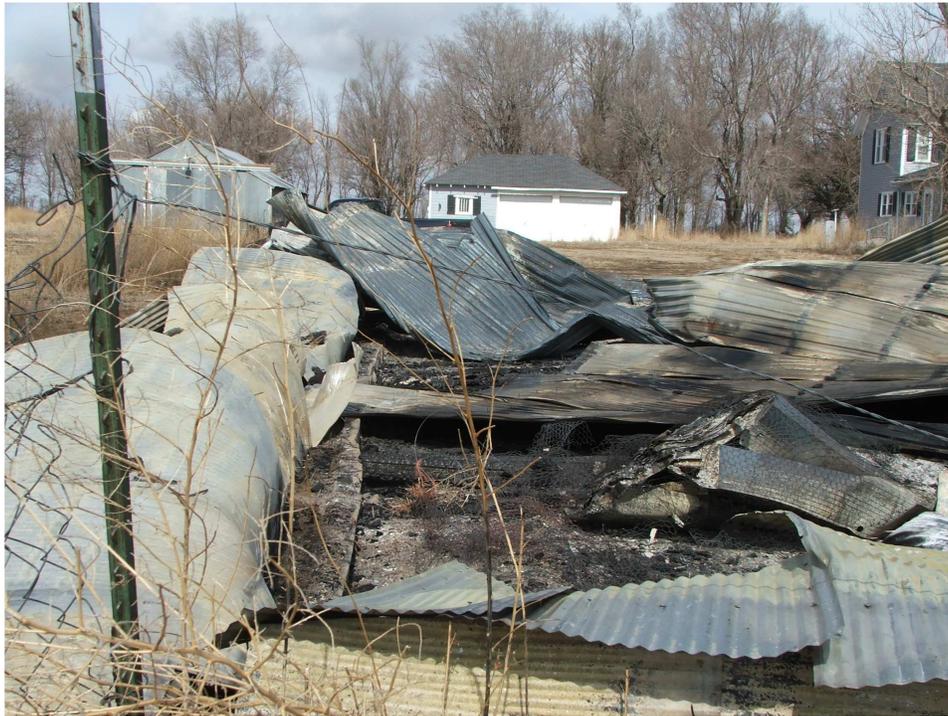
**ROLL NUMBER:** \_\_\_\_\_  
**PHOTO NUMBER:** 1  
**CAMERA DIRECTION:** Looking NE, SW corner

\*PHYSICAL NOTES: Barn burned to the ground. \*RESTRICTED: Y or N  
 \*UTM EASTING: \_\_\_\_\_  
 \*UTM NORTHING: \_\_\_\_\_
