**SOUTH DAKOTA STATE HISTORIC PRESERVATION OFFICE
HISTORIC SITES SURVEY STRUCTURE FORM**

*SURVEY DATE: August 21, 2013 *ADDRESS: 45668 308th Street
*SURVEYOR: Jim Stone *COUNTY: Clay
*CITY: Volin

CURRENT FUNCTION: <u>Calving barn</u>	FOUNDATION: <u>Native stone and poured concrete</u>
CURRENT SUBFUNCTION: <u>Cattle shelter</u>	ROOF MATERIAL: <u>Asphalt shingles over cedar shingles</u>
HISTORIC FUNCTION: <u>Livestock barn</u>	ROOF SHAPE: <u>Gable roof</u>
HISTORIC SUBFUNCTION: <u>Hay & grain storage</u>	STRUCTURAL SYSTEM: <u>Balloon framing</u>
	STYLE: <u>Gable roof barn</u>
OCCUPIED: <u>Yes</u>	TYPE: <u>Livestock barn</u>
	<u>2x6 studs, 1x8 shiplap, 1/2"x6" cedar lap siding</u>
ACCESSIBLE: <u>Yes with permission</u>	WALLS: _____
STORIES: <u>2</u>	SIGNIFICANT PERSON: <u>Ira S. Myron</u>
*DATE OF CONSTRUCTION: <u>Early 1900's</u>	CULTURAL AFFILIATION: <u>?</u>

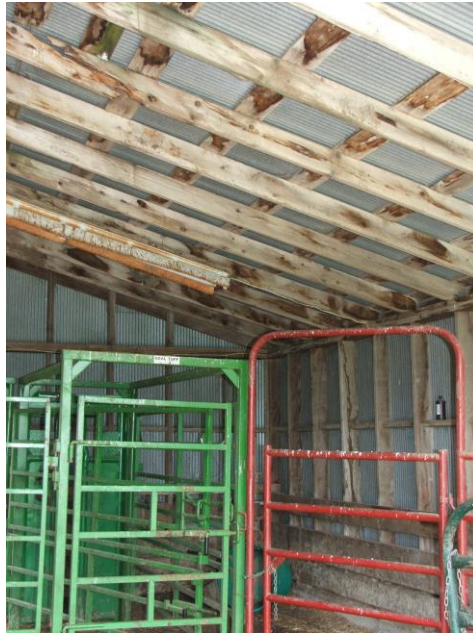
ROLL NUMBER: _____
PHOTO NUMBER: 5

CAMERA DIRECTION: North lean-to, looking NW, 2x6 studs and 2x6 rafters, steel on walls and roof.

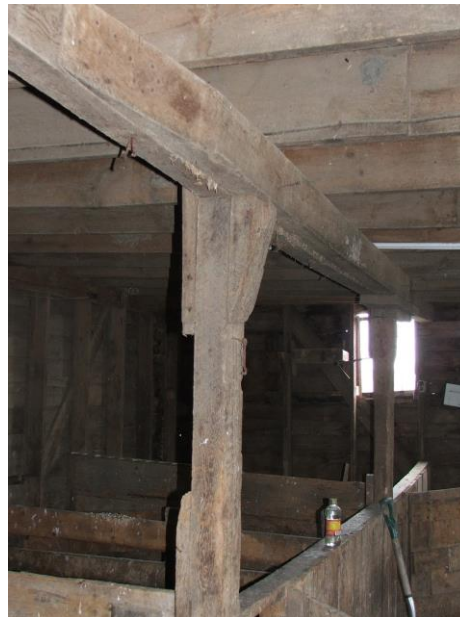
ROLL NUMBER: _____
PHOTO NUMBER: 6

CAMERA DIRECTION: First floor, looking NE, 4x6 posts, 4x6 beam, 2x10 floor joists, note 4x6 doubled.

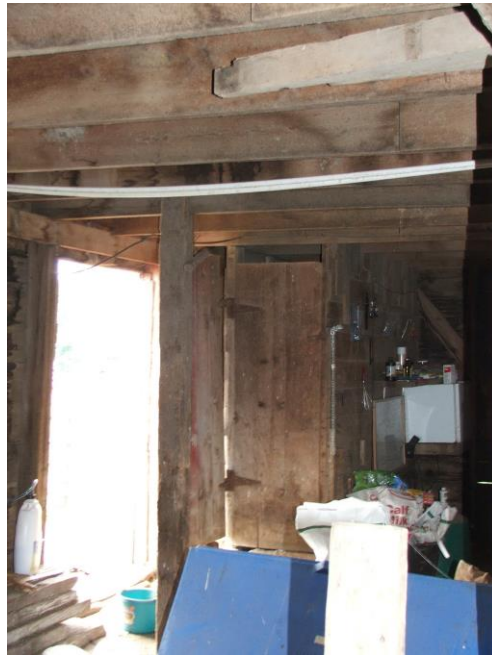
ROLL NUMBER: _____
PHOTO NUMBER: 7

CAMERA DIRECTION: First floor, looking SW,
door into 4'-6" granary
and door to stairs to
hayloft.

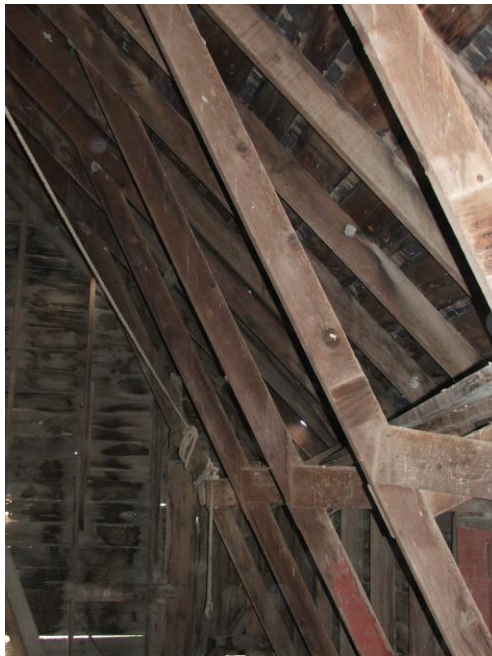
ROLL NUMBER: _____
PHOTO NUMBER: 8

CAMERA DIRECTION: Hayloft, looking SE, 2x6
rafters and 2x6 bracing
for rafters.

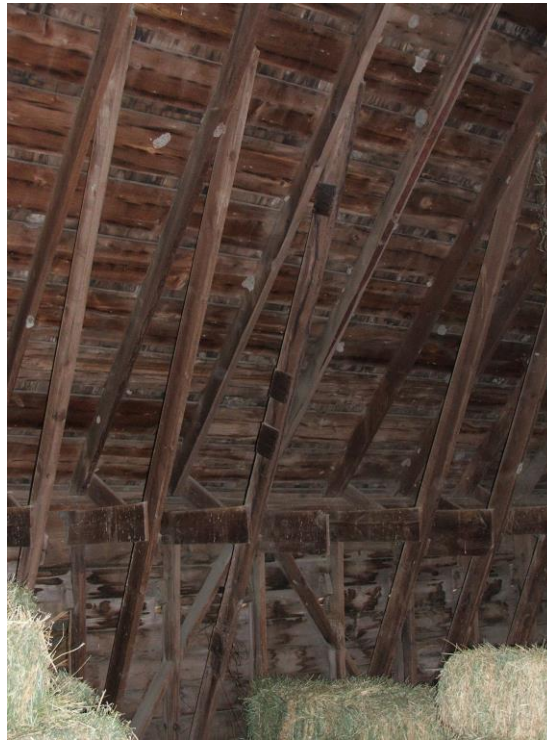
ROLL NUMBER: _____
PHOTO NUMBER: 9

CAMERA DIRECTION: Hayloft, looking NE, 2x6
rafters and 2x6 bracing
for rafters.
