**SOUTH DAKOTA STATE HISTORIC PRESERVATION OFFICE
HISTORIC SITES SURVEY STRUCTURE FORM**

*SURVEY DATE: June 5, 2013 *ADDRESS: 45979 SD 46
*SURVEYOR: Jim Stone *COUNTY: Clay
*CITY: Centerville

CURRENT FUNCTION: <u>Machinery storage</u>	FOUNDATION: <u>No foundation</u>
CURRENT SUBFUNCTION: <u>Machinery storage</u>	ROOF MATERIAL: <u>Cedar shingles</u>
HISTORIC FUNCTION: <u>Livestock barn</u>	ROOF SHAPE: <u>Gambrel</u>
HISTORIC SUBFUNCTION: <u>Hay storage</u>	STRUCTURAL SYSTEM: <u>Balloon framing</u>
	STYLE: <u>Gambrel roof barn</u>
OCCUPIED: Yes	TYPE: <u>Livestock barn</u>
Yes with	<u>2x6 studs, 1x6 #106</u>
ACCESSIBLE: permission	WALLS: <u>drop siding</u>
STORIES: <u>2</u>	SIGNIFICANT PERSON: <u>J. A. Langan</u>
*DATE OF CONSTRUCTION: <u>Early 1900's</u>	CULTURAL AFFILIATION: <u>?</u>

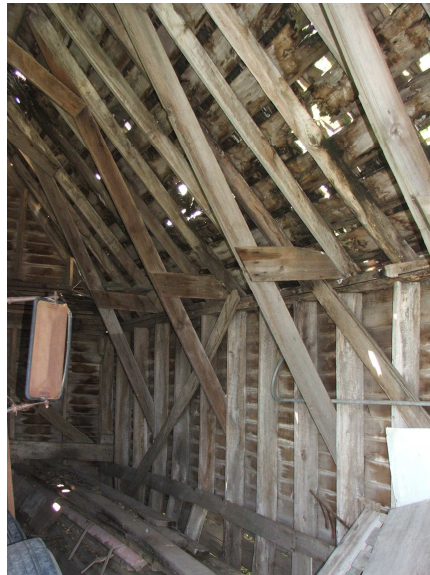
ROLL NUMBER: _____
PHOTO NUMBER: 5

CAMERA DIRECTION: First floor, looking NW,
2x6 stud wall, 2x6
rafters, 2x6 brace 6' O. C.
and 2x8 joist in back on
the West wall.

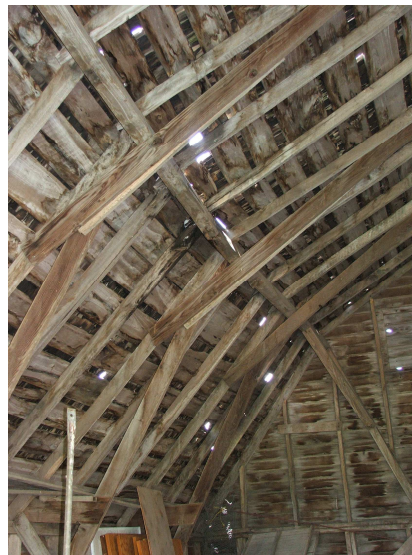
ROLL NUMBER: _____
PHOTO NUMBER: 6

CAMERA DIRECTION: First floor, looking SW,
2x6 lower rafters, 2x4
upper rafters, 6x6 beam
and bracing supporting
hip, may have been 4x6
posts supporting the 6x6
at the hip, note post on
West wall.
