**SOUTH DAKOTA STATE HISTORIC PRESERVATION OFFICE  
HISTORIC SITES SURVEY STRUCTURE FORM**

\*SURVEY DATE: February 12, 2013 \*ADDRESS: Vacated place 1/4 mile south of 302<sup>nd</sup> St. on 461<sup>st</sup> Ave.  
\*SURVEYOR: Jim Stone \*COUNTY: Clay  
\*CITY: Centerville

CURRENT FUNCTION: Storage FOUNDATION: \_\_\_\_\_  
 CURRENT SUBFUNCTION: Storage ROOF MATERIAL: Cedar shingles  
 HISTORIC FUNCTION: Livestock barn ROOF SHAPE: Gambrel  
 HISTORIC SUBFUNCTION: Hay & grain storage STRUCTURAL SYSTEM: Balloon framing  
Gambrel roof bank  
 STYLE: barn  
 OCCUPIED: Yes TYPE: Livestock barn  
8" poured  
concrete, 2x6  
studs, 1x6 #106  
 ACCESSIBLE: Yes with WALLS: \_\_\_\_\_  
permission drop siding

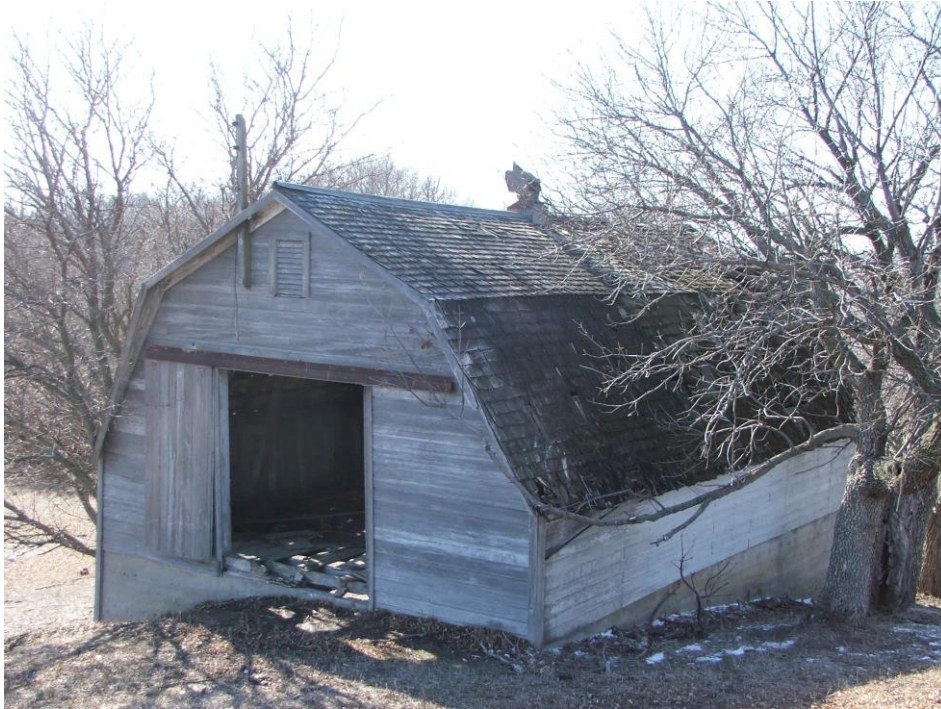
**ROLL NUMBER:** \_\_\_\_\_  
**PHOTO NUMBER:** 3  
**CAMERA DIRECTION:** Looking SW, NE corner,  
note grade of hillside.

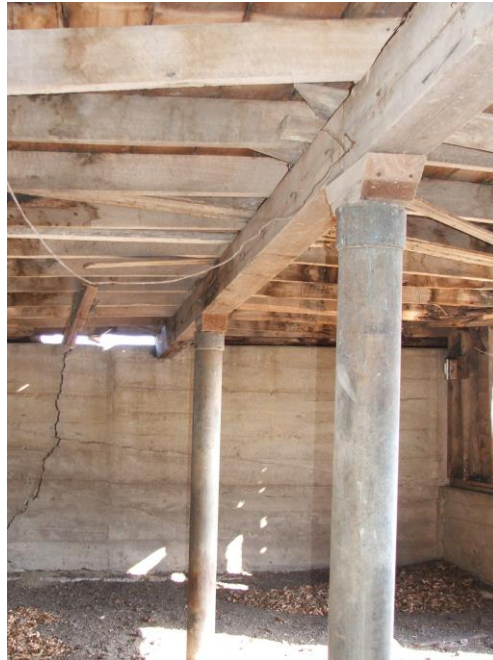
**ROLL NUMBER:** \_\_\_\_\_  
**PHOTO NUMBER:** 5

ALTERED/MOVED NOTES: Original site. Horse stalls and milk cow stanchions have been removed.  
Two wood posts have been replaced with two Heavy 6" pipe posts.

**CAMERA DIRECTION:** First floor, looking East,  
6 x 8 beam and 6" heavy  
pipe posts.

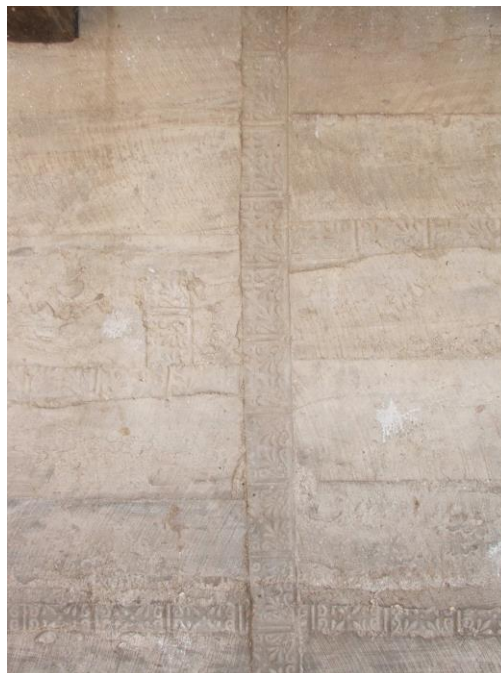
**ROLL NUMBER:** \_\_\_\_\_  
**PHOTO NUMBER:** 6

**CAMERA DIRECTION:** First floor, looking West,  
design in the poured  
concrete.

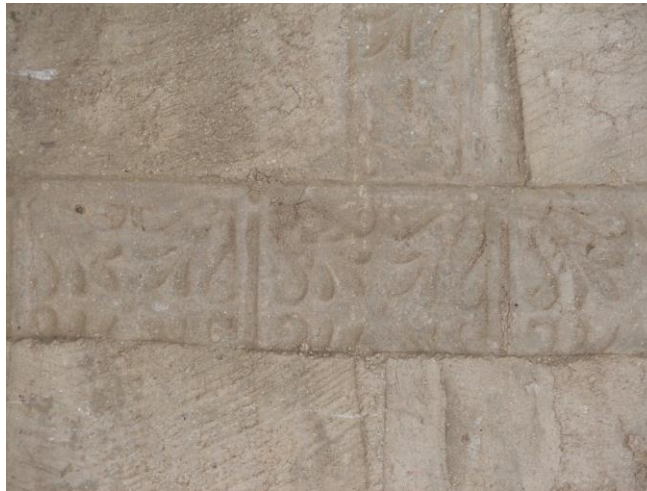
**ROLL NUMBER:** \_\_\_\_\_  
**PHOTO NUMBER:** 7

**First floor, looking West, builders used scrap embossed metal ceiling to cover holes in concrete forms before pouring.**

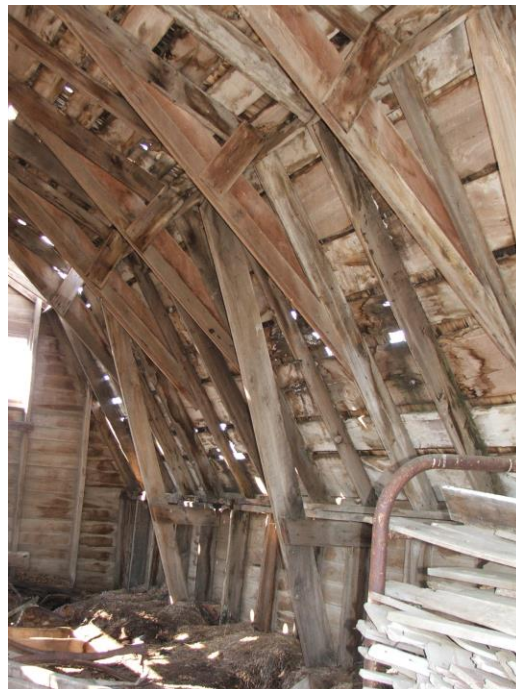
**ROLL NUMBER:** \_\_\_\_\_  
**PHOTO NUMBER:** 8

**Hayloft, looking NW, 2x4 & 1x10 bracing at hip, 4' O. C. and 2x6 brace from hip down to the floor, 8' O. C.**

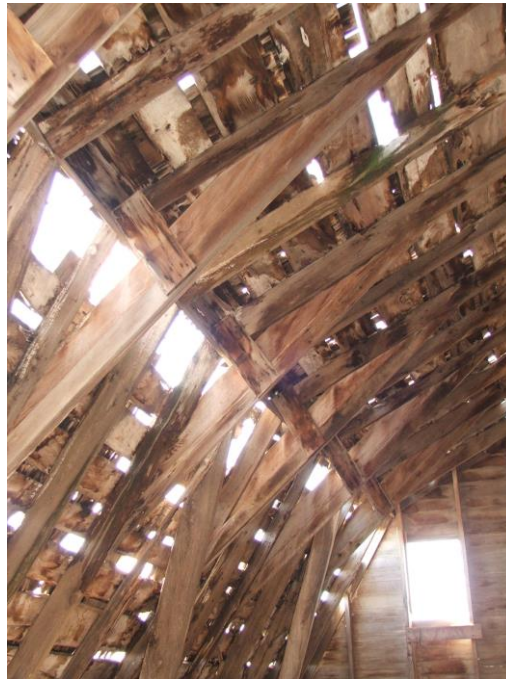
**ROLL NUMBER:** \_\_\_\_\_  
**PHOTO NUMBER:** 9

**CAMERA DIRECTION:** Hayloft, looking SW, 2x4  
& 1x10 brace at the hip,  
4' O. C. and 2x6 brace  
from hip down to floor, 8.  
O.C.
