SITE INFORMATION

*SURVEY D	5, 2012	*ADDRESS:	: 30857 463rd Ave.								
*SURVEYOR: Jim Stone				*COUNTY:	Clay						
				*CITY:	Vermillion						
LOCATION DESCRIPTION: Vermillion, from the intersection of South Dakota Highway 50 bi-pass and											
South Dakota Highway 19, North 8 miles to 309 th Street, turn right (East) about 1/2 mile to 463 rd Ave.,									. .,		
turn left (North) about ½ mile on the left (West) side.											
LEGAL DESCRIPT	ION: Johi	nson's /	Addition, SE ½	4, 35 – 94 – 52 F	Pleasant	t Val	ley T	wp.			
*QUARTER 1:	SE 1/4			OWNER NAME: Cristeen Wibben							
*QUARTER 2:				WNER ADDRESS: 30857 463 rd Ave.							
	Pleasant Va	allev		OWNER CITY:							
*RANGE:	52		c	WNER STATE:						_	
*SECTION:	35			OWNER ZIP:							
ACRES:	12.38			QUAD NAME:							
OWNER CODE 1:	P										
OWNER CODE 2:											
OWNER CODE 3:											
HISTORIC SIGN	IIFICANCE										
				REGISTER NA	ME.						
*DOE DATE:				MULTIPLE PROPERTY NAME:

STRUCTURE DETAILS

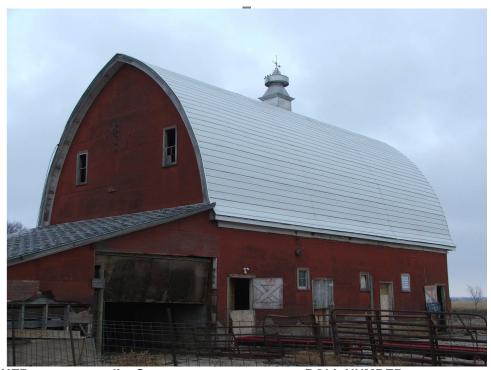
PHOTOGRAPHER: Jim Stone ROLL NUMBER: DATE OF PHOTO: December 16, 2012 PHOTO NUMBER: 1

CAMERA DIRECTION: Looking NE, SW corner

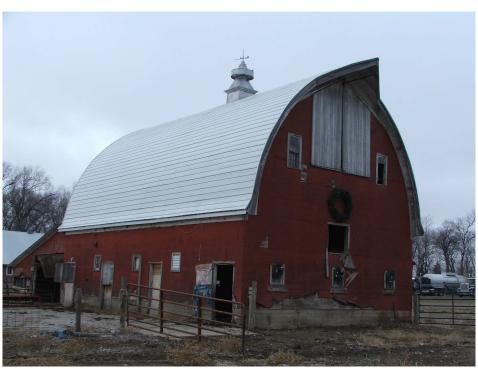
DATE OF PHOTO: December 16, 2012 PHOTO NUMBER: 2

CAMERA DIRECTION: Looking NW, SE corner

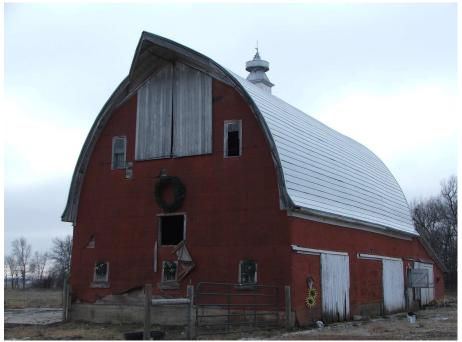
DATE OF PHOTO: December 16, 2012 PHOTO NUMBER: 3

CAMERA DIRECTION: Looking SW, NE corner

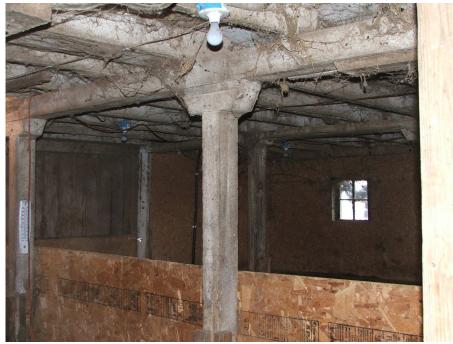
PHOTO NUMBER: 4

First floor, looking NE, 4x6 posts, 6x6 beam and camera double 2x6 floor joists.

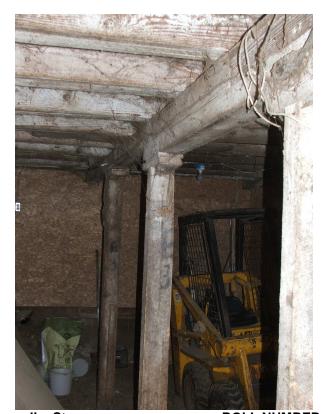
6

First floor, looking SW, 4x6 posts and 6x6 beam, note short 6x6 beam

CAMERA DIRECTION: under top 6x6
