""SITE INFORMATION					
*SURVEY DATE: July 23,	2013 *ADDRESS:	30752 Bluff Road			
*SURVEYOR: Jim Stor		Clay			
	*CITY:	Volin			
LOCATION DESCRIPTION: From Vermillion, South Dakota Highway 50, West about 8 miles to Meckling					
and 456th Ave, turn right (North) about 4-3/4 miles to Bluff Road, turn left (West) about 3-1/2 miles, on the					
right (North) side.					
LEGAL DESCRIPTION: W ½, NE ¼, 29 – 94 – 53 Bethel Twp.					
*QUARTER 1: NE 1/4	OWNER NAME:	Robert E. & Anna M. Johnson			
*QUARTER 2:	OWNER ADDRESS:				
*TOWNSHIP: Bethel	OWNER CITY:				
*RANGE: 53	OWNER STATE:	South Dakota			
*SECTION: 29	OWNER ZIP:	57072			
ACRES: 77.07	QUAD NAME:				
OWNER CODE 1: P					
OWNER CODE 2:					
OWNER CODE 3:					
HISTORIC SIGNIFICANCE					
*DOE:	REGISTER NA	REGISTER NAME:			
*DOE DATE.		MULTIPLE PROPERTY NAME:			
REASON INELIGIBLE:					
		CATEGORY:			
NOMINATION STATUS:	SIGNII	SIGNIFICANCE LEVEL 1: N S L			
DATE LISTED:	SIGNII	FICANCE LEVEL 2: N S L

#### STRUCTURE DETAILS

SHPO ID:					
*PROPERTY NAME:					
OTHER NAME:					
CURRENT FUNCTION:	Storage	FOUNDATION:	Poured concrete		
			Asphalt shingles over		
CURRENT SUBFUNCTION:	Storage	ROOF MATERIAL:			
HISTORIC FUNCTION:	Horse barn	ROOF SH

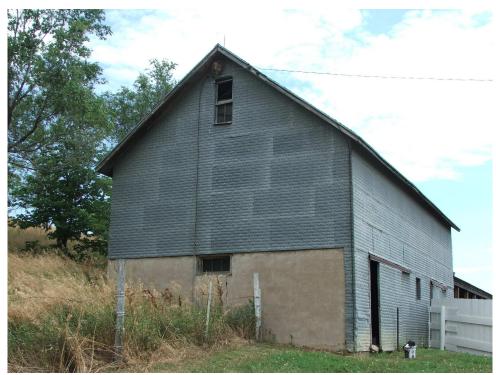
CAMERA DIRECTION: Looking NE, SW corner

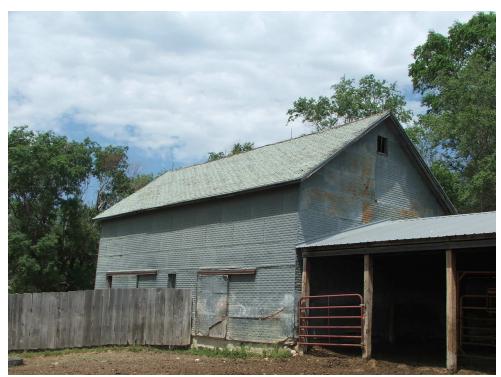
CAMERA DIRECTION: Looking NW, SE corner

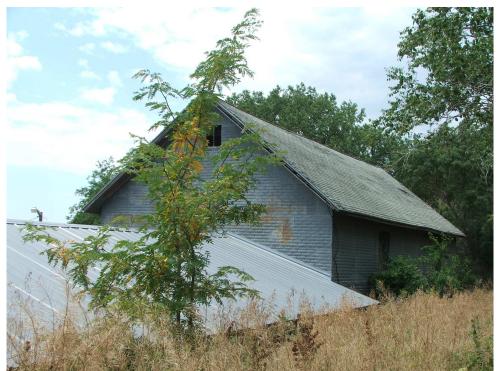
CAMERA DIRECTION: Looking SW, NE corner

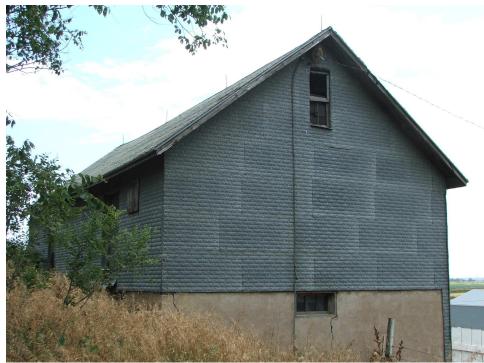
CAMERA DIRECTION: Looking SE, NW corner

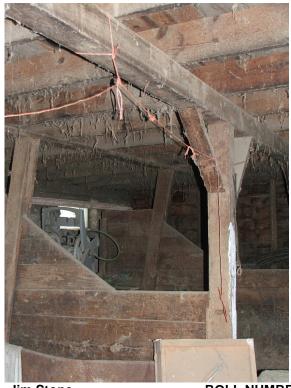
5

First floor, looking NE, 6x6 post, 6x6 beam, 2x8 joists, double horse

**CAMERA DIRECTION:** stalls

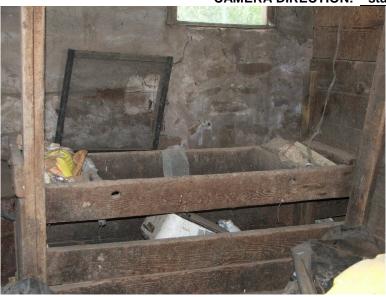
First floor, looking North, 3/4 horse stall at West

CAMERA DIRECTION: end.
