**SOUTH DAKOTA STATE HISTORIC PRESERVATION OFFICE
HISTORIC SITES SURVEY STRUCTURE FORM**

*SURVEY DATE: June 5, 2013 *ADDRESS: 29841 458th Ave.
*SURVEYOR: Jim Stone *COUNTY: Clay
*CITY: Centerville

CURRENT FUNCTION:	<u>Cow calf barn</u>	FOUNDATION:	<u>Poured concrete</u>
CURRENT SUBFUNCTION:	<u>Storage</u>	ROOF MATERIAL:	<u>Steel over cedar shingles</u>
HISTORIC FUNCTION:	<u>Livestock barn</u>	ROOF SHAPE:	<u>Gambrel</u>
HISTORIC SUBFUNCTION:	<u>Hay grain storage</u>	STRUCTURAL SYSTEM:	<u>Balloon framing</u>
OCCUPIED:	<u>No</u>	STYLE:	<u>Gambrel roof barn</u>
ACCESSIBLE:	<u>Yes with permission</u>	TYPE:	<u>Livestock barn</u> <u>2x6 studs, 1x8 diagonal sheathing, 1/2"x6" cedar lap siding.</u>
WALLS:			
STORIES:	<u>2</u>	SIGNIFICANT PERSON:	<u>J. I. Gray</u>
*DATE OF CONSTRUCTION:	<u>Early 1900's</u>	CULTURAL AFFILIATION:	<u>?</u>

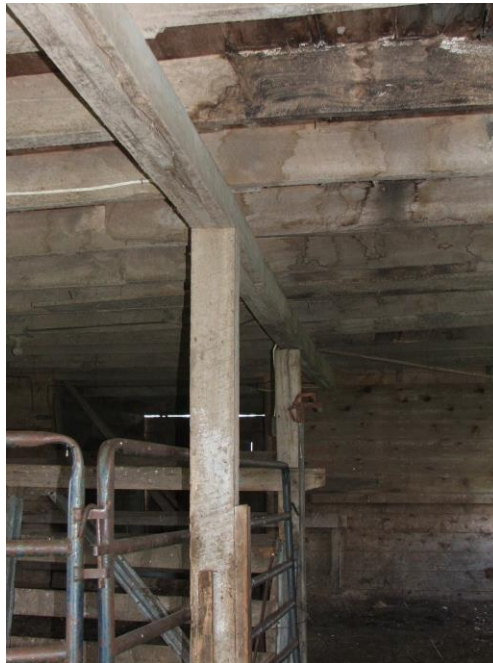
ROLL NUMBER: _____
PHOTO NUMBER: 5

INTERIOR NOTES: Two rows of 6"x6" posts, and (3) 2x6's laminated for a beam to support the 2x8 joists for the hayloft floor. Two 12' x 10' granaries at the West end with alley between. Three granaries above in the hayloft at the West end. Floor joists are 12" O. C. to support the granaries at the West end.

CAMERA DIRECTION: First floor, looking SW,
6x6 post, (3) 2x6's beam,
2x8 joists, note granary
in back on NW corner.

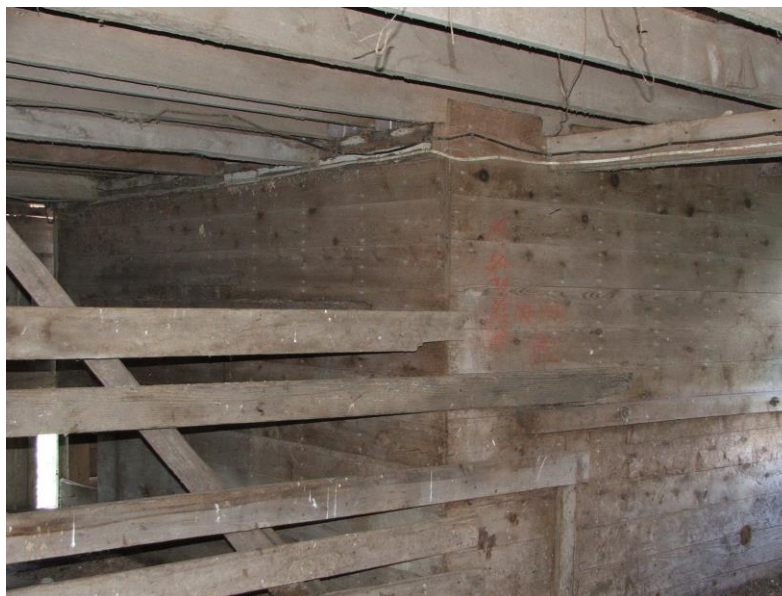
ROLL NUMBER: _____
PHOTO NUMBER: 6

CAMERA DIRECTION: First floor, looking NW,
granary in NW corner,
floor joists 12" O. C.
above to support
granaries in hayloft.

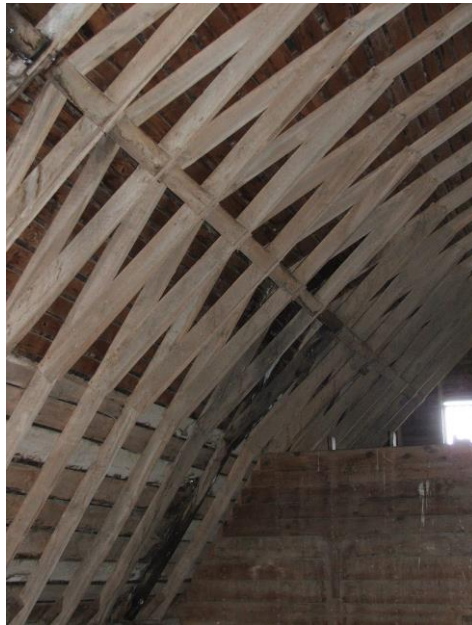
ROLL NUMBER: _____
PHOTO NUMBER: 7

**Hayloft, looking SW, 2x6
rafters with (2) 1x6's
bracing hip, note
granaries in back along
the West wall.**

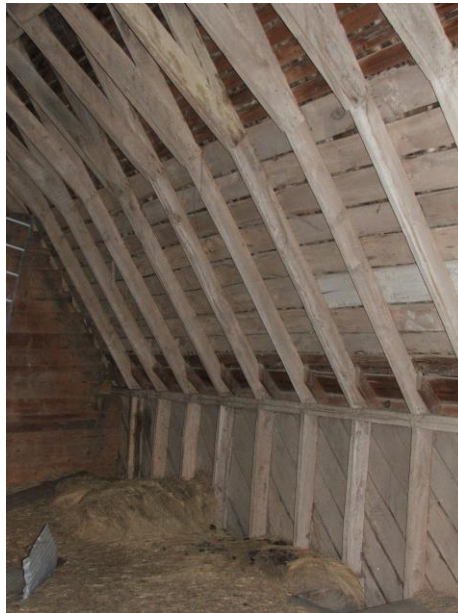
ROLL NUMBER: _____
PHOTO NUMBER: 8

**Hayloft, looking NW, 2x6
stud wall in hayloft with
diagonal sheathing.**

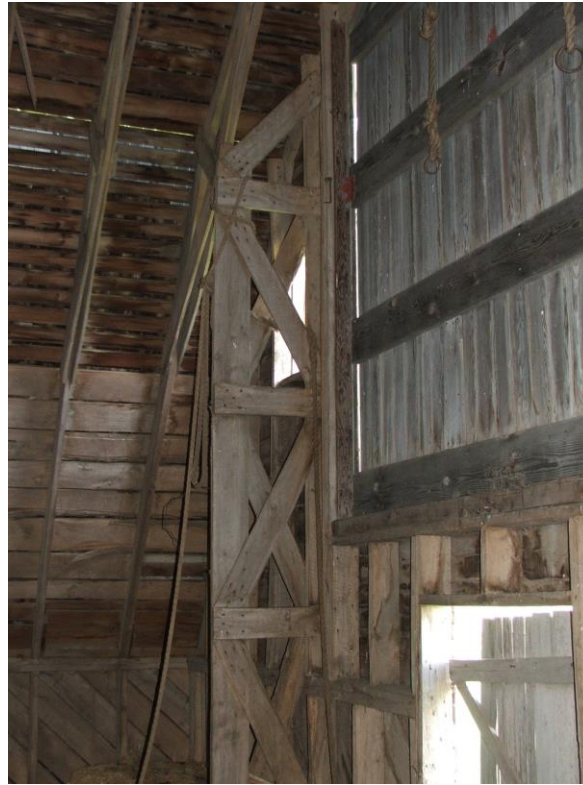
ROLL NUMBER: _____
PHOTO NUMBER: 9

CAMERA DIRECTION: Hayloft, looking NE,
vertical truss on each
side of hayloft door to
strengthen East gable
end wall.
