**SOUTH DAKOTA STATE HISTORIC PRESERVATION OFFICE
HISTORIC SITES SURVEY STRUCTURE FORM**

*SURVEY DATE: July 26, 2013 *ADDRESS: 30884 460nd Ave.
*SURVEYOR: Jim Stone *COUNTY: Clay
*CITY: Wakonda

CURRENT FUNCTION: Storage FOUNDATION: Native rock no mortar
Steel roofing over
cedar shingles
 CURRENT SUBFUNCTION: Storage ROOF MATERIAL: _____
 HISTORIC FUNCTION: Livestock barn ROOF SHAPE: Gable roof
 HISTORIC SUBFUNCTION: Hay storage STRUCTURAL SYSTEM: Balloon framing
 OCCUPIED: No STYLE: Gable roof barn
 TYPE: Livestock barn
2x4 & 2x6 studs, 1x8
#106 drop siding and
1/2"x6" cedar lap
siding.
 ACCESSIBLE: Yes with
permission WALLS: _____

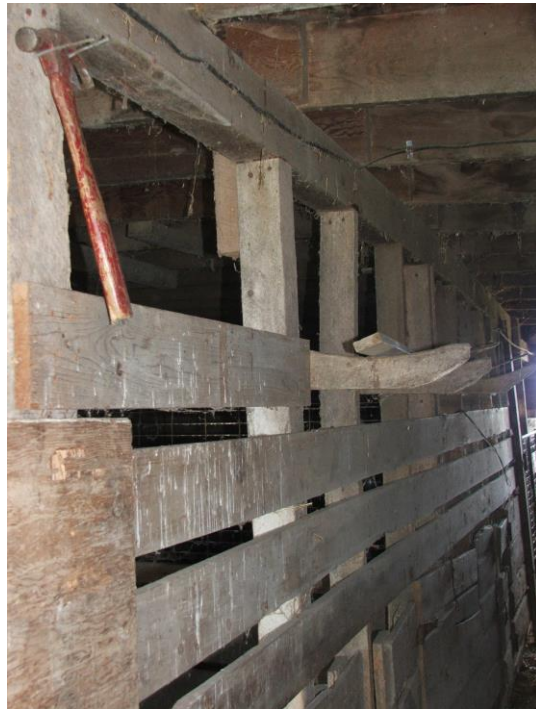
ROLL NUMBER: 5
PHOTO NUMBER: 5

First floor, looking NW,
2x6 studs, 4x6 beam, 2x8
joists, milk cow stalls
were on East wall, wood
brackets were to hang
milk pails.

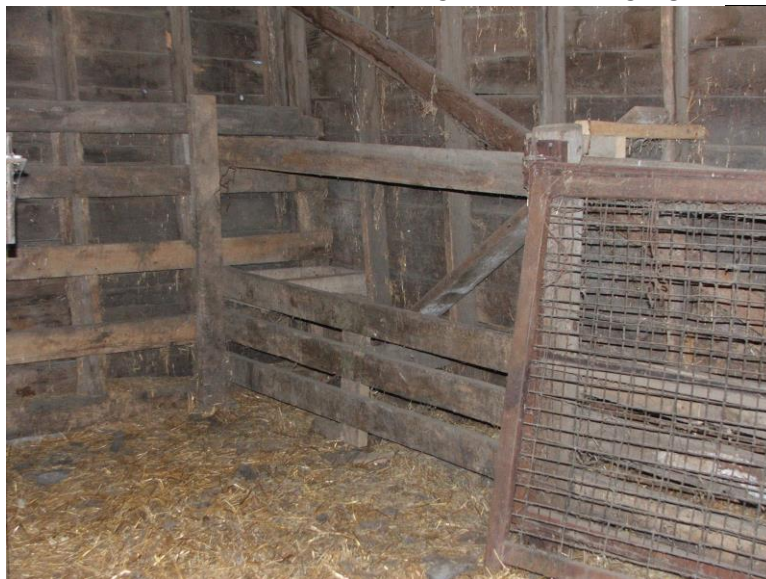
ROLL NUMBER: 6
PHOTO NUMBER: 6

First floor, looking NE,
milk cow stalls still in
place along East wall.

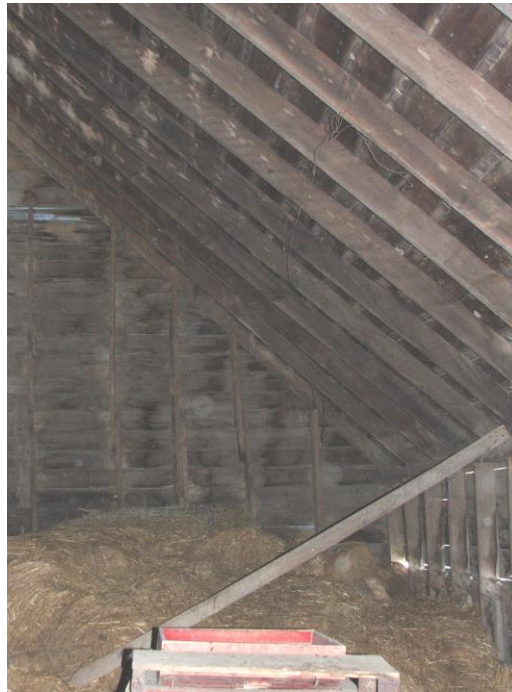
ROLL NUMBER: _____
PHOTO NUMBER: 7

**Hayloft, looking NE, 2x6
rafters, 6'- 6" stud wall in
hayloft.**

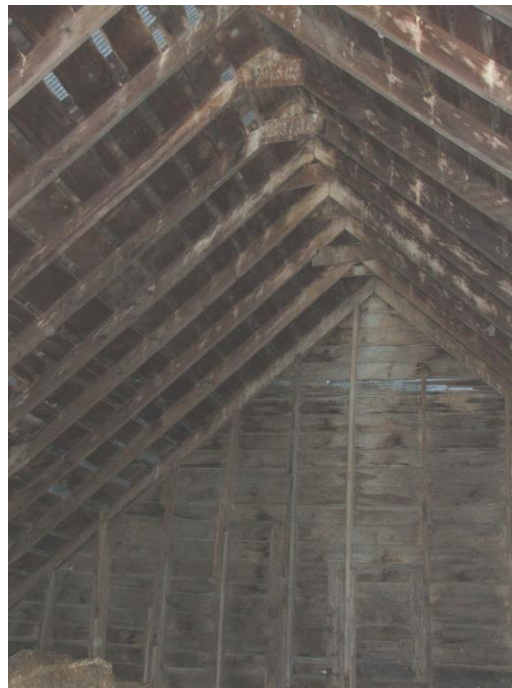
ROLL NUMBER: _____
PHOTO NUMBER: 8

**Hayloft. looking North,
1x6's bracing on rafters
at the peak.**
