**SOUTH DAKOTA STATE HISTORIC PRESERVATION OFFICE  
HISTORIC SITES SURVEY STRUCTURE FORM**

\*SURVEY DATE: July 30, 2013 \*ADDRESS: 30832 Frog Creek Road  
\*SURVEYOR: Jim Stone \*COUNTY: Clay  
\*CITY: Vermillion

CURRENT FUNCTION: <u>Vacant</u>	FOUNDATION: <u>Native stone and poured concrete</u>
CURRENT SUBFUNCTION: <u>Storage</u>	ROOF MATERIAL: <u>Steel roofing over cedar shingles</u>
HISTORIC FUNCTION: <u>Livestock barn</u>	ROOF SHAPE: <u>Gable roof</u>
HISTORIC SUBFUNCTION: <u>Hay and grain storage</u>	STRUCTURAL SYSTEM: <u>Mortised posts and beams</u>
	STYLE: <u>Post &amp; beam gable roof barn</u>
OCCUPIED: <u>No</u>	TYPE: <u>Livestock barn</u>
	<u>2x6 studs, 1x8 ship lap and 1/2"x6" cedar lap siding.</u>
ACCESSIBLE: <u>Yes with permission</u>	WALLS: _____
STORIES: <u>2</u>	SIGNIFICANT PERSON: <u>J. O. Johnson</u>
*DATE OF CONSTRUCTION: <u>Late 1800's</u>	CULTURAL AFFILIATION: <u>Norwegian</u>

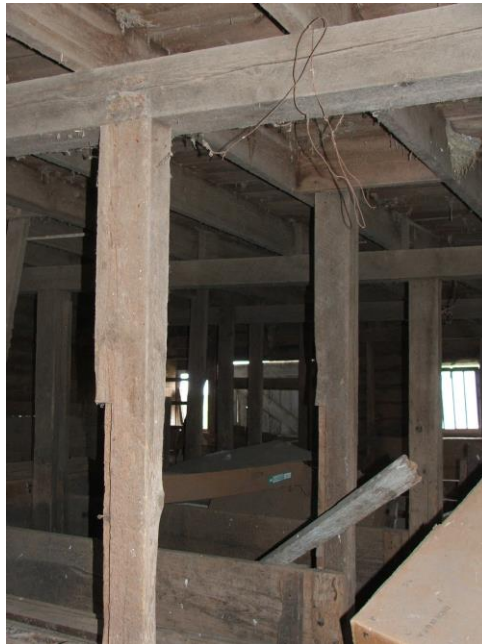
**ROLL NUMBER:** \_\_\_\_\_  
**PHOTO NUMBER:** 5

**First floor, looking SW,  
6x6 post, 6x6 beam, 2x8  
joists and horse stalls  
on West side.**

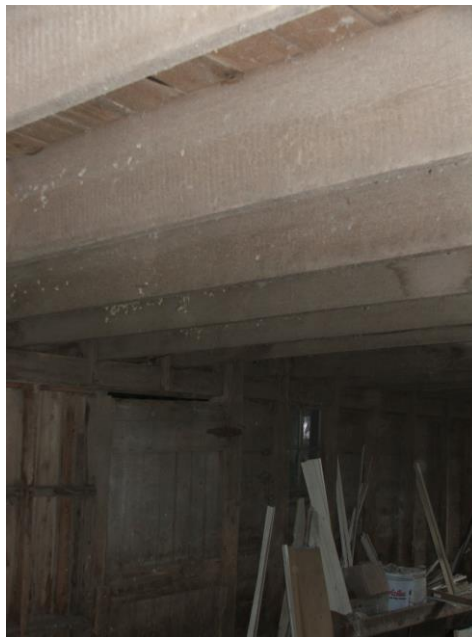
**ROLL NUMBER:** \_\_\_\_\_  
**PHOTO NUMBER:** 6

**First floor, looking SE on  
East side, note rough  
sawn 2x12 floor joists  
and 8' sliding door  
framed to 4' swing door**

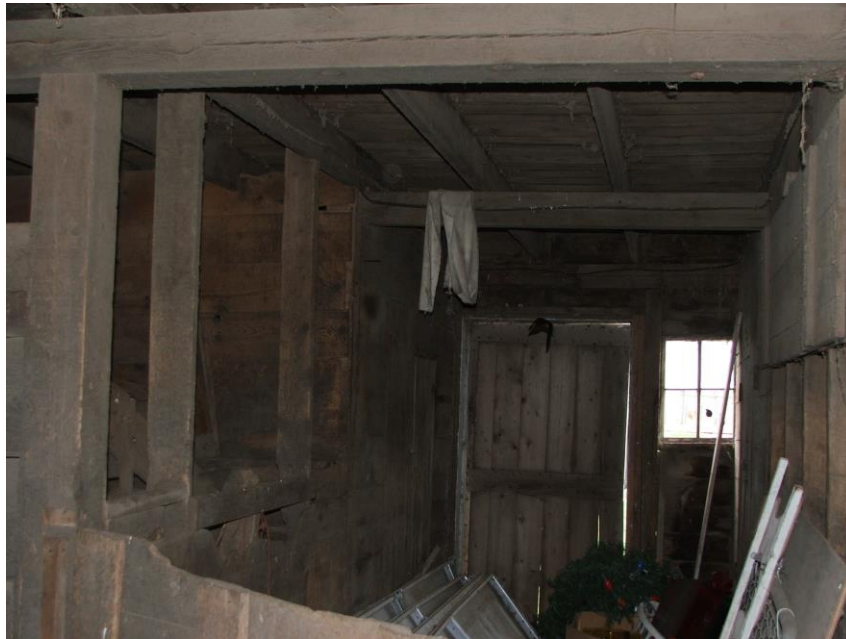
**ROLL NUMBER:** \_\_\_\_\_  
**PHOTO NUMBER:** 7

**First floor, looking North, in center feed alley, note granaries on each side on North wall.**

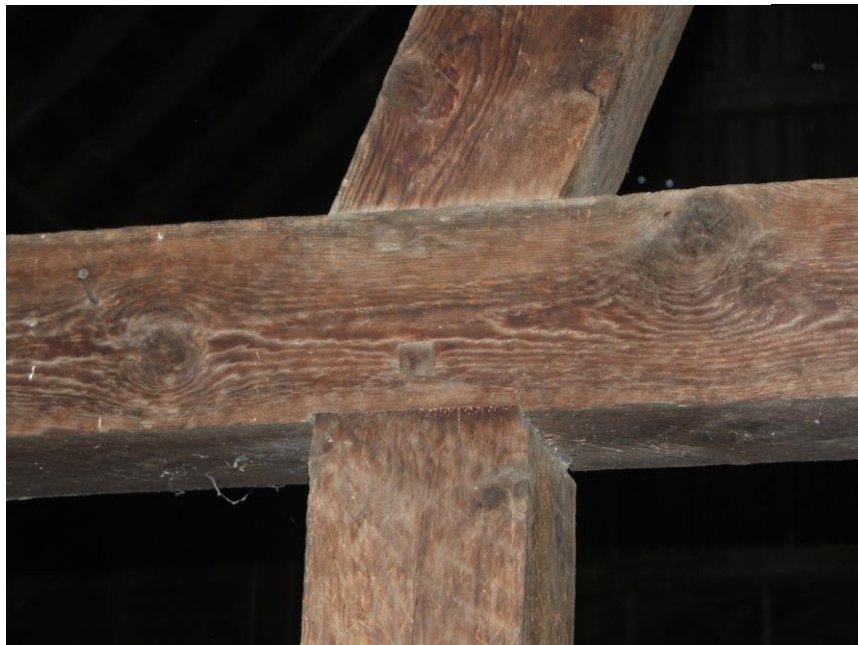
**ROLL NUMBER:** \_\_\_\_\_  
**PHOTO NUMBER:** 8

**Hayloft. looking North, 6x6 beam on 6x6 post supporting 6x6 post up to hip, all mortised and tendon with pegs.**

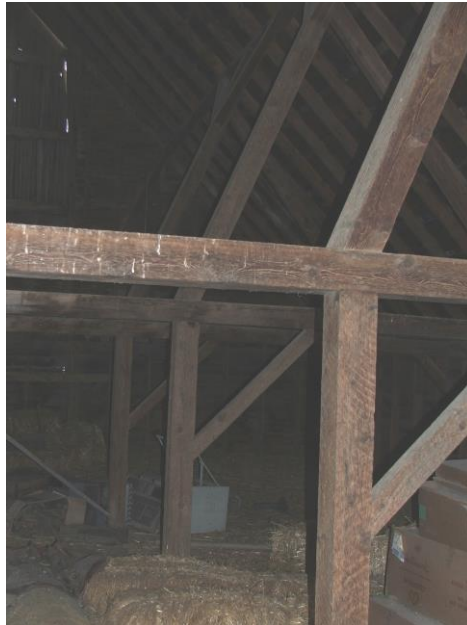
**ROLL NUMBER:** \_\_\_\_\_  
**PHOTO NUMBER:** 9

**Hayloft. looking NE, 6x6 beam on 6x6 post supporting slanted 6x6 post to roof hip.**

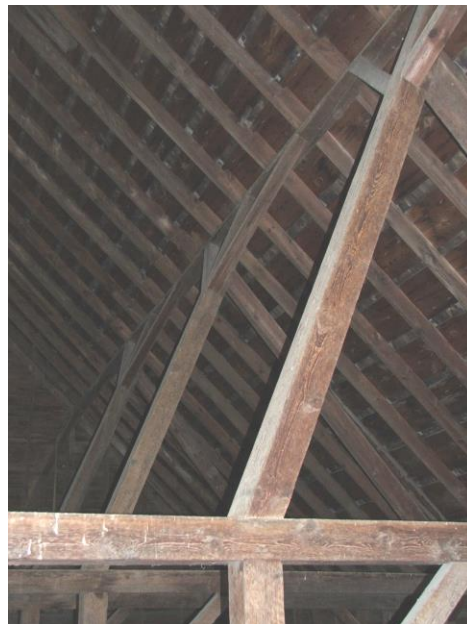
**ROLL NUMBER:** \_\_\_\_\_  
**PHOTO NUMBER:** 10

**Hayloft. looking NE, 6x6 beam on 6x6 post supporting 6x6 post up to hip, all mortised and tendon with pegs.**

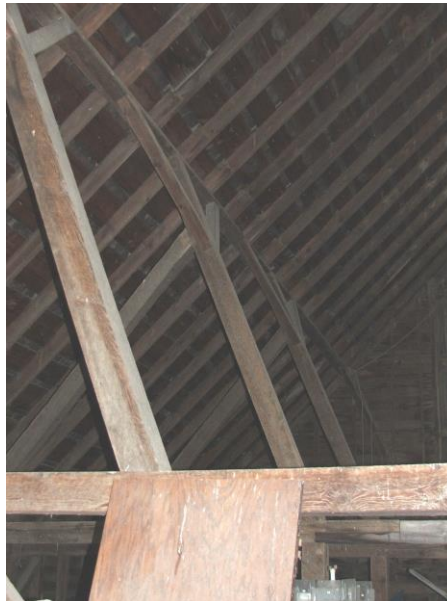
**ROLL NUMBER:** \_\_\_\_\_  
**PHOTO NUMBER:** 11

**Hayloft. looking NW, 6x6 beam on 6x6 post supporting 6x6 post up to hip, note all of the 4x4 bracing also mortised and tendon, no pegs**

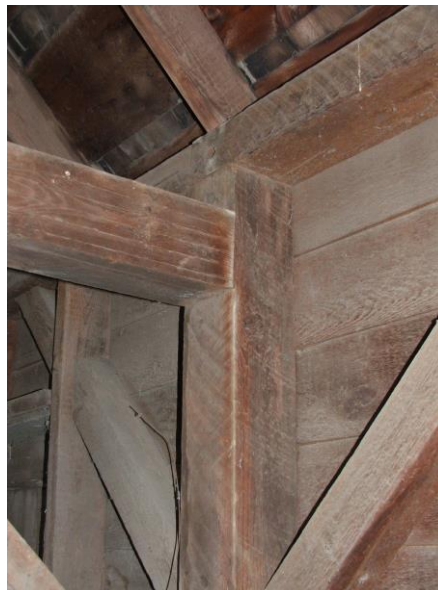
**ROLL NUMBER:** \_\_\_\_\_  
**PHOTO NUMBER:** 12

**Hayloft. looking NE, 6x6x16' post in wall on 6 supporting 6x6 beam and 4x6 beam on top of wall, all mortised and tendon with pegs.**
