#### SITE INFORMATION

#### STRUCTURE DETAILS

SHPO ID:									
*PROPERTY NAME:									
OTHER NAME:									
<b>CURRENT FUNCTION:</b>	Horse barn	FOUNDATION	l: Poured concrete						
CURRENT SUBFUNCTION:	Storage	ROOF MATERIAL	Cedar shingles						
HISTORIC FUNCTION:	Livestock barn	ROOF SHAPE	: Gable						
HISTORIC SUBFUNCTION:	Hay & grain storage	STRUCTURAL SYSTEM	Balloon framing						
		STYLE	: Gable roof barn						
OCCUPIED:	Yes	TYPE	: Livestock barn						
	Yes with		2x6 studs, 1x6						
ACCESSIBLE:	permission	WALLS:	#106 drop siding						
STORIES:	<del></del>		J. P Knudson						
*DATE OF CONSTRUCTION:	About 1920	CULTURAL AFFILIATION:	?						
ALTERED/MOVED NOTES: Original site. Any evidence of horse stalls and milk cow stanchions has									
been removed. Granaries appear to have been added later and extended into hayloft. 14' x 32' lean-to									
on the West side may have be	en added later.								
INTERIOR NOTES: Has two	rows of 4x6 nosts a	nd a 6x6 for a heam. The floor in	ists for the havloft

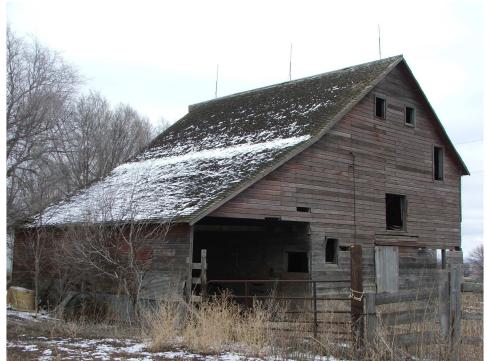
PHOTOGRAPHER: Jim Stone ROLL NUMBER: DATE OF PHOTO: February 16, 2013 PHOTO NUMBER: 1
CAMERA DIRECTION: Looking NE, SW corner

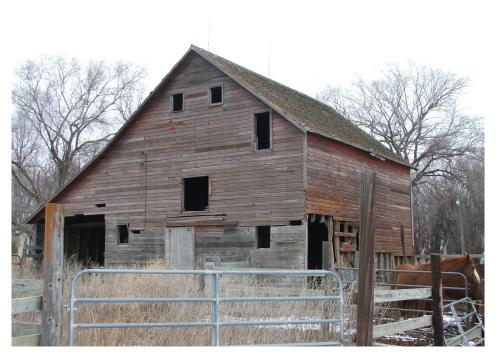
PHOTOGRAPHER: Jim Stone ROLL NUMBER: DATE OF PHOTO: February 16, 2013 PHOTO NUMBER: 2
CAMERA DIRECTION: Looking NW, SE corner

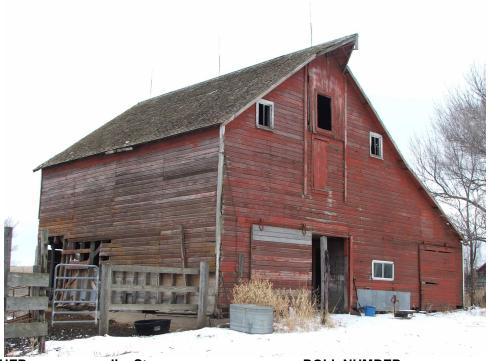
PHOTO NUMBER: 3
CAMERA DIRECTION: Looking SW, NE corner

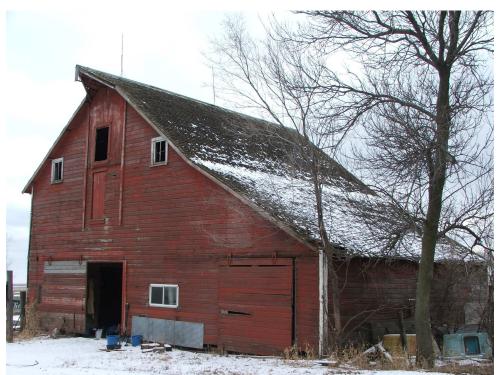
CAMERA DIRECTION: Looking SE, NW corner
