SOUTH DAKOTA STATE HISTORIC PRESERVATION OFFICE
HISTORIC SITES SURVEY STRUCTURE FORM

*ADDRESS: 30748 So. Dak. Hwy 19

CURRENT FUNCTION:	<u>Vacant</u>	FOUNDATION:	<u>Poured concrete</u>
CURRENT SUBFUNCTION:	<u>Vacant</u>	ROOF MATERIAL:	<u>Cedar shingles</u>
HISTORIC FUNCTION:	<u>Livestock barn</u>	ROOF SHAPE:	<u>Gambrel roof</u>
HISTORIC SUBFUNCTION:	<u>Hay and grain storage</u>	STRUCTURAL SYSTEM:	<u>Balloon framing</u>
		STYLE:	<u>Gambrel roof barn</u>
OCCUPIED:	<u>Yes</u>	TYPE:	<u>Livestock barn</u>
	<u>Yes with</u>		<u>2x6 & 2x8 studs, 1x6</u>
ACCESSIBLE:	<u>permission</u>	WALLS:	<u># 106 drop siding</u>
STORIES:	<u>2</u>	SIGNIFICANT PERSON:	<u>J. T. Powell</u>
*DATE OF CONSTRUCTION:	<u>1923</u>	CULTURAL AFFILIATION:	<u>?</u>

*PHYSICAL NOTES: Barn is in poor condition.

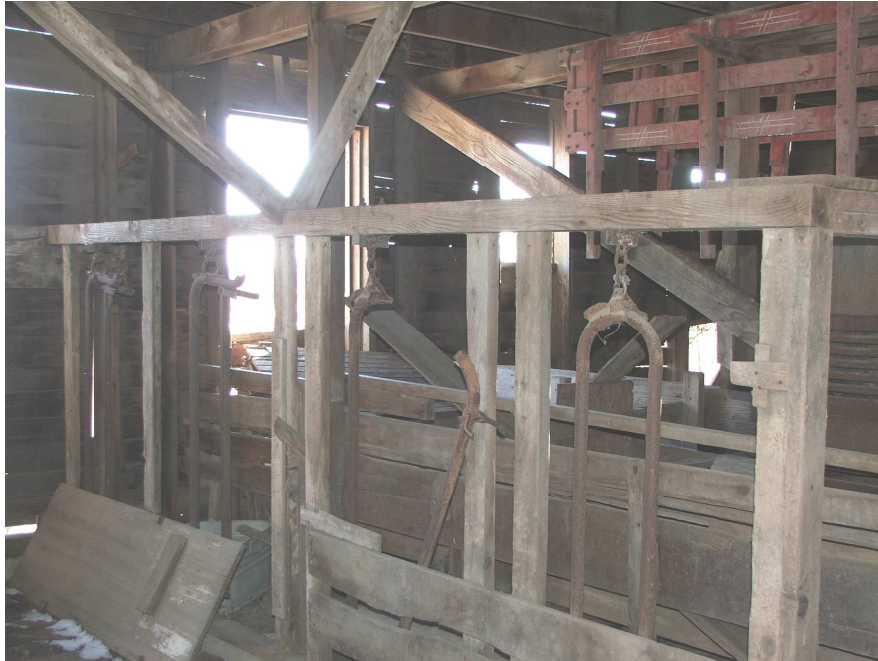
ROLL NUMBER: _____
PHOTO NUMBER: 5

ALTERED/MOVED NOTES: Original site. Any evidence of horse stalls in the main barn has been removed. 16' x 32' lean-to may have been added on the South side. 1x10 shiplap is on the South wall of the barn and no siding. There is 1/2" x 6" cedar lap siding over the 1x6 #106 drop siding on the lean-to, which could have been added later. Four milk cow stanchions may have been added in the NE corner as the concrete appears newer there.

CAMERA DIRECTION: First floor, looking SE at
6x6 posts, 6x6 beams,
2x10 floor joists and four
milk cow stanchions.

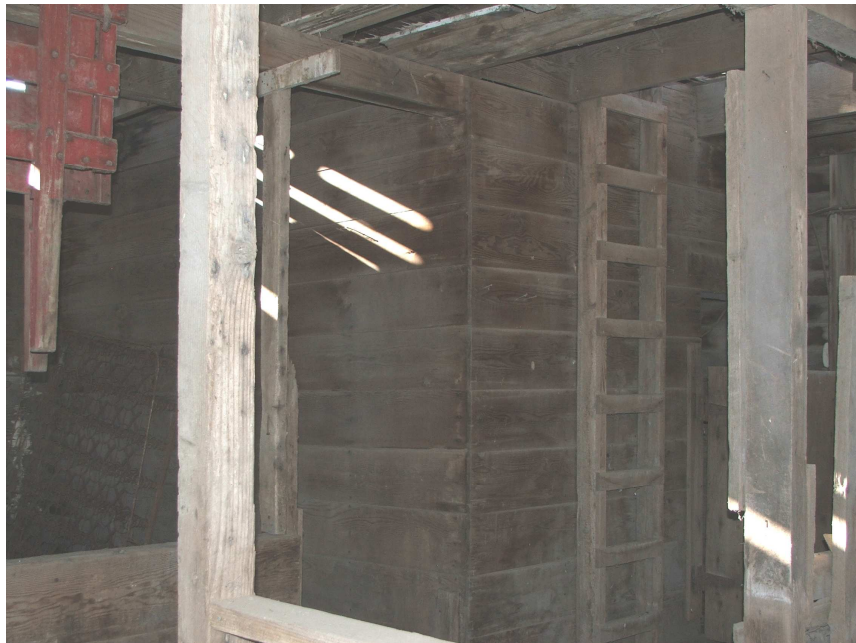
ROLL NUMBER: _____
PHOTO NUMBER: 6

CAMERA DIRECTION: First floor, looking SW,
4x6 posts, 6x6 beam and
granary in SW corner

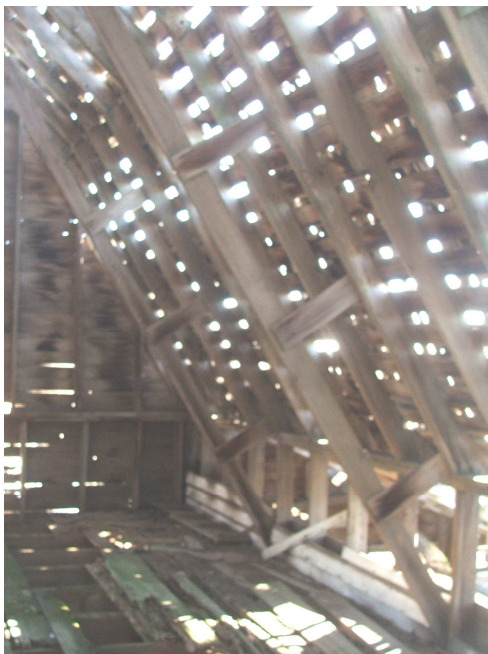
ROLL NUMBER: _____
PHOTO NUMBER: 7

Hayloft, looking SE, 2x6
rafters, 2x6 brace from
center of top rafter down
to floor, 8' O. C.

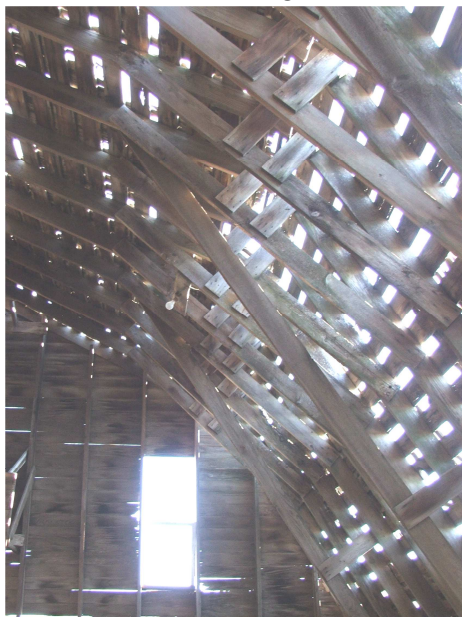
ROLL NUMBER: _____
PHOTO NUMBER: 8

Hayloft, looking SE, 2x6
rafters with 2x6 brace on
each hip, and long 2x6
brace 8' O. C.
