SITE INFORMA	TION											
*SURVEY DAT	TE: August 1	2, 2013	*ADDRESS:	30538	457 th A	ve.						
*SURVEYO	OR: Jim Ston	е	*COUNTY:	Clay								
			*CITY:	Wakor	nda							
LOCATION DESCRIPTION: From Vermillion, intersection of South Dakota Highway 50 bi-pass and												
South Dakota Highway 19, North about 11 miles to 306th Street, turn left (West) about 5 miles to 457th Ave.,												
turn right, (North) about 3/4 mile, on the right (East) side.												
LEGAL DESCRIPTION: E 391' of Anderson tract 1, E 1/2, NW 1/4, 13 – 94 – 53 Bethel Twp.

STRUCTURE DETAILS

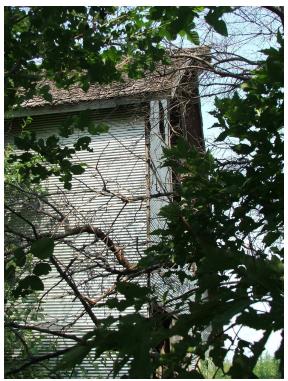
CAMERA DIRECTION: Looking NE, SW corner

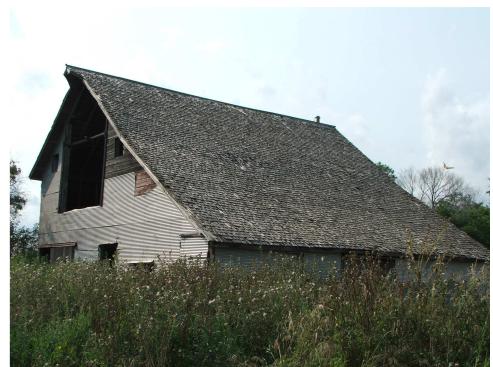
CAMERA DIRECTION: Looking NW, SE corner

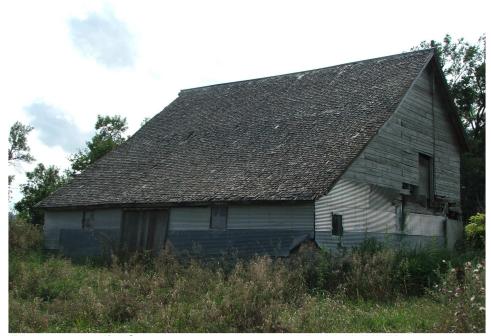
PHOTOGRAPHER: Jim Stone ROLL NUMBER:
DATE OF PHOTO: August 12, 2013 PHOTO NUMBER: 3
CAMERA DIRECTION: Looking SW, NE corner

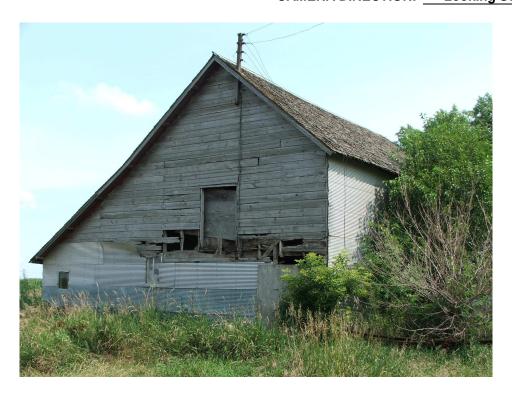
PHOTOGRAPHER: Jim Stone ROLL NUMBER: DATE OF PHOTO: August 12, 2013 PHOTO NUMBER: 4
CAMERA DIRECTION: Looking SE, NW corner
