**SOUTH DAKOTA STATE HISTORIC PRESERVATION OFFICE
HISTORIC SITES SURVEY STRUCTURE FORM**

*SURVEY DATE: May 6, 2013 *ADDRESS: 31222 453rd Ave.
*SURVEYOR: Jim Stone *COUNTY: Clay
*CITY: Gayville

CURRENT FUNCTION: Vacant FOUNDATION: No foundation
 CURRENT SUBFUNCTION: Storage ROOF MATERIAL: Asphalt shingles over cedar shingles
 HISTORIC FUNCTION: Livestock barn ROOF SHAPE: Gambrel
 HISTORIC SUBFUNCTION: Hay storage STRUCTURAL SYSTEM: Balloon framing
 OCCUPIED: Yes STYLE: Gambrel roof barn
Yes with TYPE: Livestock barn
 ACCESSIBLE: permission WALLS: 2x4 studs, 1x6 #106 drop siding

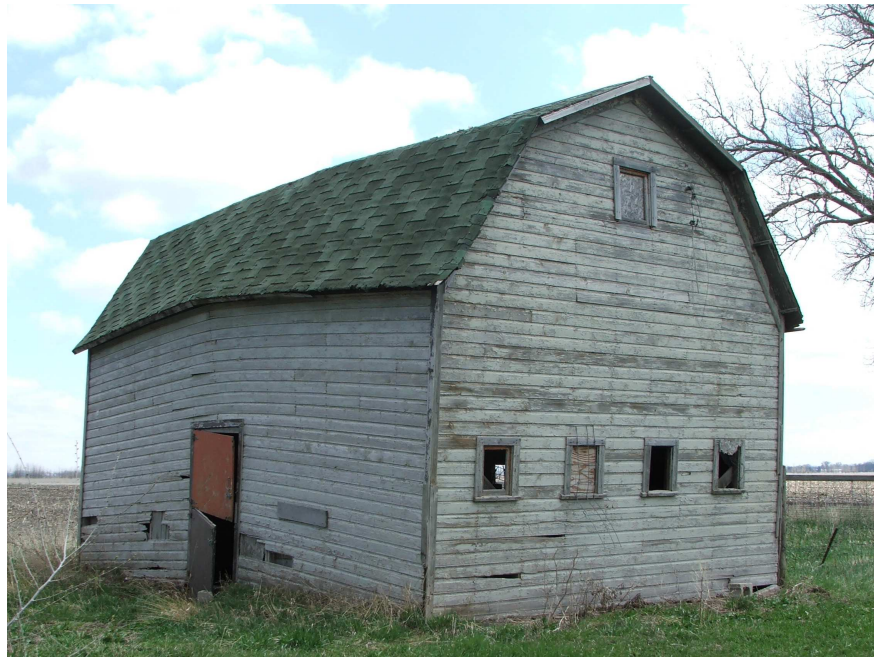
ALTERED/MOVED NOTES: Original site. Any evidence of milk cow stanchions has been removed. Roof has been covered with asphalt shingles over the cedar shingles. No foundation can be seen. A 4x6 sill is visible under North door. The rest of the bottom of the walls have rotted and sunk as per pictures.

***PHYSICAL NOTES:** Barn is in poor condition.

ROLL NUMBER: _____
PHOTO NUMBER: 4
CAMERA DIRECTION: Looking SE, NW corner, note how barn has sunk into the ground except under the door on North wall. No Foundation.

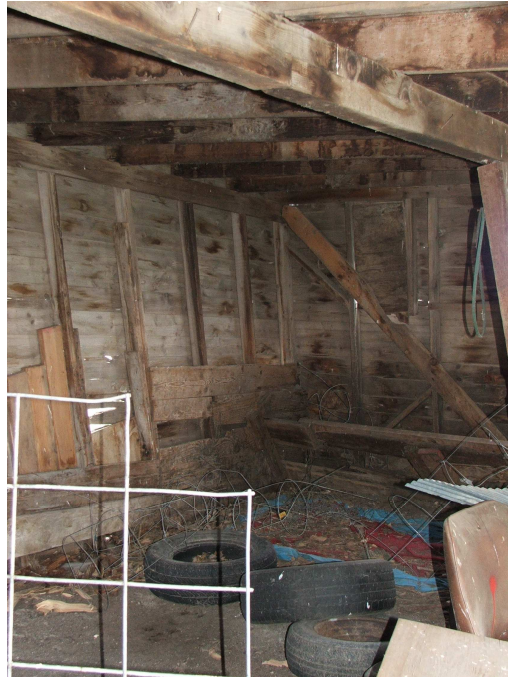
ROLL NUMBER: 5
PHOTO NUMBER: 5

**First floor, looking NE,
double horse stall in the
NE corner.**

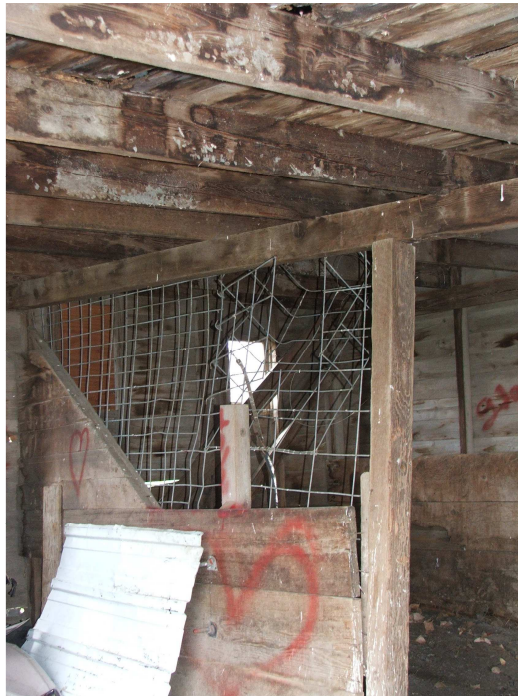
ROLL NUMBER: 6
PHOTO NUMBER: 6

**First floor, looking NW,
4x6 posts, 4x6 beam and
2x6 floor joists**

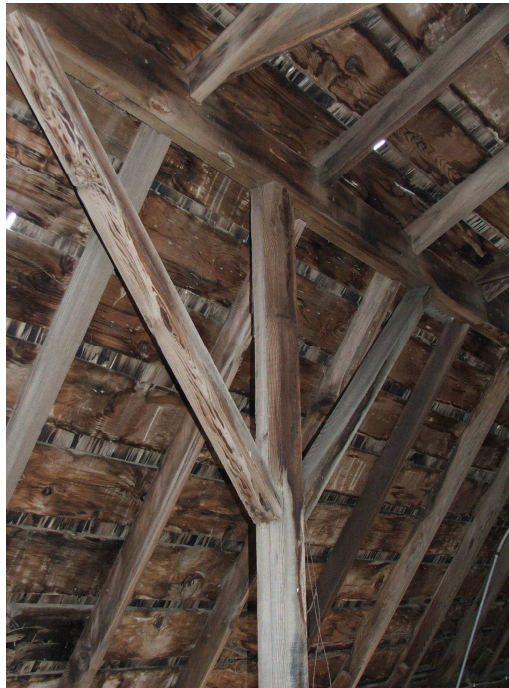
ROLL NUMBER: _____
PHOTO NUMBER: 7

**Hayloft, looking SW, 4x4
post, (2) 2x6's for a beam
supporting roof hip.**

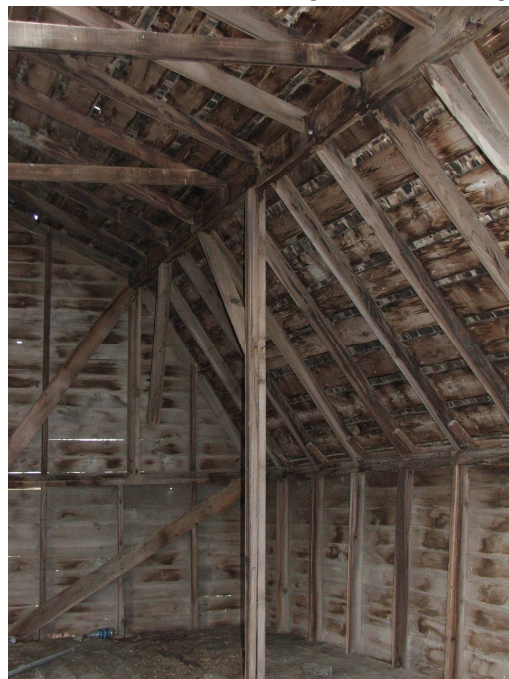
ROLL NUMBER: _____
PHOTO NUMBER: 8

**Hayloft, looking NW, 4x4
posts, (2) 2x6's for a
beam and 2x4 rafters**
