SITE INFORMATION

STRUCTURE DETAILS

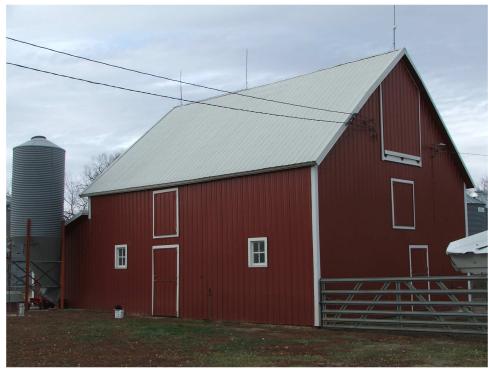
PHOTOGRAPHER: Jim Stone ROLL NUMBER: DATE OF PHOTO: December65, 2012 PHOTO NUMBER: 2

CAMERA DIRECTION: Looking NW, SE corner

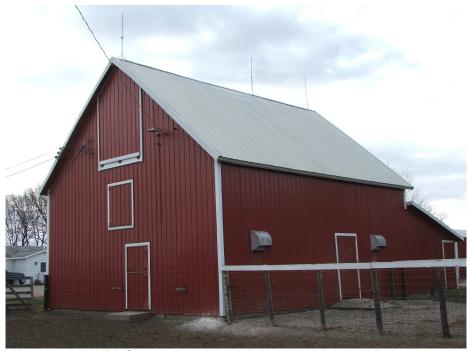
TO NUMBER: 3

CAMERA DIRECTION: Looking SW, NE corner

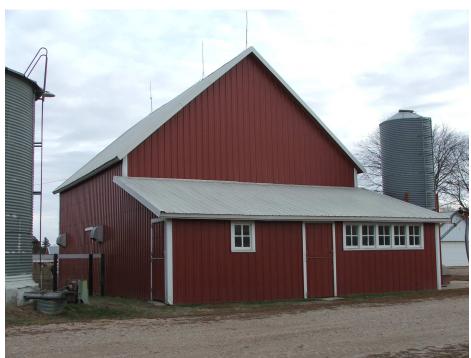
4

CAMERA DIRECTION: Looking SE, NW corner

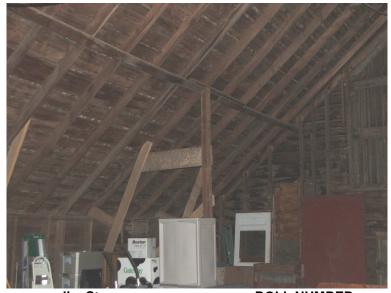
Hayloft, looking NE, 2x6 rafters, 4x4 posts and 4x4 beam supporting

CAMERA DIRECTION: center of rafters.

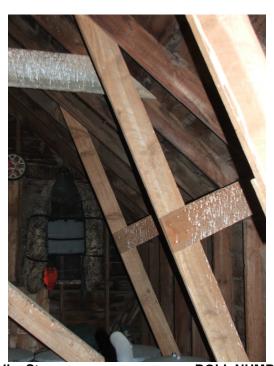
Hayloft, looking SE, 2x6 bracing from rafters down to the wall at the

CAMERA DIRECTION: floor level, 4' O.C.
