SITE INFORMATION

*ADDRESS: 31651 470th Ave.
*COUNTY: Clay
*CITY: Burbank

CURRENT FUNCTION: Shelter for one horse FOUNDATION: Poured concrete
CURRENT SUBFUNCTION: Storage ROOF MATERIAL: Steel roofing over cedar shingles
HISTORIC FUNCTION: Livestock barn ROOF SHAPE: Gambrel roof
HISTORIC SUBFUNCTION: Hay and grain storage STRUCTURAL SYSTEM: Balloon framing
STYLE: Gambrel roof barn
OCCUPIED: Yes TYPE: Livestock barn
ACCESSIBLE: Yes with permission WALLS: 2x6 studs, 1x6 #106 drop siding and steel roofing
STORIES: 2 SIGNIFICANT PERSON: James H. Lynch
*DATE OF CONSTRUCTION: 1915 to 1925 CULTURAL AFFILIATION: ?

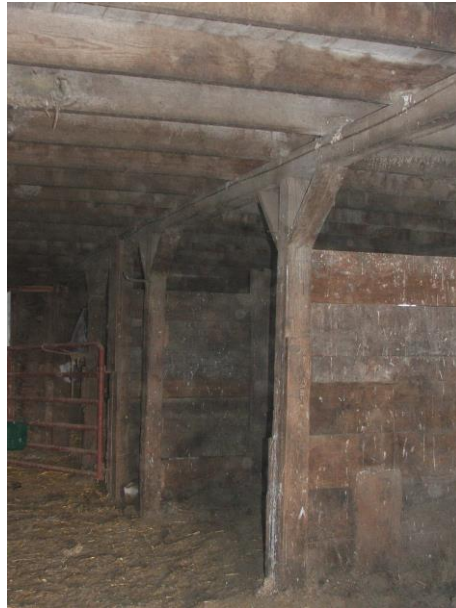
ALTERED/MOVED NOTES: Original site. Milk cow stanchions have been removed from the West side. Horse stalls removed on the East side and dividers have been built 12' O. C. Concrete gutter on the West side are filled with concrete. Walls and roof have been covered with steel roofing.

ROLL NUMBER: _____
PHOTO NUMBER: 5
CAMERA DIRECTION: First floor, looking NE at where the double horse stalls on were East side, dividers 12' O. C. were added later.

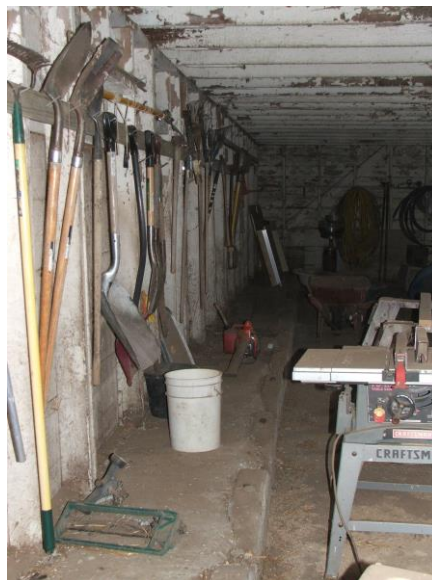
ROLL NUMBER: _____
PHOTO NUMBER: 6
CAMERA DIRECTION: First floor, West side,

2x6 solid wall, feed
trough and were 15 milk
cow stanchions were.

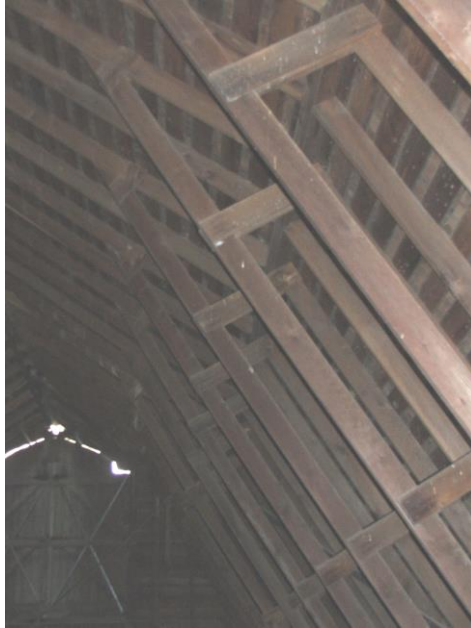
ROLL NUMBER: _____
PHOTO NUMBER: 7

Hayloft, looking SW, 2x6
rafters, 2x6 plate at the
hip, 2x6 bracing from
center of top rafters
down to hayloft floor.

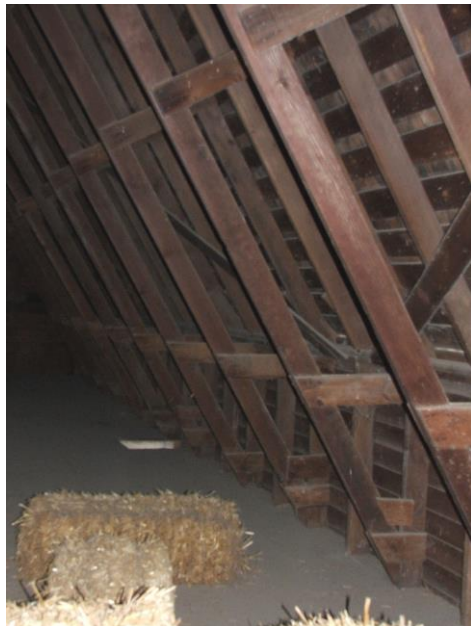
ROLL NUMBER: _____
PHOTO NUMBER: 8
CAMERA DIRECTION: Hayloft, looking SW,

lower part of 2x6
bracing, note 1x6
bracing back to wall and
rafters.

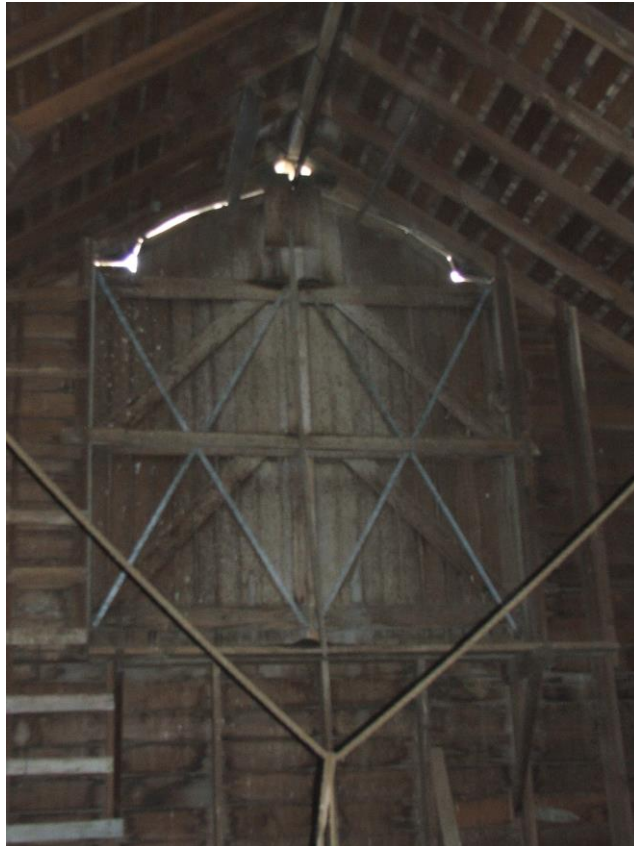
CAMERA DIRECTION: Hayloft, looking South,
South gable end wall and
hayloft door.
