**SOUTH DAKOTA STATE HISTORIC PRESERVATION OFFICE
HISTORIC SITES SURVEY STRUCTURE FORM**

*SURVEY DATE: June 21, 2013 *ADDRESS: 45678 SD 46
*SURVEYOR: Jim Stone *COUNTY: Turner
*CITY: Wakonda

CURRENT FUNCTION: <u>Storage</u>	FOUNDATION: <u>Mortared native stone</u>
CURRENT SUBFUNCTION: <u>Hay storage</u>	ROOF MATERIAL: <u>Steel roofing over cedar shingles</u>
HISTORIC FUNCTION: <u>Livestock barn</u>	ROOF SHAPE: <u>Gable roof</u>
HISTORIC SUBFUNCTION: <u>Hay and grain storage</u>	STRUCTURAL SYSTEM: <u>Balloon framing</u>
OCCUPIED: <u>Yes</u>	STYLE: <u>Gable roof barn</u>
ACCESSIBLE: <u>Yes with permission</u>	TYPE: <u>Livestock barn</u>
	<u>2x6 studs, 1x6 #106 drop siding, vertical steel roofing</u>
STORIES: <u>2</u>	WALLS: _____
*DATE OF CONSTRUCTION: <u>Early 1900's</u>	SIGNIFICANT PERSON: <u>James Holm</u>
	CULTURAL AFFILIATION: <u>?</u>

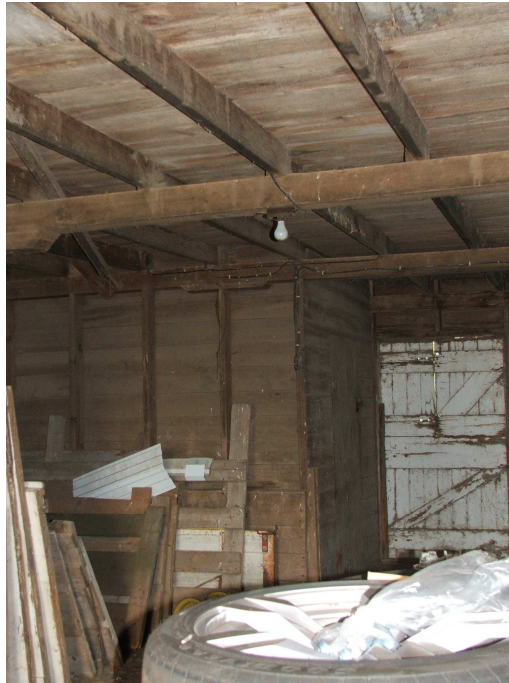
ROLL NUMBER: _____
PHOTO NUMBER: 5

**First floor, looking NW,
12' x 8' granary in NW
corner.**

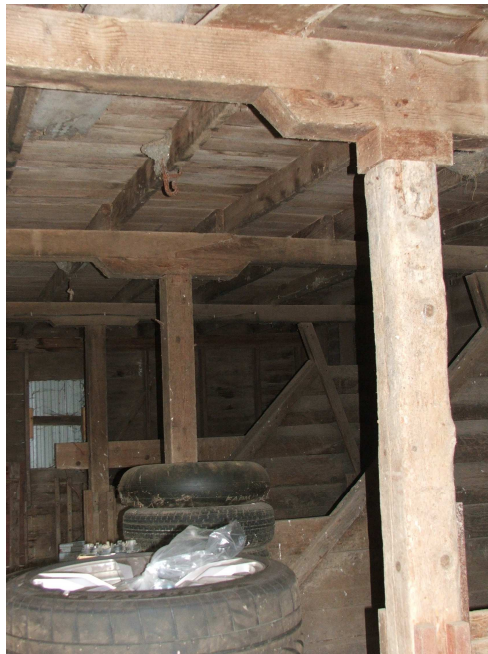
ROLL NUMBER: _____
PHOTO NUMBER: 6

**First floor, looking NE,
horse stalls on the East
wall.**

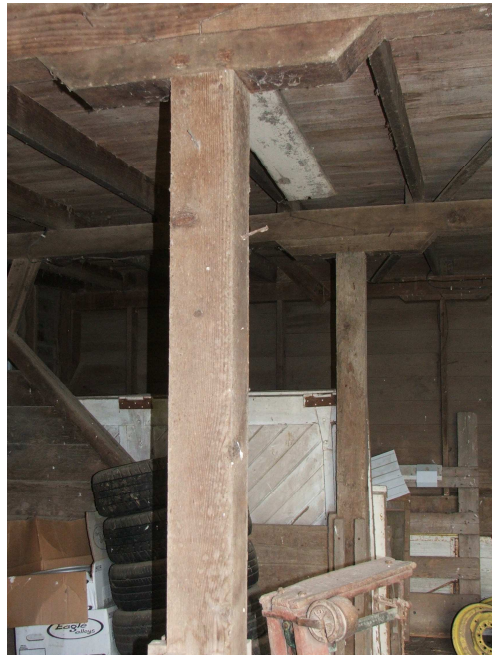
ROLL NUMBER: _____
PHOTO NUMBER: 7

**First floor, looking NW,
horse stalls on the West
wall.**

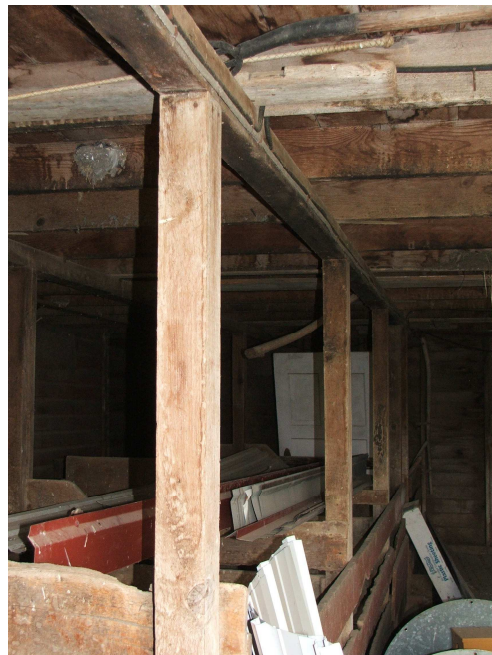
ROLL NUMBER: _____
PHOTO NUMBER: 8

**First floor, East lean-to,
looking NW, 4x4 posts,
4x4 beam and 2x6 floor
joists, where milk cow
stanchions were.**

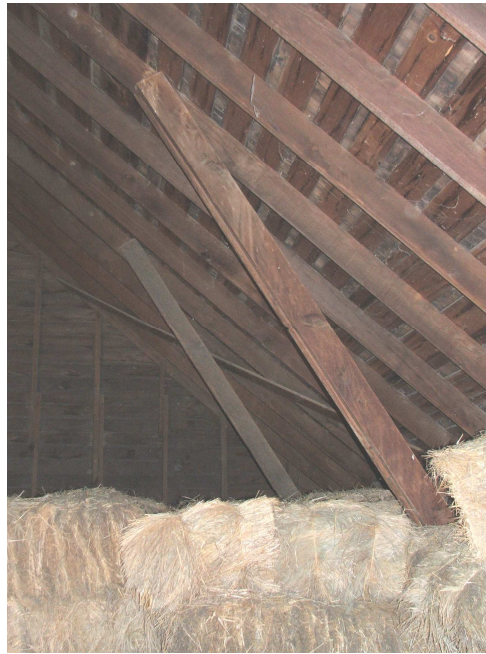
ROLL NUMBER: _____
PHOTO NUMBER: 9

**Hayloft, looking NW, 2x6
rafters, 2x6 bracing from
rafter down to floor, 8'
O. C.**

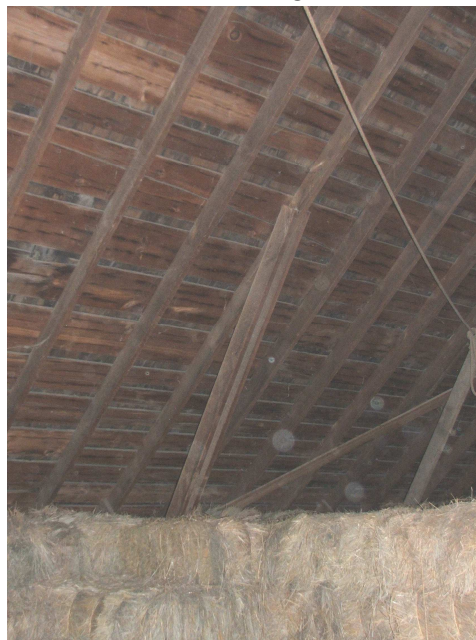
ROLL NUMBER: _____
PHOTO NUMBER: 10

**Hayloft, looking NW, 2x6
bracing from center of
rafter down to floor, 8'
O. C., note center brace
is doubled**
