SITE INFORMATION

STRUCTURE DETAILS									
SHPO ID:									
*PROPERTY NAME:		_							
OTHER NAME:									
5 111 <u>=11 111 1111</u>									
CURRENT FUNCTION:	Storage	_ FOUNDAT	ION:	Poured concrete					
CURRENT SUBFUNCTION:		ROOF MATER	1Δ1 -	Steel over cedar					
HISTORIC FUNCTION:	Livestock barn	ROOF SH		Gambrel					
			STRUCTURAL SYSTEM:						
HISTORIC SUBFUNCTION:	nay and grain Storage

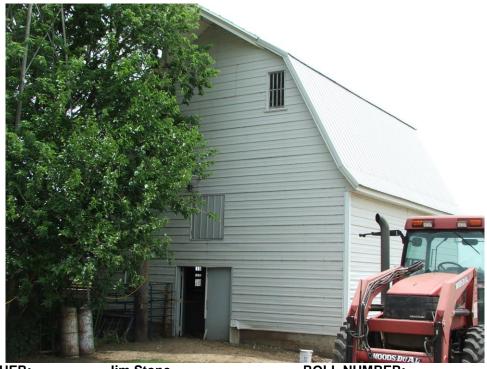
DATE OF PHOTO: June 6, 2012 PHOTO NUMBER: 1

CAMERA DIRECTION: Looking SE, NW corner

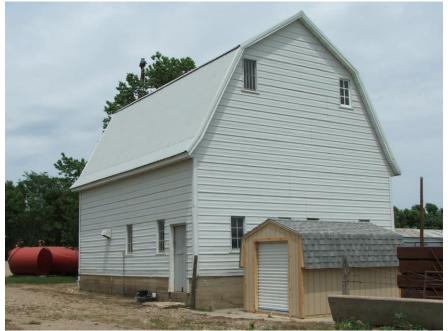
PHOTOGRAPHER: Jim Stone ROLL NUMBER: DATE OF PHOTO: June 6, 2012 PHOTO NUMBER: 2
CAMERA DIRECTION: Looking NW, SE corner

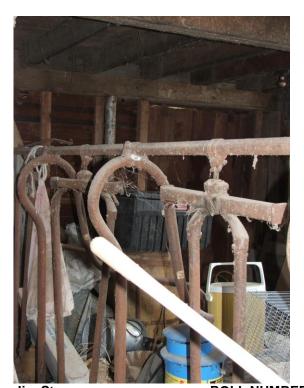
CAMERA DIRECTION: Looking NE, SW corner

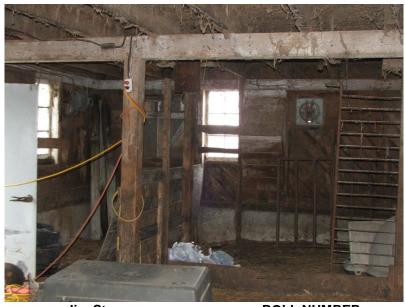
First floor, milk cow

CAMERA DIRECTION: _stanchions in SW corner

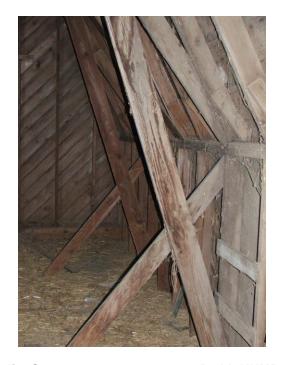
Hayloft, looking North, bottom of truss bracing

CAMERA DIRECTION: on North gable end wall

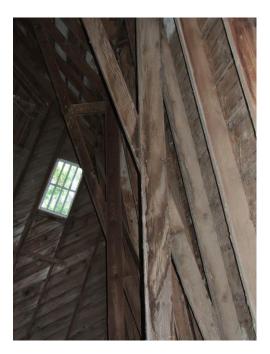
Hayloft, looking North,

CAMERA DIRECTION: 2x6 rafter bracing.

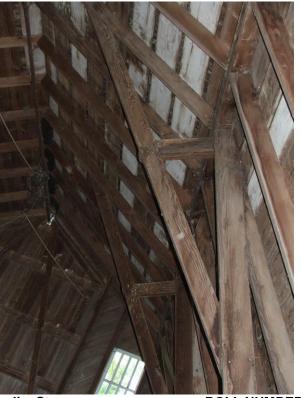
Hayloft, looking North,

lower 2x6 rafter and wall

CAMERA DIRECTION: bracing.
