SITE INFORMATION

<u>May 10, 2013</u> Jim Stone *ADDRESS: 29735 SD 19

ALTERED/MOVED NOTES: Original site. Some of the mangers in the horse stalls have been removed. Steel roofing installed on the roof. Cedar shingles removed and spaces between spaced roof sheathing filled with 2" wide boards before installing steel roofing.

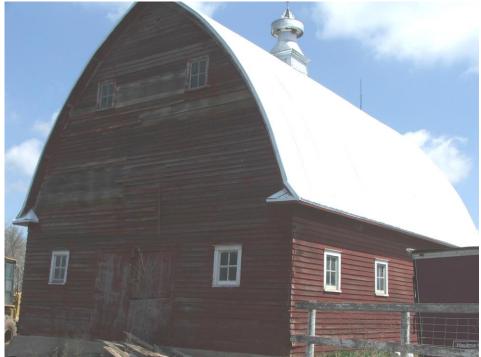
1

Looking NE, SW corner

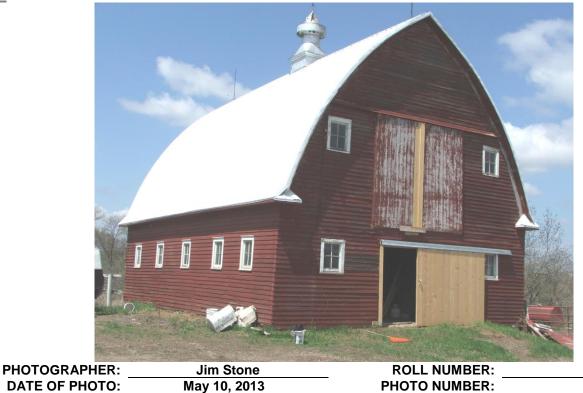
PHOTO NUMBER: 2 CAMERA DIRECTION: Looking NW, SE corner

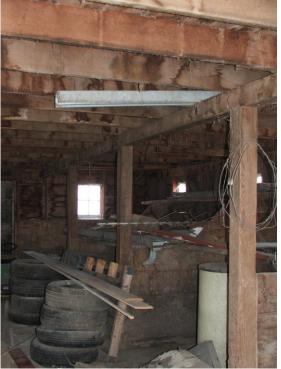
5 First floor, looking NW, 4x6 posts 4x6 beams 2x8 CAMERA DIRECTION: floor joists

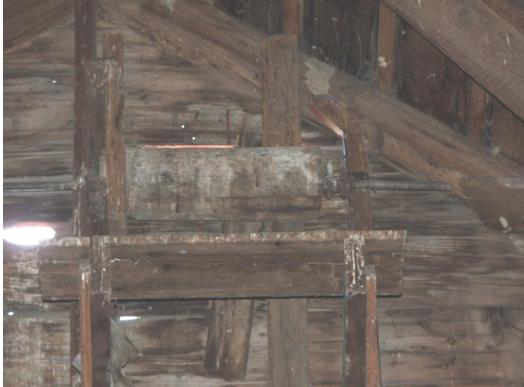
8 Hayloft, looking NW, 1x6 bracing on center of rafters 2' O. C., note verticle bracing on gable
