SOUTH DAKOTA STATE HISTORIC PRESERVATION OFFICE
HISTORIC SITES SURVEY STRUCTURE FORM

*ADDRESS: 45821 304th Street
*COUNTY: Clay
*CITY: Wakonda

HISTORIC FUNCTION: Horse barn

*DATE OF CONSTRUCTION: About 1916

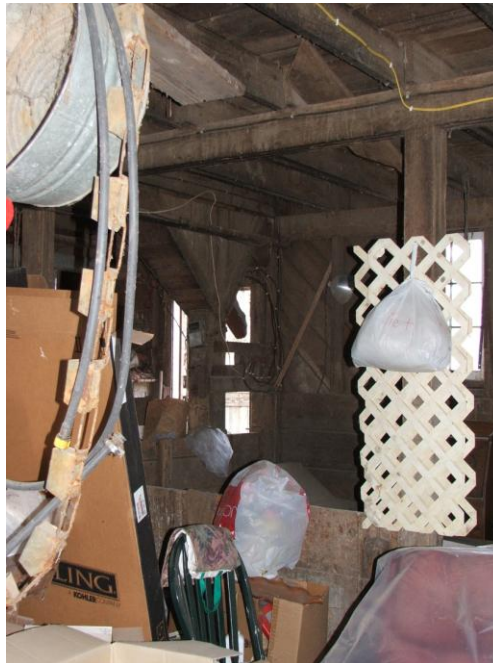
ROLL NUMBER: _____
PHOTO NUMBER: 5

CAMERA DIRECTION: First floor, looking NW
horse stalls and grain
chute from hayloft.

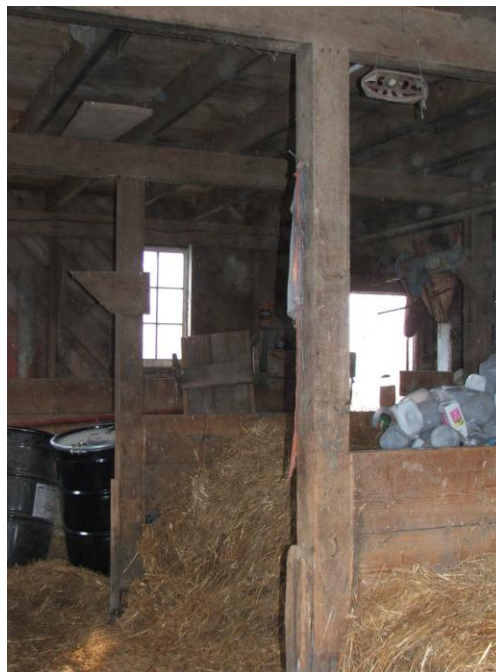
ROLL NUMBER: _____
PHOTO NUMBER: 6

CAMERA DIRECTION: First floor, looking North,
posts, beam and horse
stalls on West side.

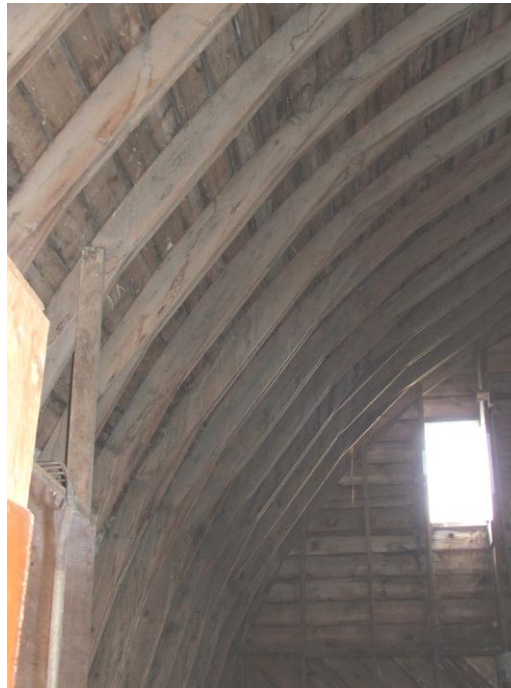
ROLL NUMBER: _____
PHOTO NUMBER: 7

Hayloft, looking West,
short 2x8's and short
1x8's to build round
rafters

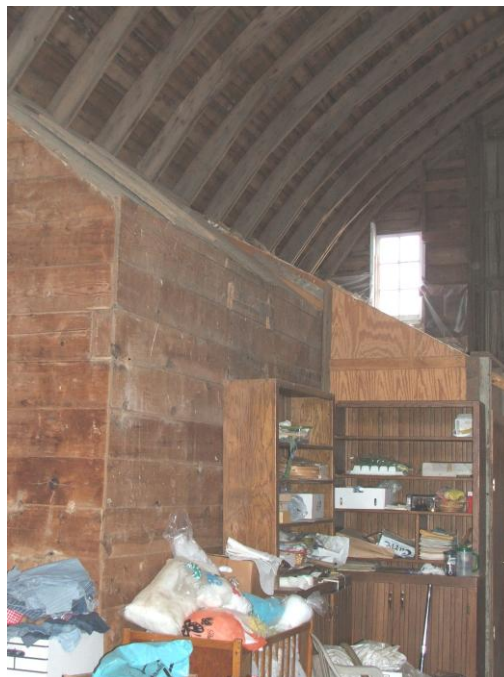
ROLL NUMBER: _____
PHOTO NUMBER: 8

Hayloft, looking NE, two
granaries in hayloft

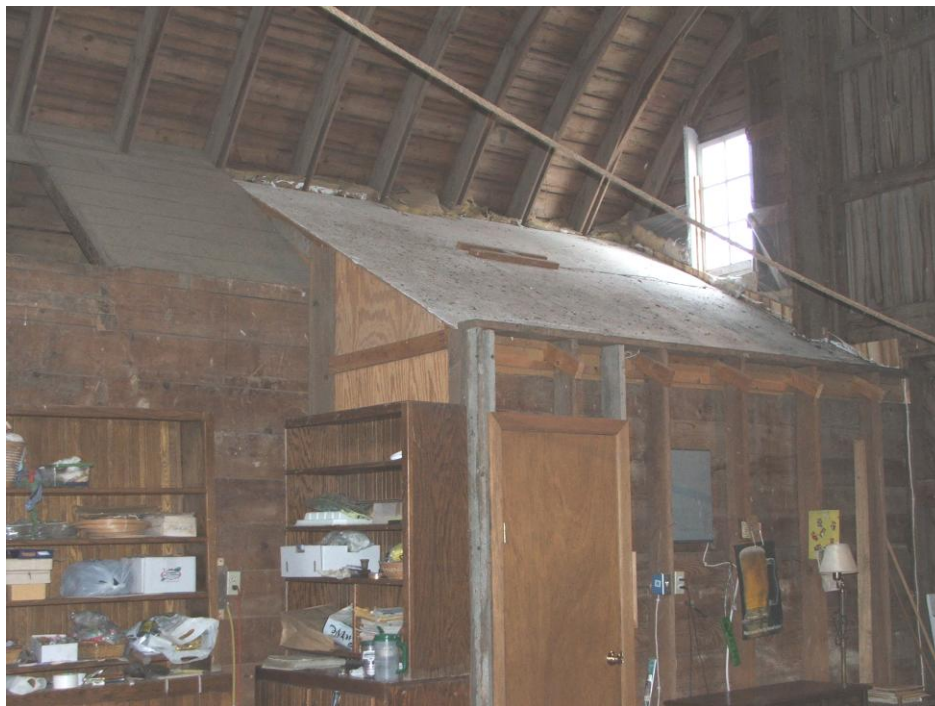
ROLL NUMBER: _____
PHOTO NUMBER: 9

CAMERA DIRECTION: Hayloft, looking NE,
12'x12' granary
converted into sewing
room, note door.
