**SOUTH DAKOTA STATE HISTORIC PRESERVATION OFFICE
HISTORIC SITES SURVEY STRUCTURE FORM**

*SURVEY DATE: November 9, 2012 *ADDRESS: 45592 300th Street
*SURVEYOR: Jim Stone *COUNTY: Clay
*CITY: Wakonda

CURRENT FUNCTION:	<u>Vacant</u>	FOUNDATION:	<u>Poured concrete foundation</u>
CURRENT SUBFUNCTION:	<u>Storage</u>	ROOF MATERIAL:	<u>Cedar shingles</u>
HISTORIC FUNCTION:	<u>Livestock barn</u>	ROOF SHAPE:	<u>Gable</u>
HISTORIC SUBFUNCTION:	<u>Hay storage</u>	STRUCTURAL SYSTEM:	<u>Balloon framing</u>
		STYLE:	<u>Gable roof barn</u>
OCCUPIED:	<u>Yes</u>	TYPE:	<u>Livestock barn</u>
			<u>2x6 stud with 1x6</u>
			<u>#106 drop siding</u>
ACCESSIBLE:	<u>Yes with permission</u>	WALLS:	<u>galv. steel roofing</u>
STORIES:	<u>2</u>	SIGNIFICANT PERSON:	<u>Jas. Montgomery Jr.</u>
*DATE OF CONSTRUCTION:	<u>About 1900</u>	CULTURAL AFFILIATION:	<u>?</u>

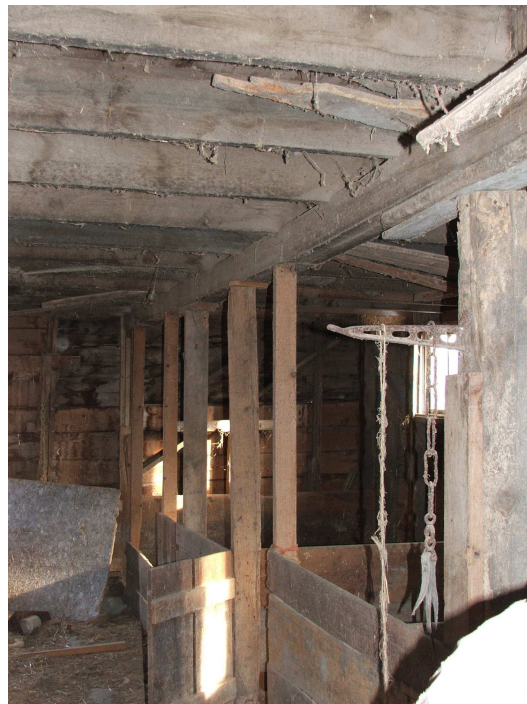
ROLL NUMBER: _____
PHOTO NUMBER: 4
CAMERA DIRECTION: First floor, looking East,
4x6 posts, 6x6 beam and
2x8 floor joists

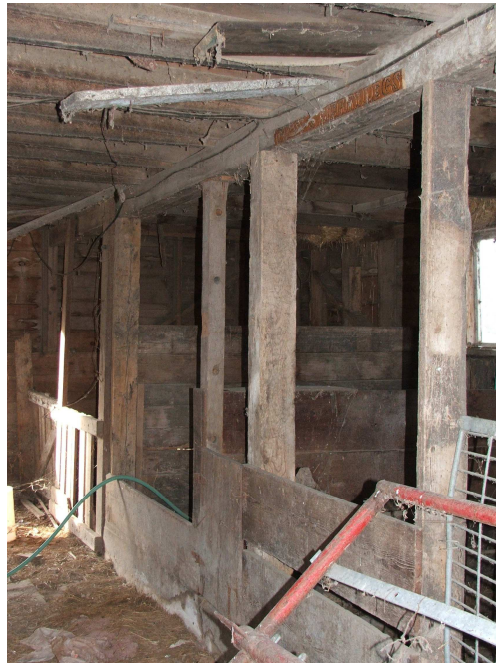
ROLL NUMBER: _____
PHOTO NUMBER: 5

CAMERA DIRECTION: First floor, looking West,
pens along North wall

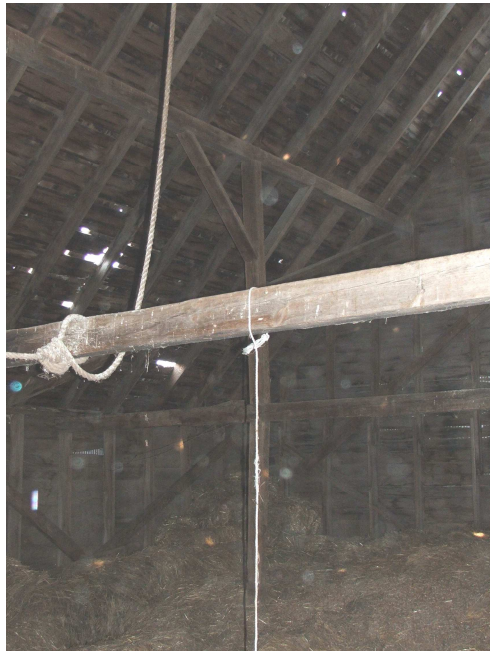
ROLL NUMBER: _____
PHOTO NUMBER: 6

CAMERA DIRECTION: Hayloft, looking NE, 4x6
cross beam, 4x6 posts
above and below with
6x6 beam at top to
support rafters.

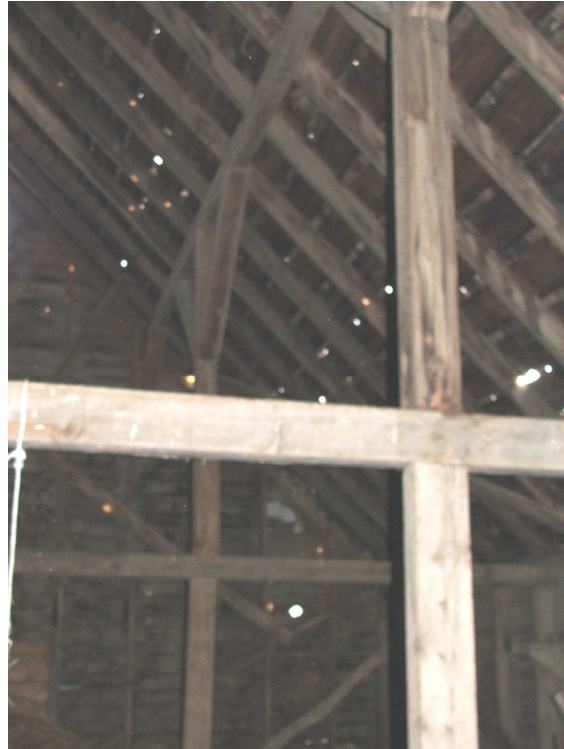
ROLL NUMBER: _____
PHOTO NUMBER: 7

CAMERA DIRECTION: Hayloft, looking East,
two 4x6 cross beams,
4x6 posts under and on
top to support 6x6 beam
that supports rafters.
