```SITE INFORM	<u>ATION</u>										
*SURVEY DA	2013	*ADDRESS:	45450 299th Street								
*SURVEYOR: Jim Stone		е	*COUNTY:	Clay							
					Vermillion						
LOCATION DESCRIPTION: From Vermillion, the intersection of South Dakota Highway 50 bi-pass and											
South Dakota Highway 19, North 6 miles to 311th Street, turn left (West) about 1/2 mile, turn left (South)											
about ¼ mile on the right (West) side.											
LEGAL DESCRIPTION: Lot 1, Cleland Subdivision, NE ¼, 15 – 93 – 52 Spirit Mound Twp.											
*QUARTER 1:	NE 1/4		OWNER NAME: James C. & Jennifer L. Katrenak								
*QUARTER 2:		OWN	NER ADDRESS:	31125 462 nd Ave.							
*TOWNSHIP:	Spirit Mound		OWNER CITY:	Vermillion							
*RANGE:	52		OWNER STATE: South Dakota								
*SECTION:	15		OWNER ZIP:	57069							
ACRES:	10.30		QUAD NAME:								
OWNER CODE 1:	Р										
OWNER CODE 2:											
OWNER CODE 3:											
HISTORIC SIGN	<b>IFICANCE</b>

#### STRUCTURE DETAILS

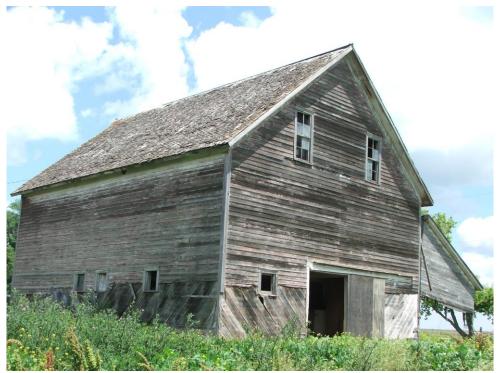
CAMERA DIRECTION: Looking NW, SE corner

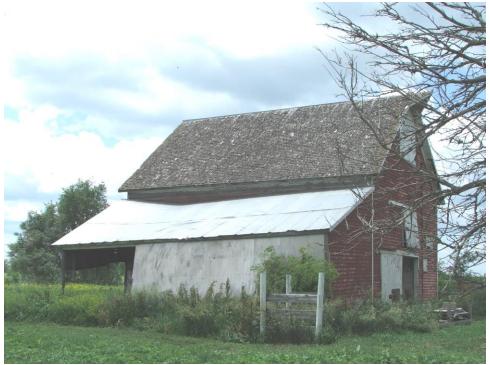
PHOTOGRAPHER: Jim Stone ROLL NUMBER: DATE OF PHOTO: June 29, 2013 PHOTO NUMBER: 3
CAMERA DIRECTION: Looking SW, NE corner

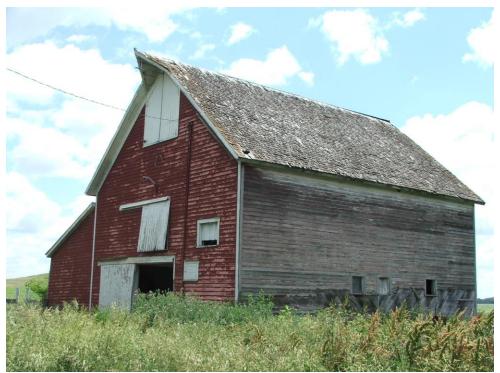
DATE OF PHOTO: June 29, 2013 PHOTO NUMBER: 4

CAMERA DIRECTION: Looking SE, NW corner

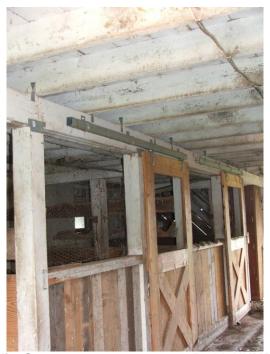
5

First floor, looking SE, 6x6 post, (3) 2x8's beam, 2x8 joists, box stalls on East wall.

CAMERA DIRECTION: East wall.

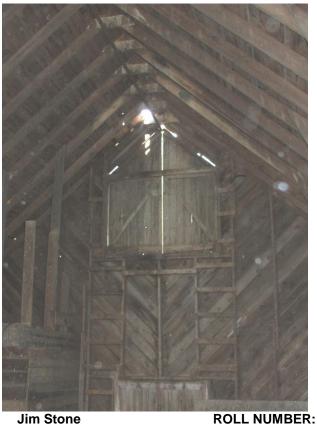
Hayloft, looking North, North gable wall and hayloft door, note CAMERA DIRECTION: diagonal sheathing.
