SITE INFORMATION

*SURVEY DATE: Aug. 14, 2012

*ADDRESS: 30362 Greenfield Road *COUNTY: Clay

SHPO ID:		_	
*PROPERTY NAME:			
OTHER NAME:			
CURRENT FUNCTION:	Livestock	FOUNDATION:	Native stone with mortar
CURRENT SUBFUNCTION:	Straw and grain storage	ROOF MATERIAL:	Some steel over cedar shingles
HISTORIC FUNCTION:	Livestock barn	ROOF SHAPE:	Gable
HISTORIC SUBFUNCTION:	Hay and grain storage	STRUCTURAL SYSTEM:	Balloon framing
		STYLE:	Western feeder barn
OCCUPIED:	Yes	TYPE:	Livestock barn
ACCESSIBLE:	Yes with permission	WALLS:	2x4, sheathing & ½"x 8" cedar lap siding (shorts)
STORIES:		SIGNIFICANT PERSON:Ja	y & Cleo Clark
*DATE OF CONSTRUCTION:	<u>?</u> CU	LTURAL AFFILIATION:	?

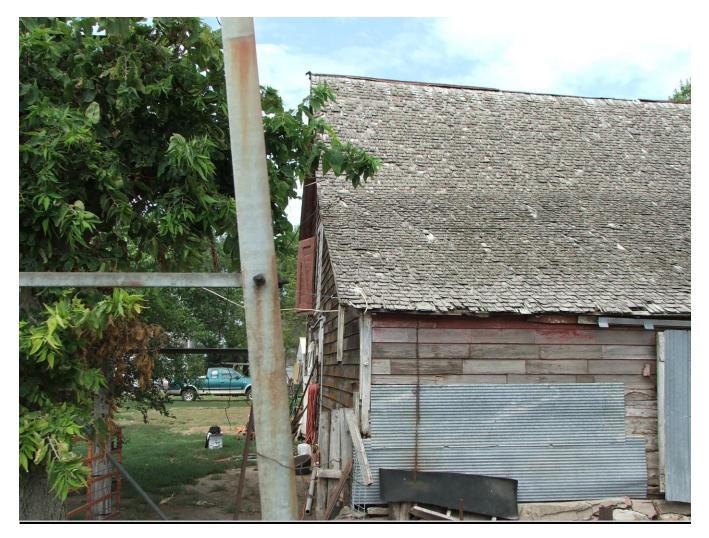
DATE OF PHOTO:
 Aug. 14, 2012
 PHOTO NUMBER:
 1

CAMERA DIRECTION:
 Looking NE, SW corner

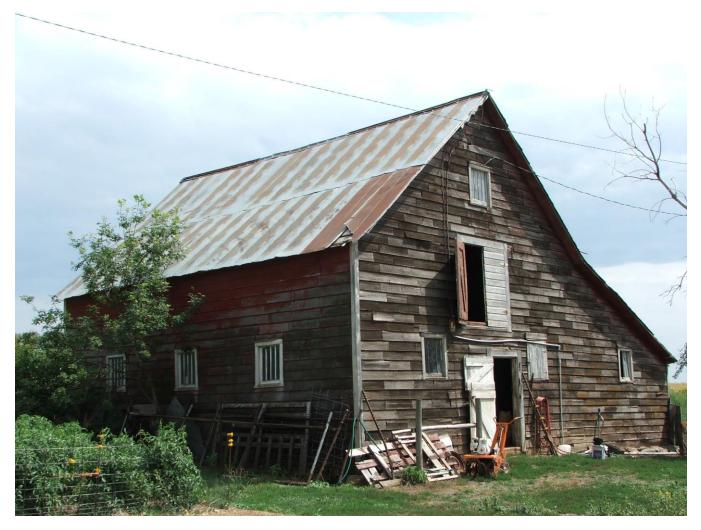
DATE OF PHOTO:
 Aug. 14, 2012
 PHOTO NUMBER:
 4

CAMERA DIRECTION:
 Looking SE, NW corner

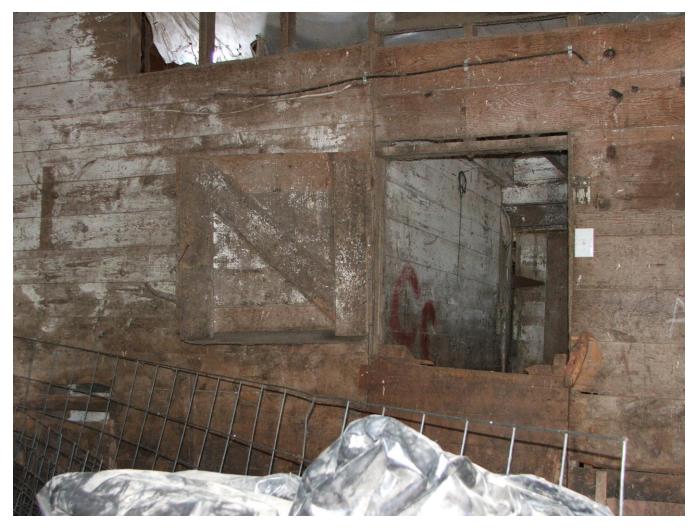
5

First floor, South lean-to,

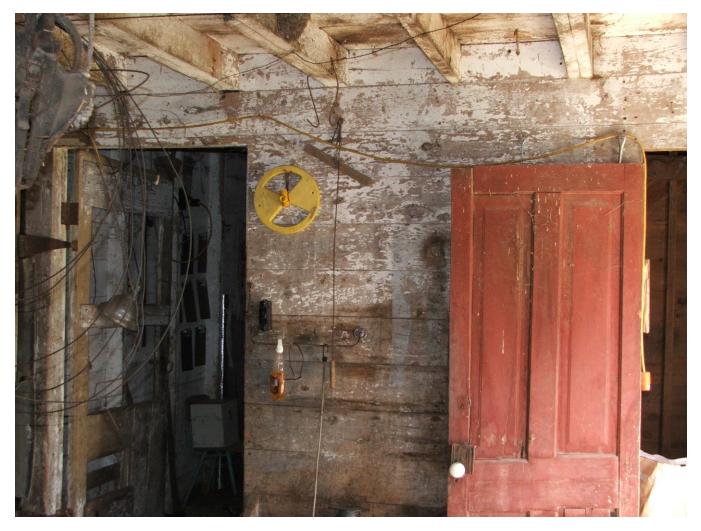
PHOTO NUMBER: 6 First floor, main barn, looking South, granary CAMERA DIRECTION: and milk room

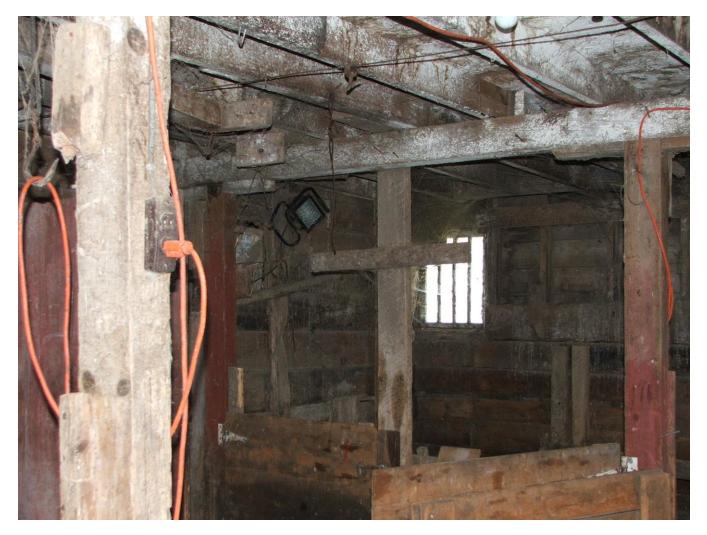
7

First floor, main barn, looking NW, granary in NW corner

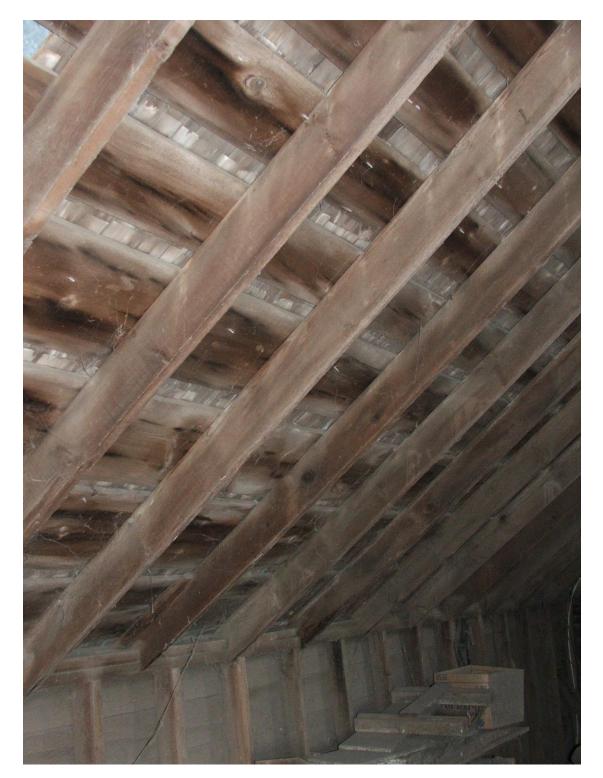
DATE OF PHOTO:
 Aug. 14, 2012
 PHOTO NUMBER:
 8

OTHER NOTES: <u>Windows were 4"x24" four light</u>. Walls are 2x4 with sheathing and ½"x8" cedar lap lap siding in 3' lengths (referred to as shorts and is cheaper). Rafters are 2x6 with no bracing. The North side is covered with corrugated galv. steel. The South side is cedar shingles. There is some corrugated galv. steel to repair places on the walls.

Hayloft, looking NE, no
 CAMERA DIRECTION:
 rafter bracing
