"SITE INFORMATION				
*SURVEY DATE: June 21, 2013	*ADDRESS: 29778 455 <sup>th</sup> Ave.			
*SURVEYOR: Jim Stone	*COUNTY: Clay			
	*CITY: Wakonda			
LOCATION DESCRIPTION: From Vermillion, the intersection of South Dakota Highway 50 bi-pass and				
South Dakota Highway 19, North 15 miles to 302 <sup>nd</sup> Street, turn left (West) about 7 miles to 455 <sup>th</sup> Ave., turn				
right (North) 4-1/4 miles, on the right (East) side.				
LEGAL DESCRIPTION: Stockland tract 1, W ½, SW ¼, 3 – 95 – 53 Star Twp.				
*QUARTER 1:SW 1/4	OWNER NAME: Wesley E. Stockland			
*QUARTER 2:OV	VNER ADDRESS: 29778 455 <sup>th</sup> Ave.			
*TOWNSHIP: Star	OWNER CITY: Wakonda			
*RANGE:53	OWNER STATE: South Dakota			
*SECTION:3	OWNER ZIP: 57073			
ACRES: <u>8.63</u>	QUAD NAME:			
OWNER CODE 1: P				
OWNER CODE 2:				
OWNER CODE 3:				
HISTORIC SIGNIFICANCE				
*DOE:	REGISTER NAME:			
*DOE DATE:	MULTIPLE PROPERTY NAME:			
DEACON INCLICIBLE.

#### STRUCTURE DETAILS

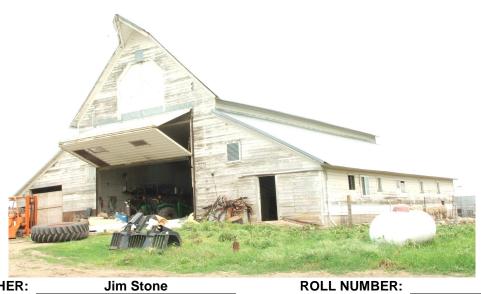
Looking NE, SW corner

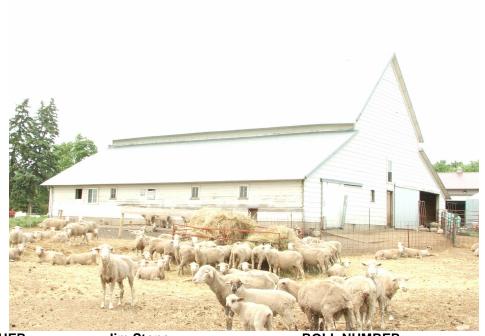
CAMERA DIRECTION: Looking NW, SE corner

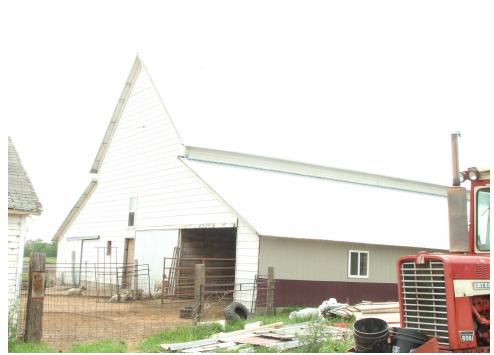
PHOTOGRAPHER: Jim Stone ROLL NUMBER: DATE OF PHOTO: June 21, 2013 PHOTO NUMBER: 3
CAMERA DIRECTION: Looking SW, NE corner

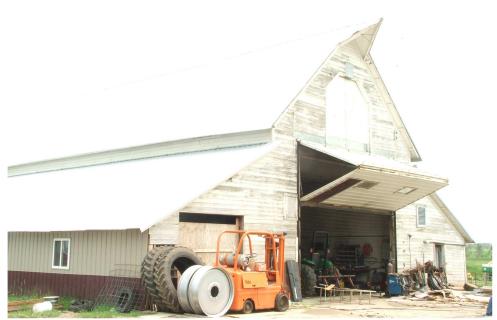
PHOTOGRAPHER: Jim Stone ROLL NUMBER:
DATE OF PHOTO: June 21, 2013 PHOTO NUMBER:
CAMERA DIRECTION: Looking SE, NW corner
