SITE INFORMATION				
*SURVEY DATE: August 12,	2013 *ADDRESS: 30533 457 <sup>th</sup> Ave.			
*SURVEYOR:Jim Stone	*COUNTY: Clay			
	*CITY: Wakonda			
LOCATION DESCRIPTION: From Vermillion, intersection of South Dakota Highway 50 bi-pass and				
South Dakota Highway 19, North about 11 miles to 306th Street, turn left (West) about 5 miles to 457th Ave.,				
turn right, (North) about 3/4 mile, on the left (West) side.				
LEGAL DESCRIPTION: SE 1/4, NE 1/4, 14 – 94 – 53 Bethel Twp.				
*QUARTER 1: <u>NE 1/4</u>	OWNER NAME: Donald H. & Janice D. Lyso			
*QUARTER 2:	OWNER ADDRESS: 30520 458th Ave.			
*TOWNSHIP: Bethel	OWNER CITY: Wakonda			
*RANGE:53	OWNER STATE: South Dakota			
*SECTION:14	OWNER ZIP: <u>57073</u>			
ACRES: 40.24	QUAD NAME:			
OWNER CODE 1: P				
OWNER CODE 2:				
OWNER CODE 3:				
LISTODIC SIGNIFICANCE				
HISTORIC SIGNIFICANCE				
*DOE: REGISTER NAME:				
*DOE DATE:	MULTIPLE PROPERTY NAME:			
REASON INELIGIBLE:

SHPO ID:				
*PROPERTY NAME:				
OTHER NAME:				
CURRENT FUNCTION:	Vacant	FOUNDATION:	Poured concrete	
CURRENT CURFUNCTION.	Vocant	DOOF MATERIAL	Asphalt shingles over	
CURRENT SUBFUNCTION:	Vacant	ROOF MATERIAL:		
HISTORIC FUNCTION:	Livestock barn	ROOF SHAPE	-	
H

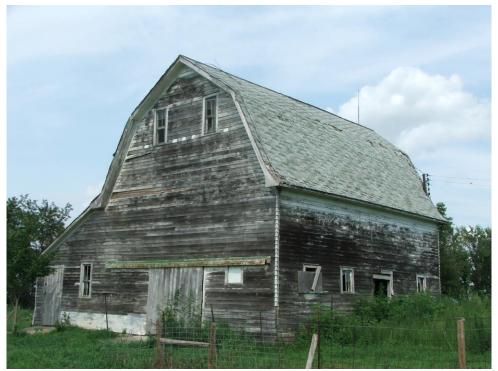
Looking NE, SW corner

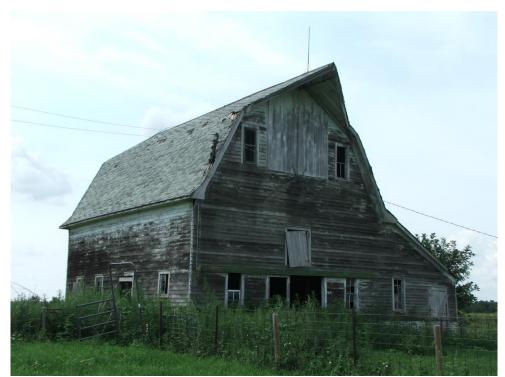
CAMERA DIRECTION: Looking NW, SE corner

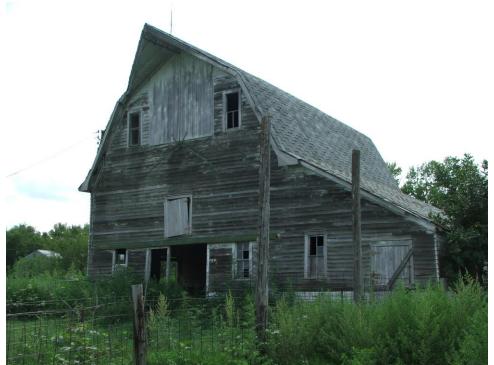
PHOTOGRAPHER: Jim Stone ROLL NUMBER: DATE OF PHOTO: August 12, 2013 PHOTO NUMBER: 3

CAMERA DIRECTION: Looking SW, NE corner

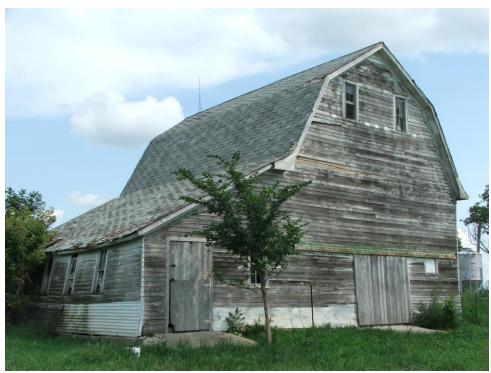
PHOTOGRAPHER: Jim Stone ROLL NUMBER: DATE OF PHOTO: August 12, 2013 PHOTO NUMBER: 4
CAMERA DIRECTION: Looking SE, NW corner
