SITE INFORMATION

*SURVEY DATE: March 2	3, 2012 *ADDRESS	S: 45438 Timber Road			
*SURVEYOR: Jim Stor	ne *COUNTY	: Clay			
	*CITY	7: Meckling			
	-	kota Highway 50 about 1 mile, turn le			
(South) on South Dakota highway	19, turn right (West) on Timber Ro	oad about 8 miles, on the right (North	h)		
side.					
LEGAL DECORIDEDAN E 1/ OW	1/ F 0.000 -f.W.000! 0 .00 . 5	50. Namura Tura			
LEGAL DESCRIPTION: E 1/2 SW	1/4, Exc. S 693' of W 300', 9 – 92 – 5	53, Norway Twp.			
*QUARTER 1: SW 1/4	OWNER NAME:	Marianne Jepsen			
*QUARTER 2:	OWNER ADDRESS:	45438 Timber Road			
*TOWNSHIP: Norway					
*RANGE: <u>52-53 W</u>		OWNER STATE: South Dakota			
*SECTION: 9	OWNER ZIP:				
ACRES: 114	QUAD NAME:	:			
OWNER CODE 1: P					
OWNER CODE 2: F S L F					
OWNER CODE 3: F S L F	•				
HISTORIC SIGNIFICANCE					
*DOE:	REGISTER N	IAME:			
*DOE DATE:		MULTIPLE PROPERTY NAME:			
REASON INELIGIBLE:					
		CATEGORY:			
NOMINATION STATUS:	SIGN	IIFICANCE LEVEL 1: N S L

STRUCTURE DETAILS						
SHPO ID:						
*PROPERTY NAME:						
OTHER NAME:						
O THER TO MINE.						
CURRENT FUNCTION:	Hogs and shee	p FOUNDATION:	Poured concrete			
CURRENT SUBFUNCTION:		ROOF MATERIAL:	Steel over cedar			
HISTORIC FUNCTION:	L

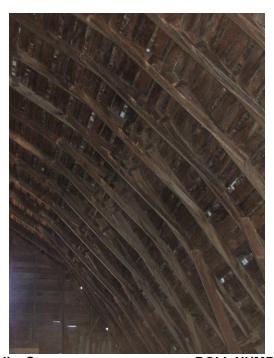
CAMERA DIRECTION: braced rafter system

Hayloft, looking NW,

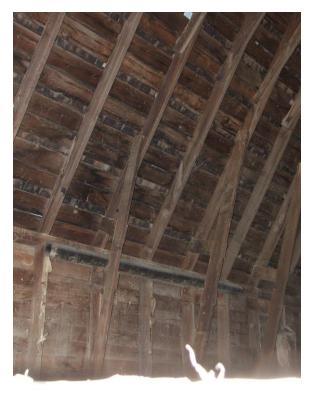
PHOTOGRAPHER: Jim Stone ROLL NUMBER:
DATE OF PHOTO: March 23, 2012 PHOTO NUMBER: 5
Hayloft, looking SW
CAMERA DIRECTION: braced rafter system
