**SOUTH DAKOTA STATE HISTORIC PRESERVATION OFFICE  
HISTORIC SITES SURVEY STRUCTURE FORM**

\*SURVEY DATE: September 3, 2013 \*ADDRESS: 31275 Saginaw Ave.  
\*SURVEYOR: Jim Stone \*COUNTY: Clay  
\*CITY: Vermillion

CURRENT FUNCTION: Vacant FOUNDATION: Poured concrete  
 CURRENT SUBFUNCTION: Vacant ROOF MATERIAL: Steel roofing over cedar shingles  
 HISTORIC FUNCTION: Livestock barn ROOF SHAPE: Gable roof  
 HISTORIC SUBFUNCTION: Hay storage STRUCTURAL SYSTEM: Post and beams  
 OCCUPIED: Yes STYLE: Gable roof barn  
 TYPE: Livestock barn  
 ACCESSIBLE: Yes with permission WALLS: 2x6 studs, 1x12 vertical siding, 30" x 30" steel sheets.

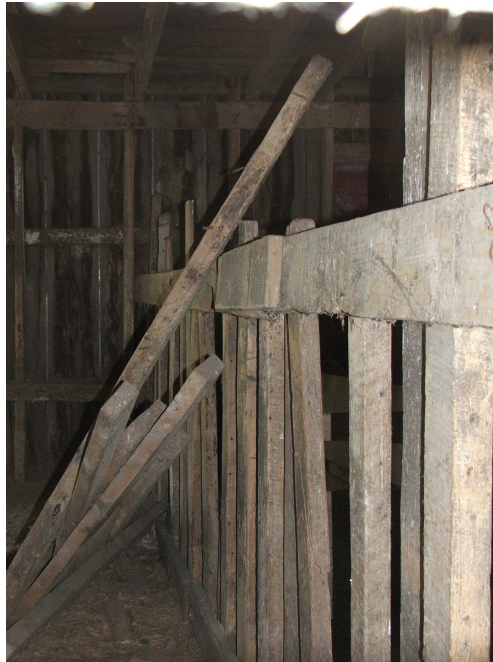
**ROLL NUMBER:** \_\_\_\_\_  
**PHOTO NUMBER:** 5

**CAMERA DIRECTION:** First floor original barn,  
looking SE, Six milk cow  
stanchions still in place.

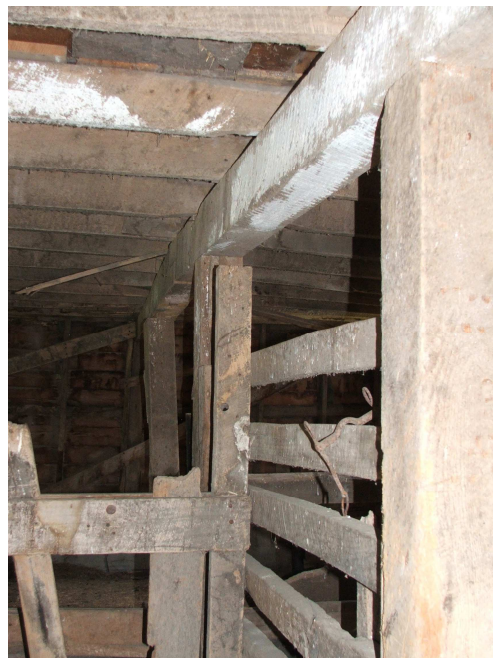
**ROLL NUMBER:** \_\_\_\_\_  
**PHOTO NUMBER:** 6

**CAMERA DIRECTION:** First floor, looking SW,  
6x6 posts, 6x8 beam, 2x6  
floor joists, posts are  
mortised into beams

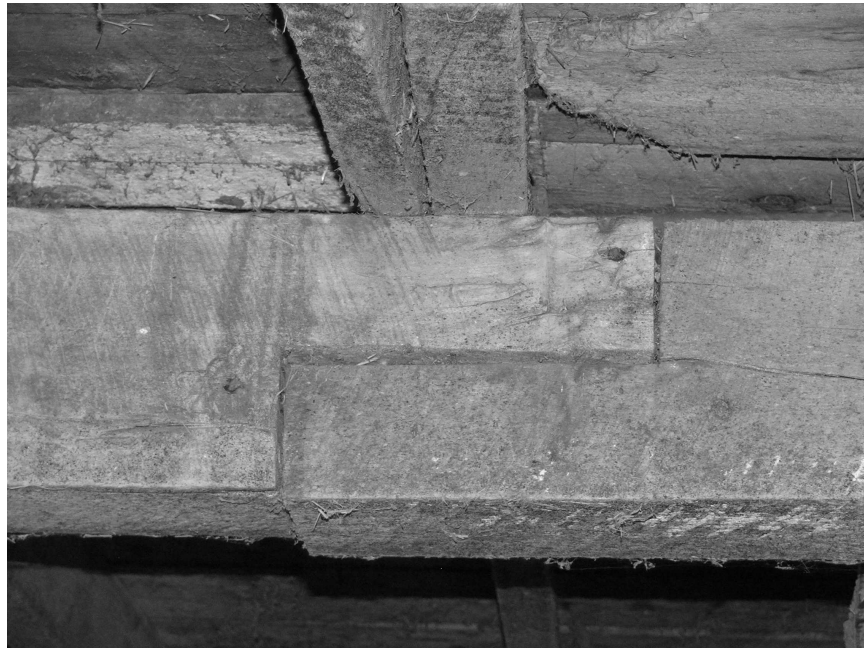
**ROLL NUMBER:** \_\_\_\_\_  
**PHOTO NUMBER:** 7

**CAMERA DIRECTION:** First floor, looking East, scarf joint in 6 x 8 beam

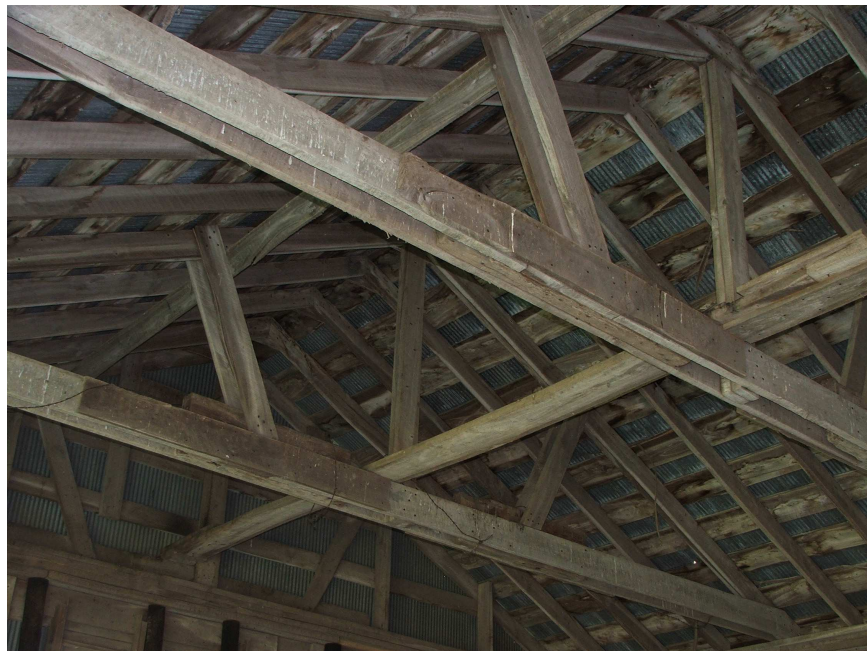
**ROLL NUMBER:** \_\_\_\_\_  
**PHOTO NUMBER:** 8

**CAMERA DIRECTION:** Trusses in the South addition, looking SW, trusses are built from 2x8 rough sawn cottonwood

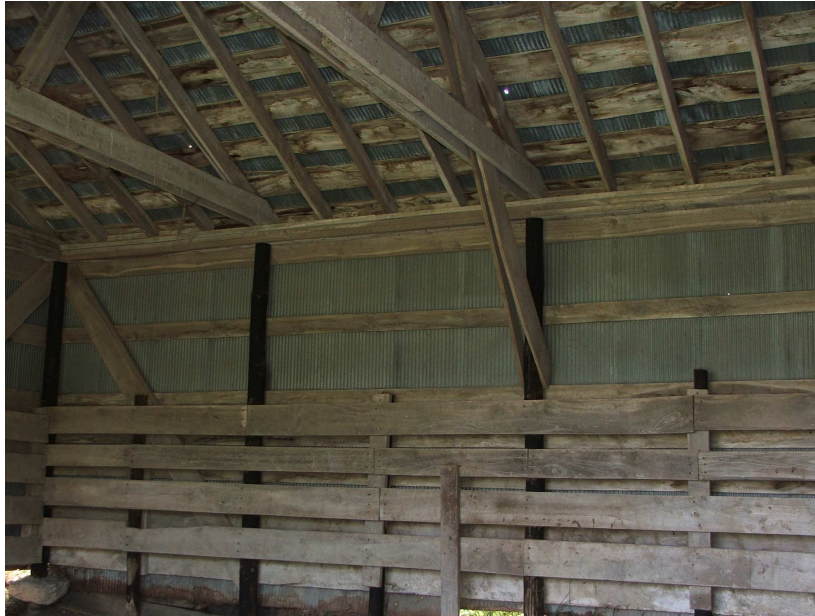
**ROLL NUMBER:** \_\_\_\_\_  
**PHOTO NUMBER:** 9

**CAMERA DIRECTION:** South addition, looking SW, posts between poles that are 8' O. C.

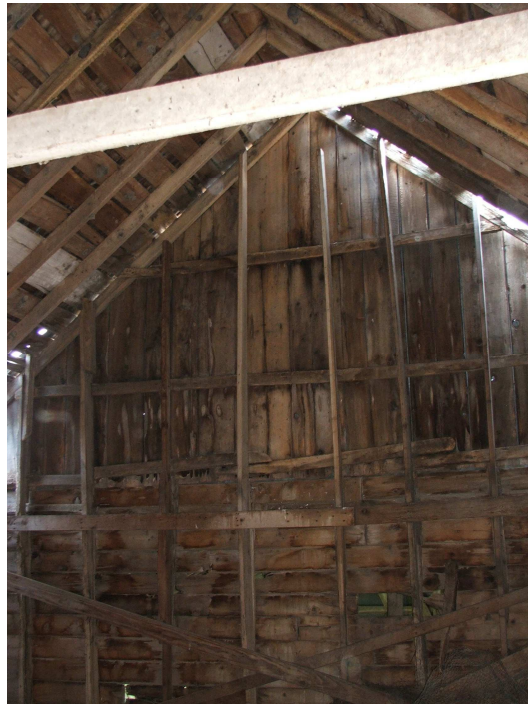
**ROLL NUMBER:** \_\_\_\_\_  
**PHOTO NUMBER:** 10

**OTHER NOTES:** 2x6 stud walls with 1x12 vertical siding on all four walls. Bottom 10' of South wall has the 1x12 vertical siding removed and replaced with 1x8 shiplap applied horizontally. The South addition has vertical 1-1/4" x 26" galvanized, corrugated steel roofing on the walls and on the roof.

**CAMERA DIRECTION:** Hayloft, looking SE, South gable end, note 1x12 vertical siding above and 1x8 shiplap below.

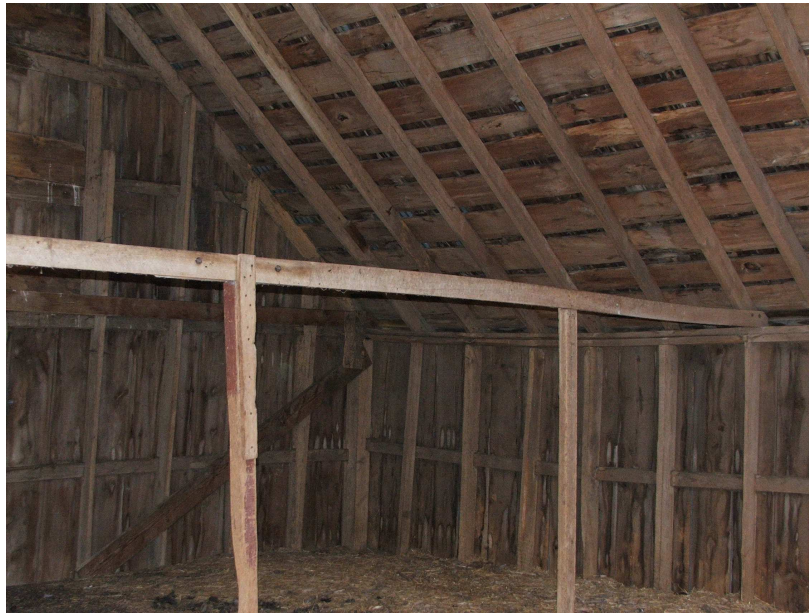
**ROLL NUMBER:** \_\_\_\_\_  
**PHOTO NUMBER:** 11

**Hayloft, looking NE, 2x4  
bracing added to keep  
walls from spreading  
out.**

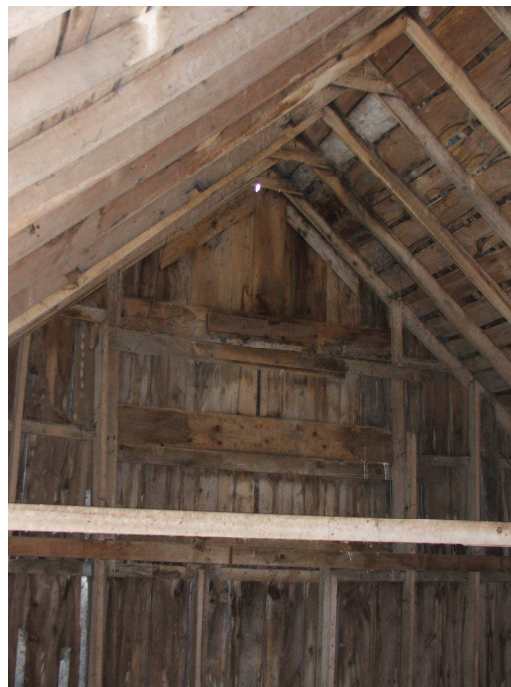
**ROLL NUMBER:** \_\_\_\_\_  
**PHOTO NUMBER:** 12

**Hayloft, looking NE,  
North gable end and  
hayloft door.**
