SOUTH DAKOTA STATE HISTORIC PRESERVATION OFFICE
HISTORIC SITES SURVEY STRUCTURE FORM

*ADDRESS: 46733 So. Dak. Highway 46
*COUNTY: Clay
*CITY: Beresford

CURRENT FUNCTION: Calving barn

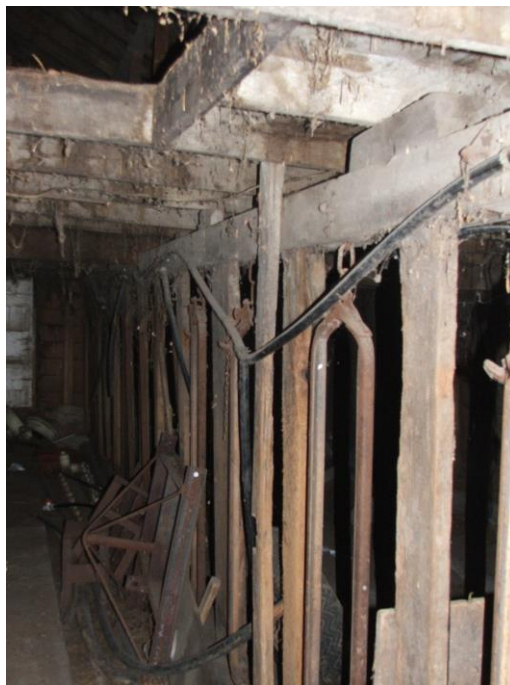
ROLL NUMBER: _____
PHOTO NUMBER: 5

First floor, West lean-to,
looking SW, 12 milk cow
stanchions in lean-to

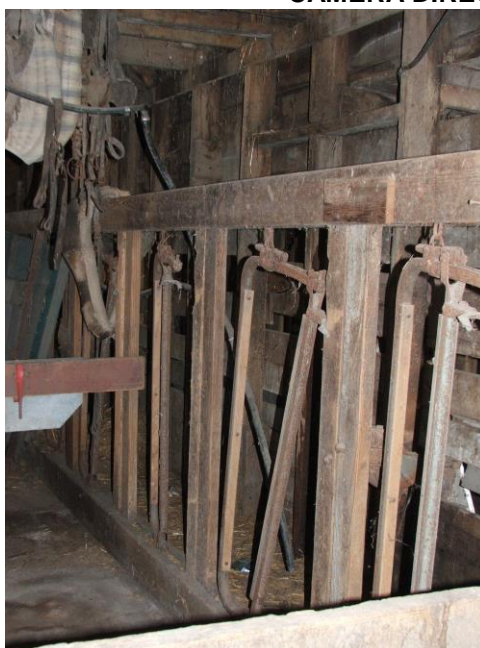
ROLL NUMBER: _____
PHOTO NUMBER: 6

First floor, main barn,
looking SW, 10 milk cow
stanchions still in place.

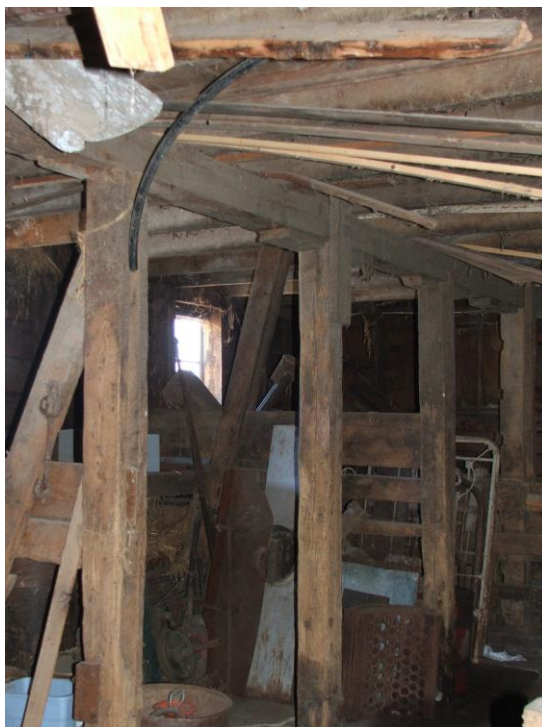
ROLL NUMBER: _____
PHOTO NUMBER: 7

CAMERA DIRECTION: First floor, main barn,
looking SE, horse stalls
stalls in place

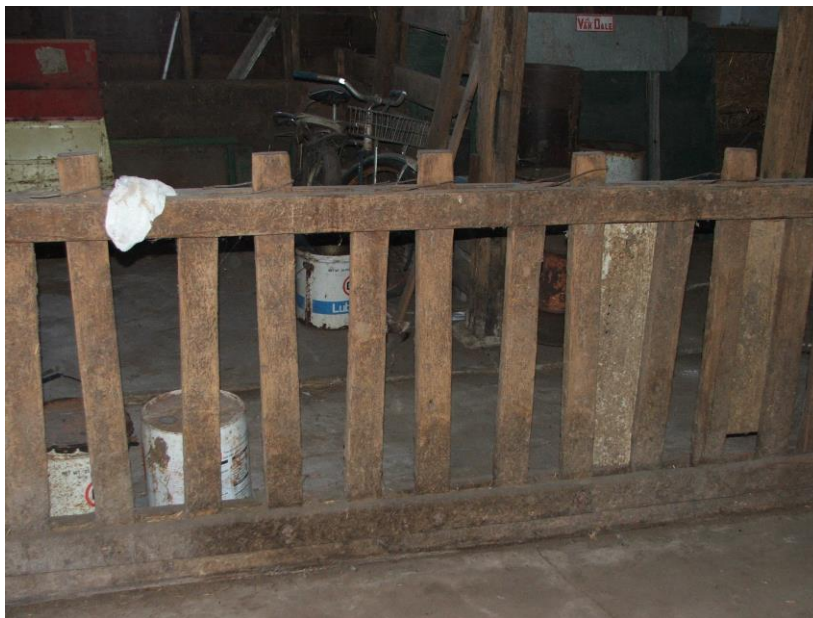
ROLL NUMBER: _____
PHOTO NUMBER: 8

CAMERA DIRECTION: First Floor, main barn,
looking East, bucket calf
stanchions

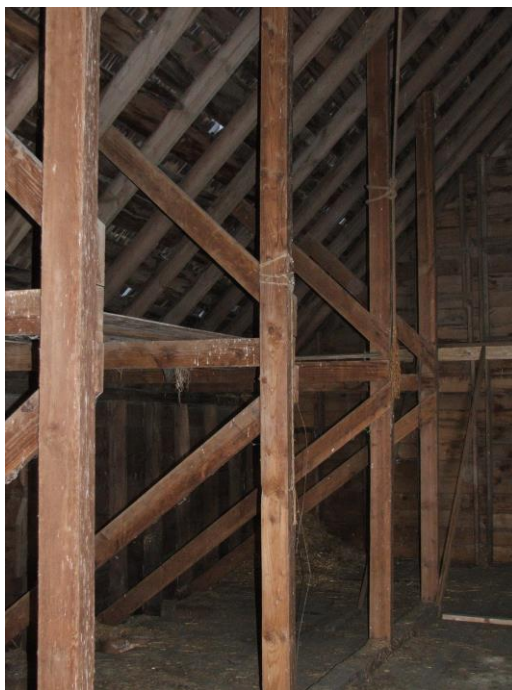
ROLL NUMBER: _____
PHOTO NUMBER: 9

Hayloft, looking SE, 4x6
posts supporting center
of rafters and 2x6
bracing back to wall and
rafters

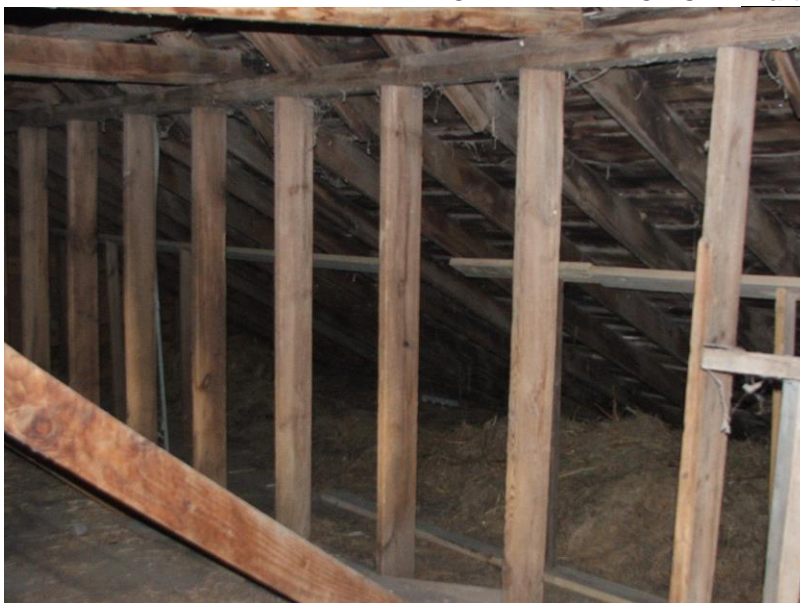
ROLL NUMBER: _____
PHOTO NUMBER: 10

Hayloft, looking SW,
open 2x6 wall between
hayloft and hayloft over
West lean-to
