SOUTH DAKOTA STATE HISTORIC PRESERVATION OFFICE
HISTORIC SITES SURVEY STRUCTURE FORM

*SURVEY DATE: December 5, 2012
*SURVEYOR: Jim Stone

*ADDRESS: 46629 303rd Street
*COUNTY: Clay
*CITY: Beresford

CURRENT FUNCTION: <u>Vacant</u>	FOUNDATION: <u>Native stone and poured concrete foundation</u>
CURRENT SUBFUNCTION: <u>Storage</u>	ROOF MATERIAL: <u>Asphalt shingles over cedar shingles</u>
HISTORIC FUNCTION: <u>Livestock barn</u>	ROOF SHAPE: <u>Gothic round</u>
HISTORIC SUBFUNCTION: <u>Hay and grain storage</u>	STRUCTURAL SYSTEM: <u>Balloon framing</u>
	STYLE: <u>Wisconsin dairy barn</u>
OCCUPIED: <u>No</u>	TYPE: <u>Livestock barn</u>
	<u>2x6 studs with 1x6 #106 drop siding and 1/2"x8" cedar lap siding</u>
ACCESSIBLE: <u>Yes with permission</u>	WALLS: <u>lap siding</u>
STORIES: <u>2</u>	SIGNIFICANT PERSON: <u>John Dahlin</u>
*DATE OF CONSTRUCTION: <u>1920 to 1930</u>	CULTURAL AFFILIATION: <u>Swedish</u>

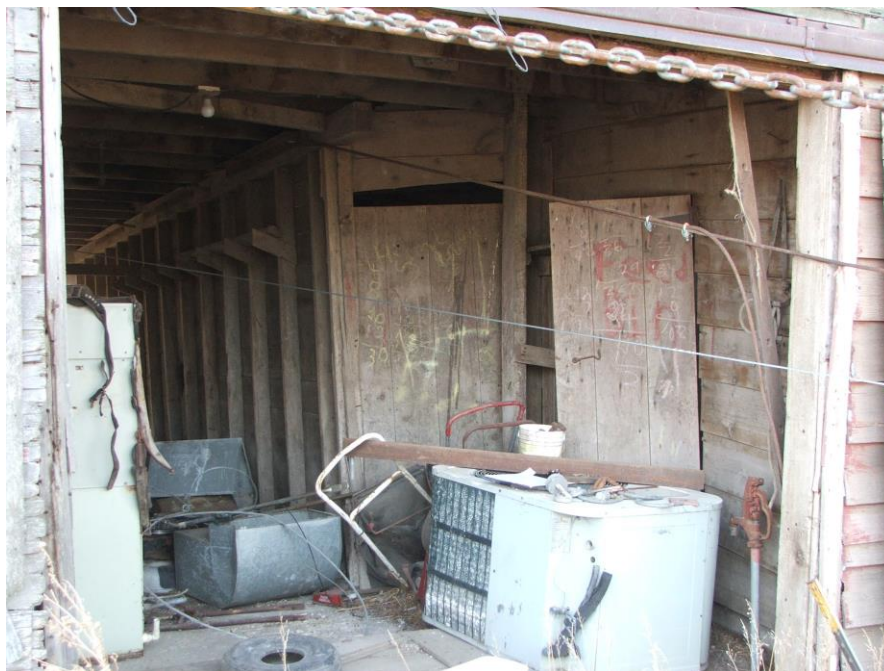
ROLL NUMBER: _____
PHOTO NUMBER: 5

CAMERA DIRECTION: First floor, looking SW,
granary in NW corner
and dividing wall for
West 12'

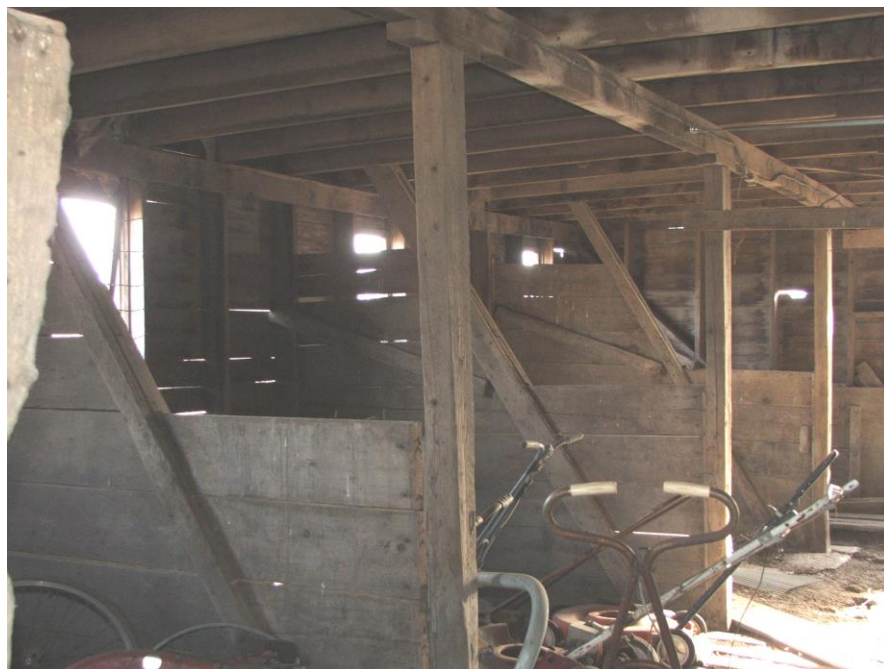
ROLL NUMBER: _____
PHOTO NUMBER: 6

CAMERA DIRECTION: First floor, looking SE,
horse stalls on East wall.

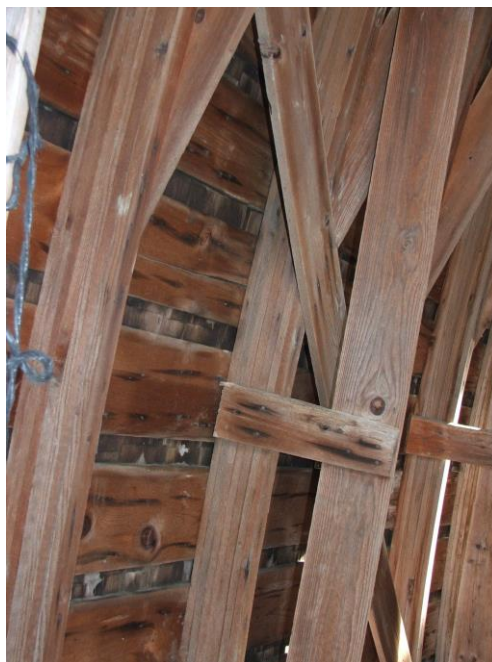
ROLL NUMBER: _____
PHOTO NUMBER: 7

CAMERA DIRECTION: Hayloft, looking SE, 7 ply
3/4"x full 2" cedar rafters
and 2x6 brace 4' O.C..

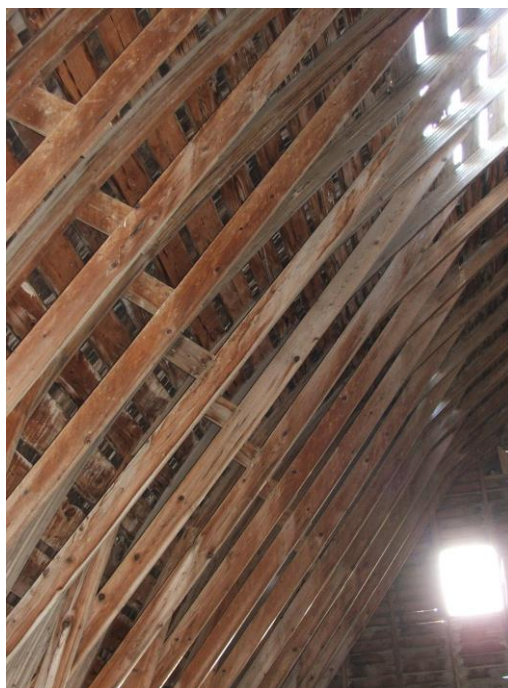
ROLL NUMBER: _____
PHOTO NUMBER: 8

CAMERA DIRECTION: Hayloft, looking SE, 2x6
hip bracing on rafters, 4'
O.C.

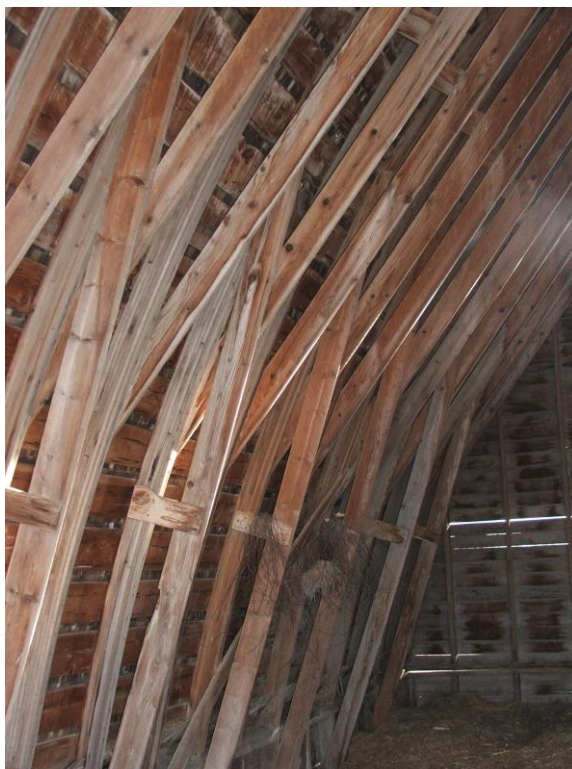
ROLL NUMBER: _____
PHOTO NUMBER: 9

CAMERA DIRECTION: Hayloft, looking SE,
lower 2x6 bracing on
rafters, 4' O.C.
