"SITE INFORM	ATION							
*SURVEY D	ATE: July 26,	2013 *ADDRESS:	5: 46008 310 th Street					
*SURVE	YOR: Jim Stor	ne *COUNTY:	Clay					
		*CITY:	Vermillion					
LOCATION DESCRIPTION: From Vermillion, intersection of South Dakota Highway 50 bi-pass and								
South Dakota Highway 19, North about 8 miles to 310 th Street, turn left (West) about 2-1/2 miles follow								
310 th Street, it will have two corners, on the right (North) side.								
LEGAL DESCRIPTION: W ½, SW ¼ Exc W 330' of N 396' of SW ¼, SW 1/4, 4 – 93 – 52 Spirit Mound								
Twp.								
*QUARTER 1:	SW 1/4	OWNER NAME:	OWNER NAME: Kurt T. & Margaret E. Amundson					
*QUARTER 2:		OWNER ADDRESS:	46003					
*TOWNSHIP:	Spirit Mound	OWNER CITY:	OWNER CITY: Vermillion					
*RANGE:	52	OWNER STATE: South Dakota						
*SECTION:	4	OWNER ZIP:	57069					
ACRES:	75.01	QUAD NAME:						
OWNER CODE 1:	Р							
OWNER CODE 2:								
OWNER CODE 3:								
HISTORIC SIGNIFICANCE

STRUCTURE DETAILS

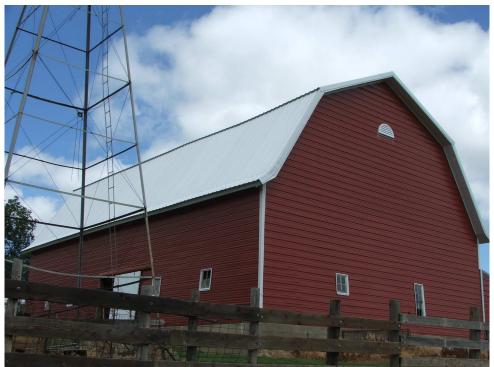
PHOTOGRAPHER: Jim Stone ROLL NUMBER: DATE OF PHOTO: July 26, 2013 PHOTO NUMBER: 1

CAMERA DIRECTION: Looking NE, SW corner

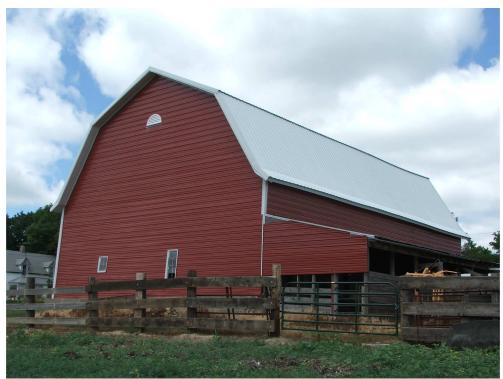
PHOTOGRAPHER: Jim Stone ROLL NUMBER: DATE OF PHOTO: July 26, 2013 PHOTO NUMBER: 2
CAMERA DIRECTION: Looking NW, SE corner

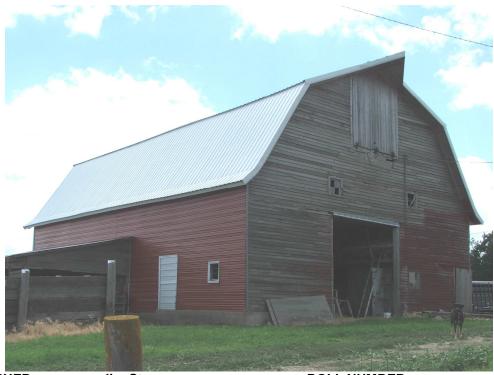
ROLL NUMBER: PHOTO NUMBER: CAMERA DIRECTION: Looking SW, NE corner

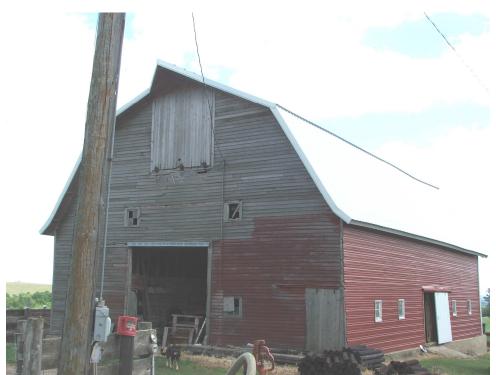
CAMERA DIRECTION: Looking SE, NW corner

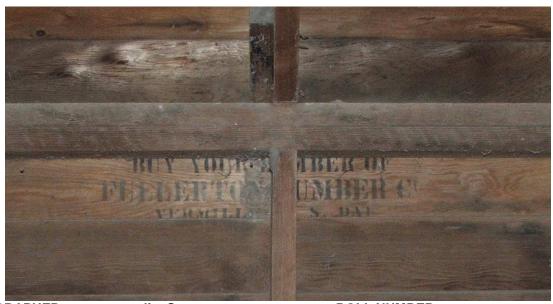
Hayloft, looking West, painted stencil,
Buy Your Lumber of(?)
Fullerton Lumber Co.

CAMERA DIRECTION: Vermillion, So. Dak.

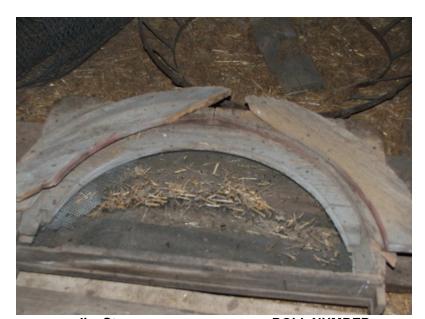
10

Hayloft, old ½ round wood window from the South gable end peak, was replaced with a ½ round vinyl louver.
