<u>Site</u>	INF	<u>ORM/</u>	<u>NOITA</u>

*SURVEY DA	ATE: <u>M</u>	arch 20	, 2013	*ADDRESS:	29750 467 th Ave						
*SURVEY	OR: Ji	m Stone	е	*COUNTY:	Clay						
	·			*CITY:	Beresford						
					'						
LOCATION DESCR	IPTION: F	rom Ver	million, South	Dakota Highway	/ 50 Eas	st 2 r	niles	to C	Greer	nfield	Road,
turn left (North) 18	miles, on the	e left (W	est) side.								
LEGAL DESCRIPTION	ON: <u>SW 1/4</u>	4, NE ¼,	3 - 95 - 51 G	lenwood Twp.							
*OUADTED 4.	NIT 4/4			NAVAIED NAME.	Manal	– also,	l l	a .a al			
*QUARTER 1:	NE 1/4				Marc Edward Landeen						
*QUARTER 2:	01		OVVN	ER ADDRESS:							
*TOWNSHIP:	Glenwood	1			Beresford						
*RANGE:	51		O		South Dakota						
*SECTION:	3			OWNER ZIP:							
ACRES:	159.70			QUAD NAME:							
OWNER CODE 1: OWNER CODE 2:	Р										
OWNER CODE 3:											
HISTORIC SIGN	<u>IFICANCE</u>										
*D(OE:			REGISTER NA	ME:						
*DOE: *DOE DATE:				MULTIPLE PR	OPERT	ΥN	AME:				
REASON INELIGIBLE:											
					C	CATE	GOF	RY:

STRUCTURE DETAILS

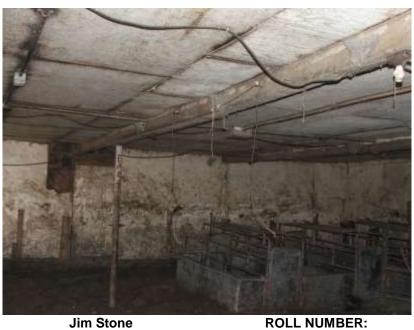
First floor, looking into CAMERA DIRECTION: milk room.
