""SITE INFORMATION									
*SURVEY DATE: July	<i>,</i> 18, 2013	*ADDRESS:	45242 300th Street						
	Stone	*COUNTY:	Clay						
		- *CITY:							
LOCATION DESCRIPTION: From Vermillion, the intersection of South Dakota Highway 50 bi-pass and									
South Dakota Highway 19, North 15 miles to 302 nd Street, turn left (West) about 10miles to 452 th Ave., turn									
right (North) 2 miles to 300st Street, turn right (East) about ¼ mile, on the left (North) side.									
LEGAL DESCRIPTION: S ½, S ½, Lots 1 & 2, SW ¼, 18 – 95 – 53 Star Twp.									
			Clark V. Christer	nsan					
*QUARTER 1: SW1/4		OWNER NAME:	CD-Virgil E. Chri		n Est	ate			
*QUARTER 2:	OWI	NER ADDRESS:	45238 300 th Street						
*TOWNSHIP: Star		OWNER CITY:	Wakonda						
*RANGE:53		OWNER STATE:	South Dakota						
*SECTION: 18		OWNER ZIP:	57073						
ACRES: 38.20		QUAD NAME:							
OWNER CODE 1: P									
OWNER CODE 2:									
OWNER CODE 3:

STRUCTURE DETAILS

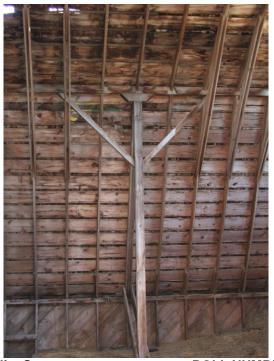
First floor, looking NE, solid 2x6 wall that has been removed, 6x6 and (3)2x6's posts have been

CAMERA DIRECTION: placed at random.

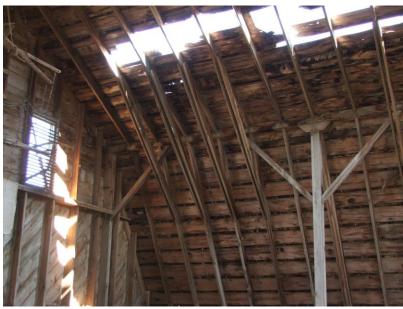
Hayloft, looking North, 6x6 post, 6x6 beam

CAMERA DIRECTION: supporting hip.

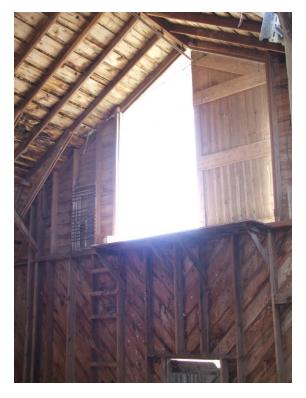
8

Hayloft, looking NW, (2) 1x6 bracing on 2x6

CAMERA DIRECTION: rafters at the hip.
