```SITE INFORMATION

*SURVEY DATE: February 22, 2014

*ADDRESS: 46140 Riverside Street

SHPO ID:				
*PROPERTY NAME:				
OTHER NAME:				
CURRENT FUNCTION:	Calving barn	FOUNDA	TION:	Native stone w/ mortar
CURRENT SUBFUNCTION:	Storage	ROOF MATE	RIAL:	Steel roofing over cedar shingles
HISTORIC FUNCTION:	Livestock barn	ROOF SH	APE:	Gable roof
HISTORIC SUBFUNCTION:	Hay and grain storag	ge STRUCTURAL SYS	STEM:	Balloon framing
		S	TYLE:	Western feeder barn
OCCUPIED:	Yes	1	TYPE:	Livestock barn
ACCESSIBLE:	Yes with permission	WALLS:		2x6 & 2x4 studs, ¹ / ₂ "x6" cedar lap siding and steel
STORIES:	2	SIGNIFICANT PERSON:	J	ohn L. Sjoberg
*DATE OF CONSTRUCTION:	1900 to 1915	CULTURAL AFFILIATION:		Swedish

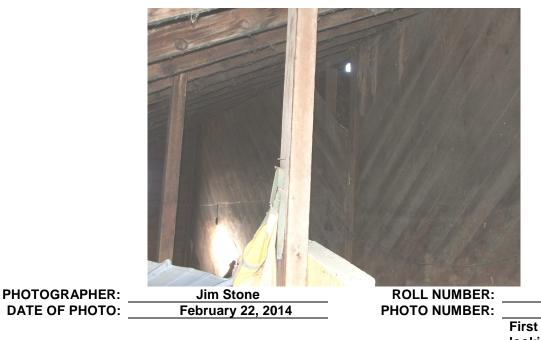
First floor, Center barn area, looking SW, note part of a divider for a CAMERA DIRECTION: double horse stall.
