**SOUTH DAKOTA STATE HISTORIC PRESERVATION OFFICE
HISTORIC SITES SURVEY STRUCTURE FORM**

*SURVEY DATE: December 29, 2012 *ADDRESS: 46837 307th Street
*SURVEYOR: Jim Stone *COUNTY: Clay
*CITY: Beresford

CURRENT FUNCTION: Shop

HISTORIC FUNCTION: Livestock barn

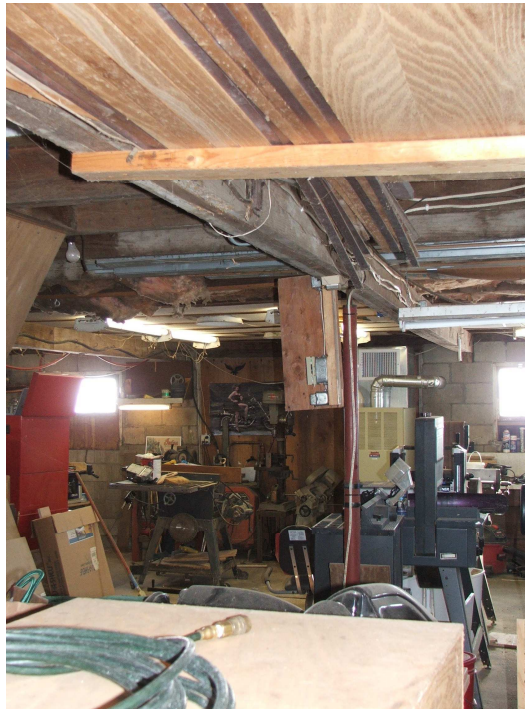
ROLL NUMBER: 5
PHOTO NUMBER: 5

CAMERA DIRECTION: First floor, looking
South, beam and post on
West side

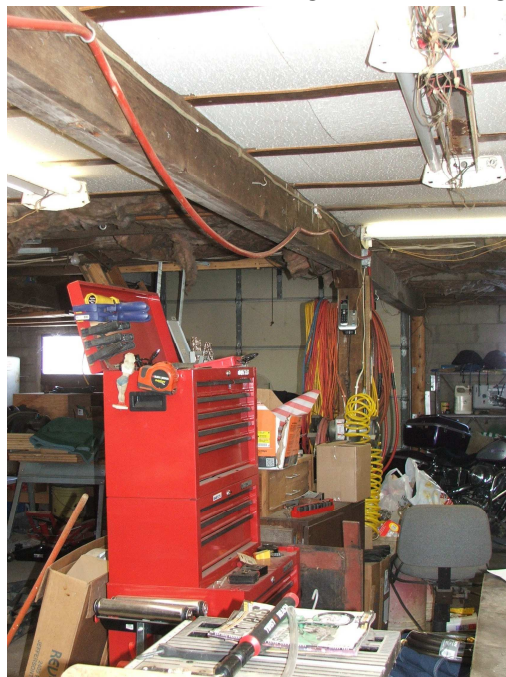
ROLL NUMBER: 6
PHOTO NUMBER: 6

CAMERA DIRECTION: First floor, looking North,
beam and post on East
side

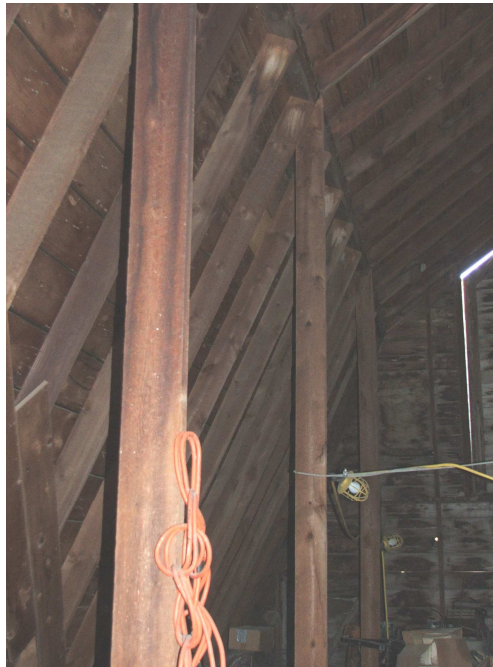
ROLL NUMBER: _____
PHOTO NUMBER: 7

**Hayloft, looking North,
2x6 posts supporting (2)
2x6's at the hip on West
side.**

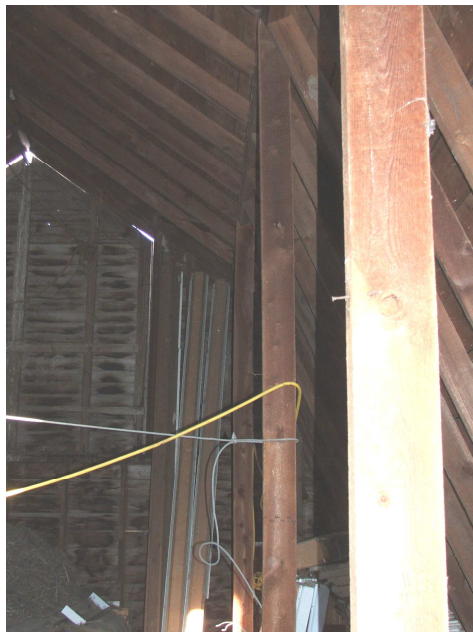
ROLL NUMBER: _____
PHOTO NUMBER: 8

**Hayloft, Looking North,
2x6 posts, (2) 2x6's
beam supporting hip on
East side.**
