#### SITE INFORMATION

#### STRUCTURE DETAILS

SHPO ID:					
*PROPERTY NAME:					
OTHER NAME:					
CURRENT FUNCTION:	Horse barn	FOUNDATION:	Native rock with sand and lime mortar		
oomen ononom	110100 54111	i companioni	Steel roofing over		
CURRENT SUBFUNCTION:	Storage	ROOF MATERIAL:	cedar shingles		
HISTORIC FUNCTION:	Livestock barn	ROOF SHAPE:	Gable		
HISTORIC SUBFUNCTION:	UBFUNCTION: <u>Hay and grain storage</u> STRUCTURA		Balloon framing		
		STYLE:	Gable roof barn		
OCCUPIED:	Yes	TYPE:	Livestock barn		
ACCESSIBLE:	Yes with permission	WALLS:	2x6 studs with sheathing and 1x6 #106 drop siding.		
CTODICO.	2	CONTENT DEDOOM:	I I avantus -		
STORIES: *DATE OF CONSTRUCTION:		SIGNIFICANT PERSON:L. LTURAL AFFILIATION:	J. Lorentzen  Danish		
DATE OF CONSTRUCTION.	1000 10 1090	LIURAL AFFILIATION.	DailiSii		
re-mortared with Portland cer		oncrete blocks) 8 feet high. F	oundation has been		
	4x4 beams in the North	vith 4x6 for beams in south enend of the main barn. Any evi

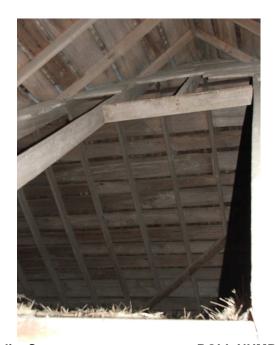
8

First floor, North end of East lean-to, note sheathing lower diagonal
