**SOUTH DAKOTA STATE HISTORIC PRESERVATION OFFICE
HISTORIC SITES SURVEY STRUCTURE FORM**

*SURVEY DATE: July 2, 2013 *ADDRESS: 29714 455th Ave.
*SURVEYOR: Jim Stone *COUNTY: Clay
*CITY: Wakonda

| CURRENT FUNCTION: <u>Sheep barn</u> | FOUNDATION: <u>Poured concrete</u> |

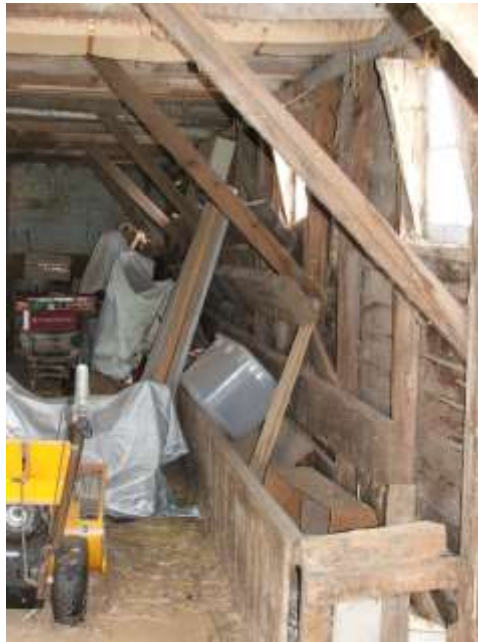
ROLL NUMBER: 5
PHOTO NUMBER: 5

CAMERA DIRECTION: First floor, looking NE,
30' milk cow manger
along the East wall.

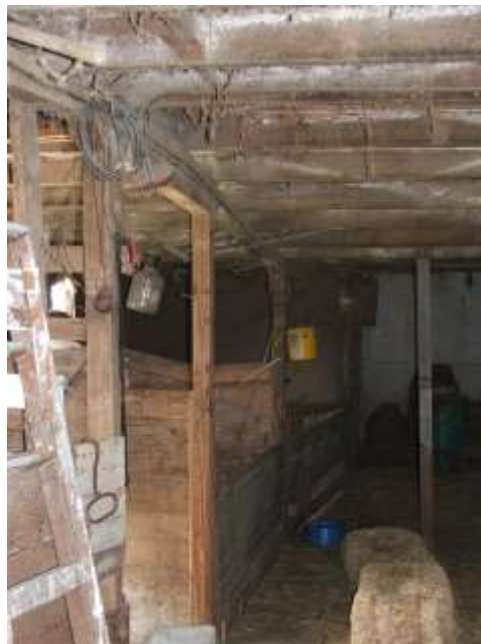
ROLL NUMBER: 6
PHOTO NUMBER: 6

CAMERA DIRECTION: First floor, looking NW,
remains of double horse
stalls and granary in NW
corner.

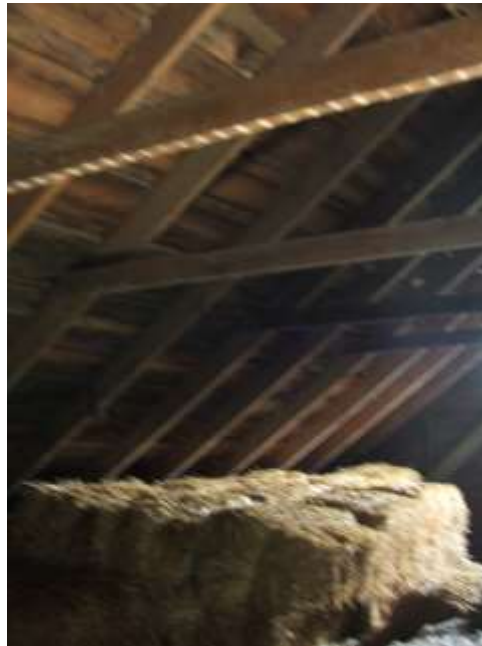
ROLL NUMBER: _____
PHOTO NUMBER: 7

CAMERA DIRECTION: Hayloft, looking SE, 2x4
rafters with 2x4
horizontal brace 4' O. C.

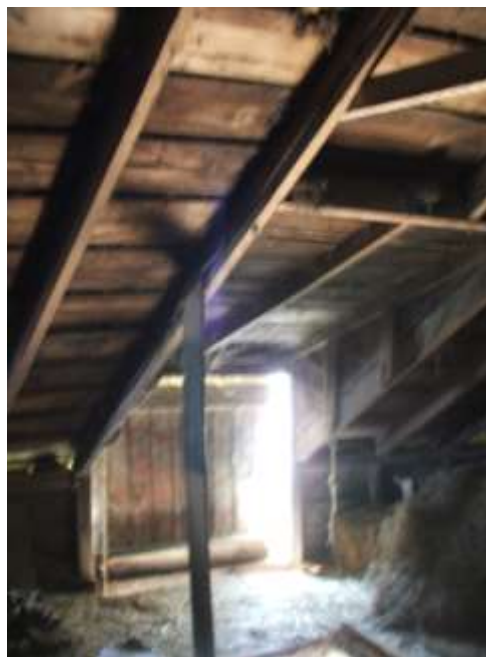
ROLL NUMBER: _____
PHOTO NUMBER: 8

CAMERA DIRECTION: Hayloft, looking NW,
dormer on center of
West wall with hayloft
door.
