#### SITE INFORMATION

### STRUCTURE DETAILS

row of 6x6 posts 9' O.C	. with 6x6 for beam in the cente	r of the barn. 2x8								
floor joists.											
		siding and steel roofing. Rafter									
shingles and steel roofing. Windows are 9"x12" four light. New concrete floor under barn.											
*PHYSICAL NOTES: Barn is	s in very good condition										
		*RESTRICTED: Y o	or N								
*UTM EASTING:											
*UTM NORTHING:

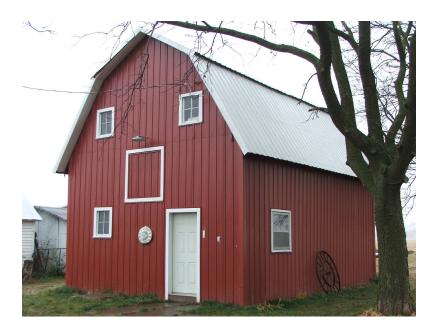
DATE OF PHOTO: October 24, 2012 PHOTO NUMBER: 3

CAMERA DIRECTION: Looking SE, NW corner

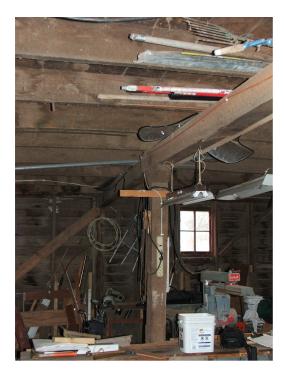
PHOTOGRAPHER: Jim Stone ROLL NUMBER: PHOTO NUMBER: 4

First floor, looking CAMERA DIRECTION: South, posts and beam

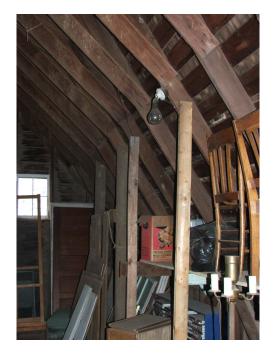
Hayloft, looking North,

CAMERA DIRECTION: hip rafter

(2) 1x6 bracing on each

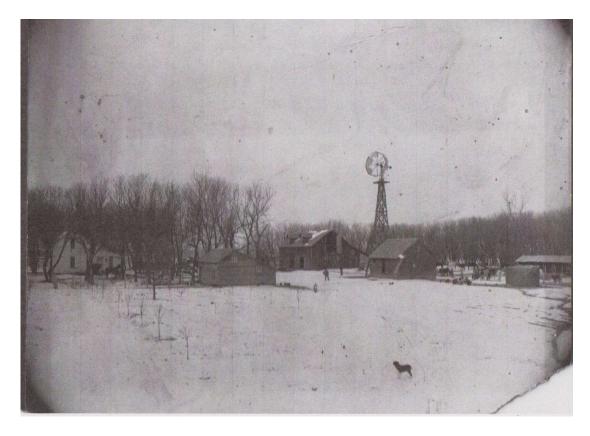
Picture of first barn on this farm, in center back by windmill,
It has two dormers. Picture taken in 1901.
This barn burned down shortly after this, but don't know the year.

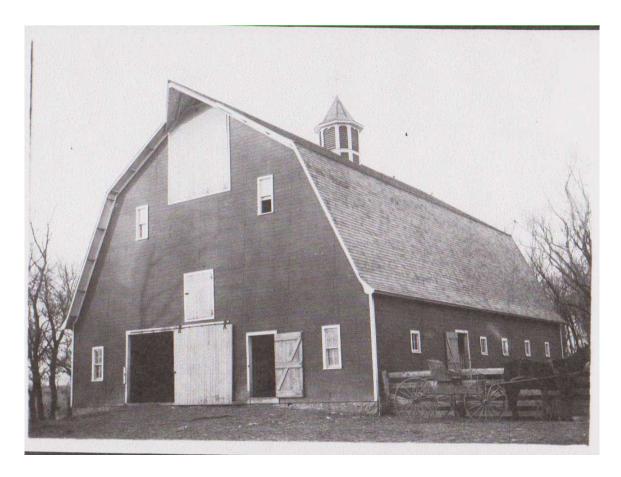
This is the second barn on this farm. Built after the first barn burned down.

Red rock foundation is still visable. Barn was taken down in \_\_\_\_\_because the roof was falling in. Foundation measures 46 feet wide and 67 feet long.

Barn was built in 1909. Date of picture is unknown.
