SOUTH DAKOTA STATE HISTORIC PRESERVATION OFFICE
HISTORIC SITES SURVEY STRUCTURE FORM

*SURVEY DATE: February 5, 2013

*ADDRESS: 46083 303rd Street

HISTORIC FUNCTION: Livestock barn

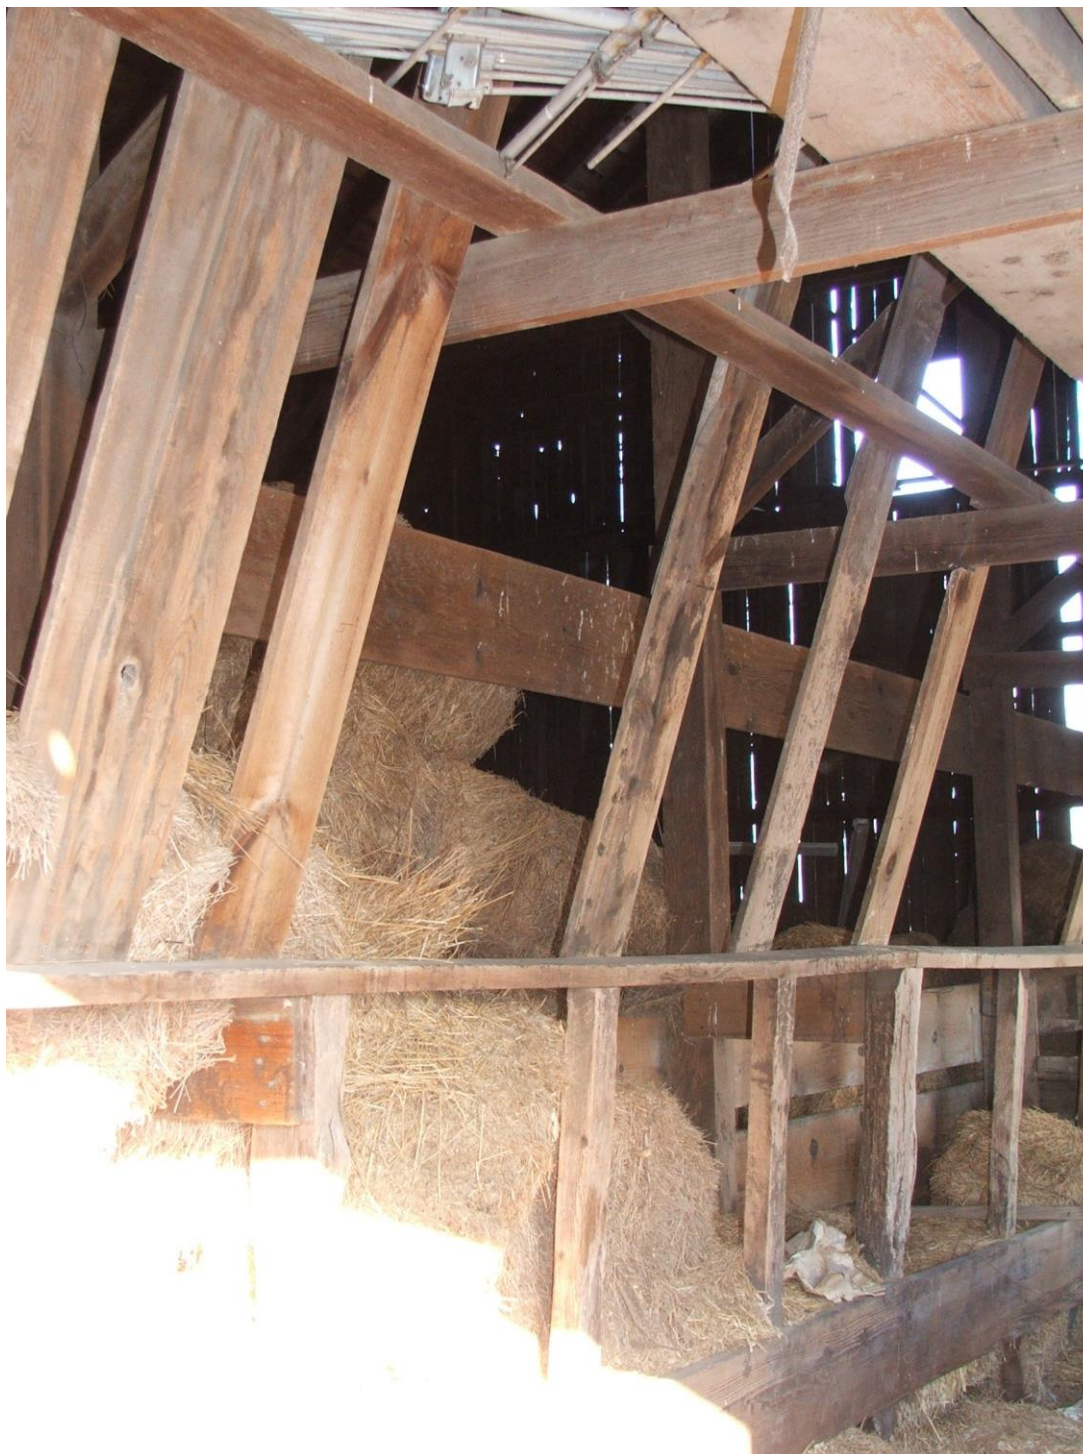
ROLL NUMBER: _____
PHOTO NUMBER: 5

CAMERA DIRECTION: First floor, South side,
looking NE, Feed bunk
and hay feed rack above

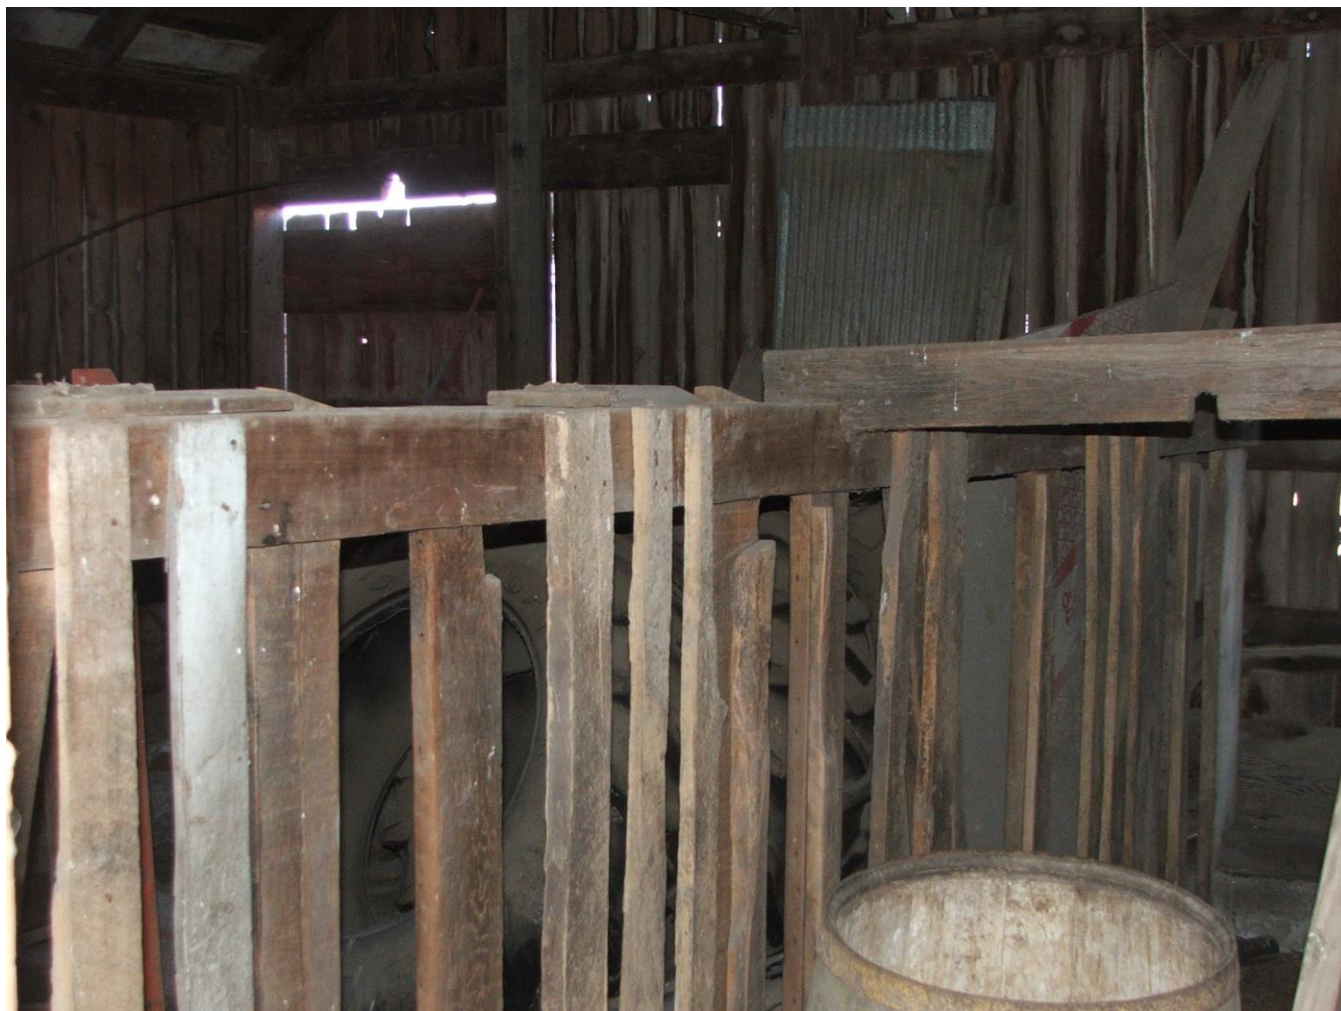
ROLL NUMBER: _____
PHOTO NUMBER: 6

CAMERA DIRECTION: First floor, North side,
looking NE, seven milk
cow stanchions

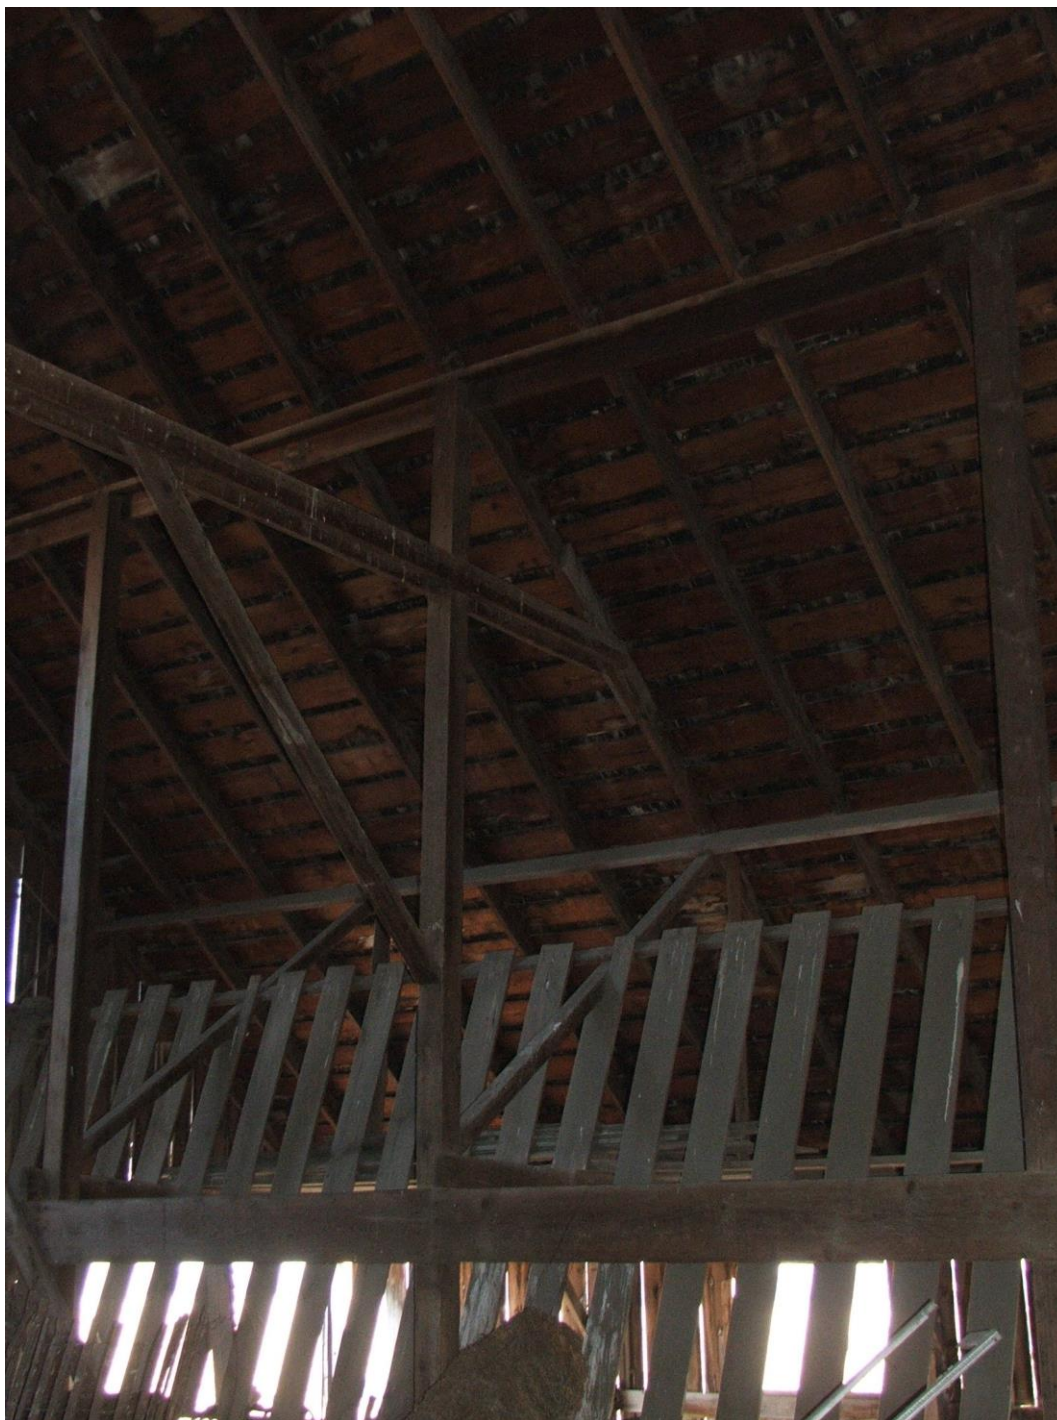
ROLL NUMBER: _____
PHOTO NUMBER: 7

CAMERA DIRECTION: First floor, center area,
looking SE, hay feed
rack and 6x6 posts 20'
high with bracing

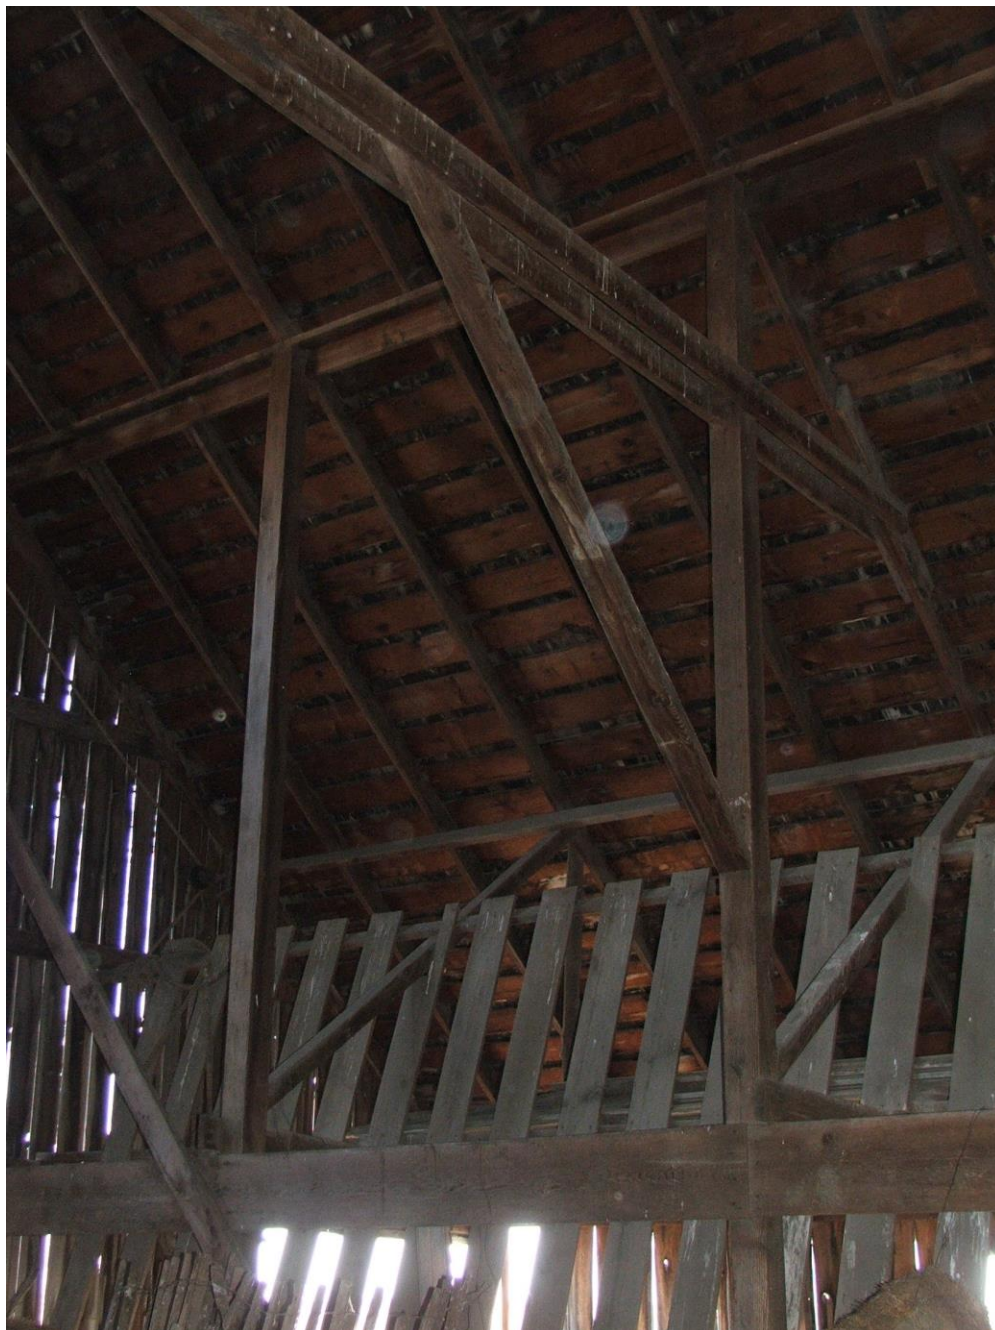
ROLL NUMBER: _____
PHOTO NUMBER: 8

CAMERA DIRECTION: First floor, looking SE,
6x6 post 20' high, (2)
2x6's for a beam to
support rafters and
bracing
