**SOUTH DAKOTA STATE HISTORIC PRESERVATION OFFICE
HISTORIC SITES SURVEY STRUCTURE FORM**

CURRENT FUNCTION: <u>Storage</u>	FOUNDATION: <u>Poured concrete</u>
CURRENT SUBFUNCTION: _____	ROOF MATERIAL: <u>Steel over cedar shingles</u>
HISTORIC FUNCTION: <u>Horse barn</u>	ROOF SHAPE: <u>Gambrel</u>
HISTORIC SUBFUNCTION: <u>Hay and grain storage</u>	STRUCTURAL SYSTEM: <u>Balloon framing</u>
OCCUPIED: <u>Yes</u>	STYLE: <u>Gambrel roof barn</u>
ACCESSIBLE: <u>Yes with permission</u>	TYPE: <u>Horse barn</u>
	WALLS: <u>2x6 studs, with sheathing and siding</u>
STORIES: <u>2</u>	SIGNIFICANT PERSON: <u>?</u>
*DATE OF CONSTRUCTION: <u>1920's - 1930's</u>	CULTURAL AFFILIATION: <u>?</u>

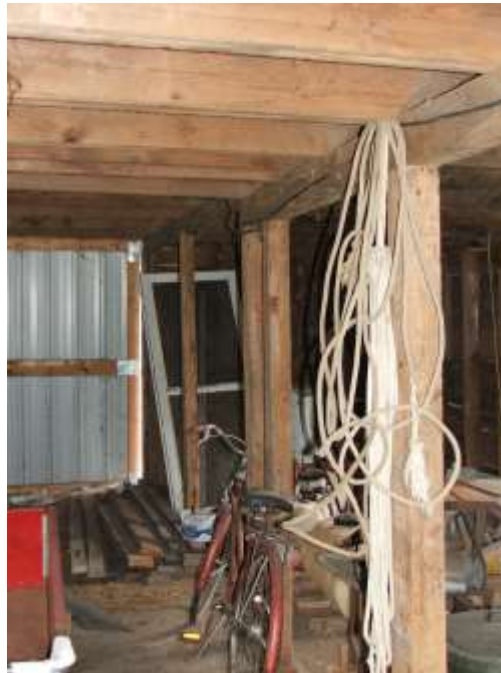
ROLL NUMBER: _____
PHOTO NUMBER: 5

CAMERA DIRECTION: First floor, looking East,
posts, beam & floor
joists

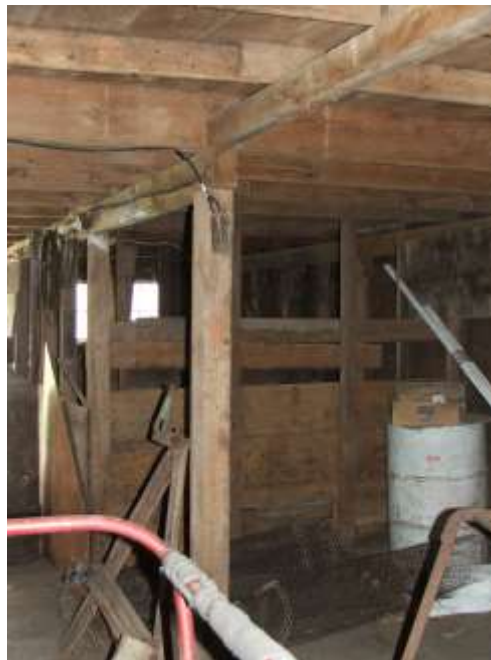
ROLL NUMBER: _____
PHOTO NUMBER: 6

CAMERA DIRECTION: First floor, looking West,
posts, beam, pen & feed
room in NW corner

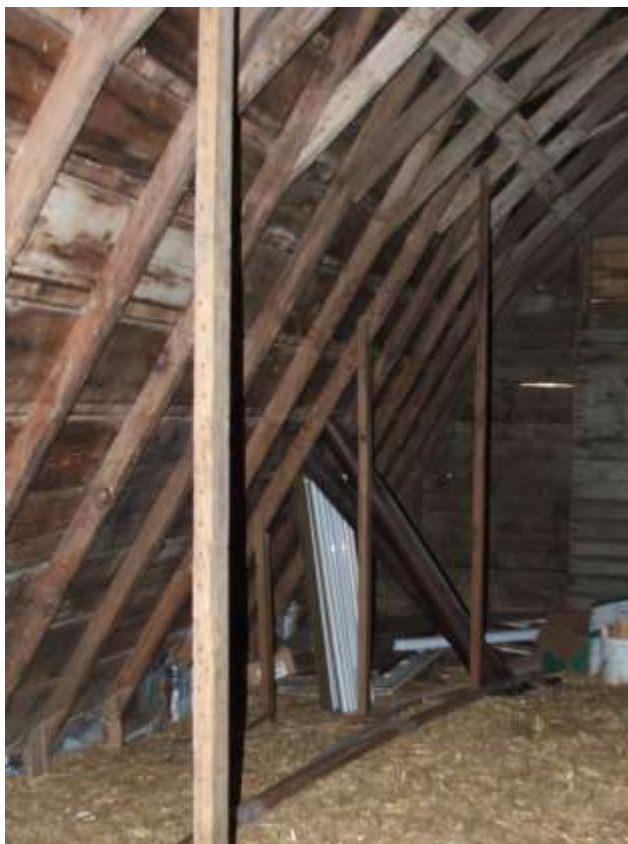
ROLL NUMBER: _____
PHOTO NUMBER: 9

CAMERA DIRECTION: Hayloft, looking East, (2)
2x4's posts, I do not
know the purpose
