**SOUTH DAKOTA STATE HISTORIC PRESERVATION OFFICE
HISTORIC SITES SURVEY STRUCTURE FORM**

*SURVEY DATE: August 10, 2013 *ADDRESS: 30548 454th Ave.
*SURVEYOR: Jim Stone *COUNTY: Clay
*CITY: Volin

CURRENT FUNCTION: Storage FOUNDATION: Poured concrete
 CURRENT SUBFUNCTION: Storage ROOF MATERIAL: Steel roofing over cedar shingles
 HISTORIC FUNCTION: Livestock barn ROOF SHAPE: Gable roof
 HISTORIC SUBFUNCTION: Hay storage STRUCTURAL SYSTEM: Balloon framing
 OCCUPIED: No STYLE: Gable roof barn
 TYPE: Livestock barn
 ACCESSIBLE: Yes with permission WALLS: 2x6 studs, sheathing and 1/2"x6" cedar lap siding

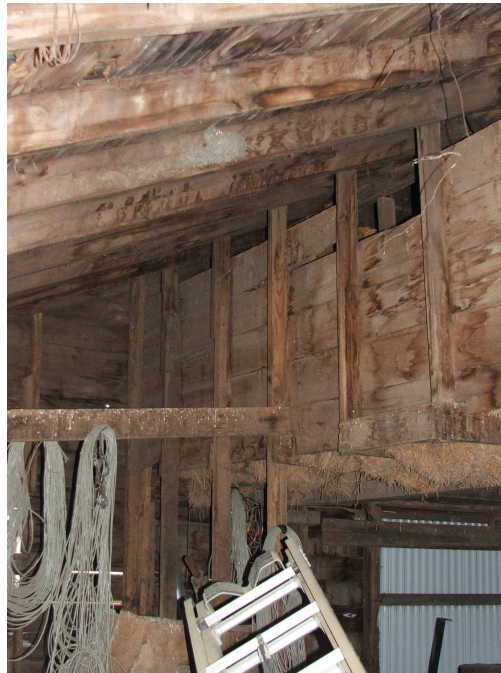
ROLL NUMBER: 5
PHOTO NUMBER: 5

ALTERED/MOVED NOTES: Original site. Roof covered with steel roofing over cedar shingles. All evidence of milk cow stanchions and horse stalls has been removed. Hayloft has been extended 2 feet into North lean-to. 8' sliding door may have been added on East wall.

CAMERA DIRECTION: Looking SE & up, from North lean-to, 2x6 rafters and 2' extension of hayloft.

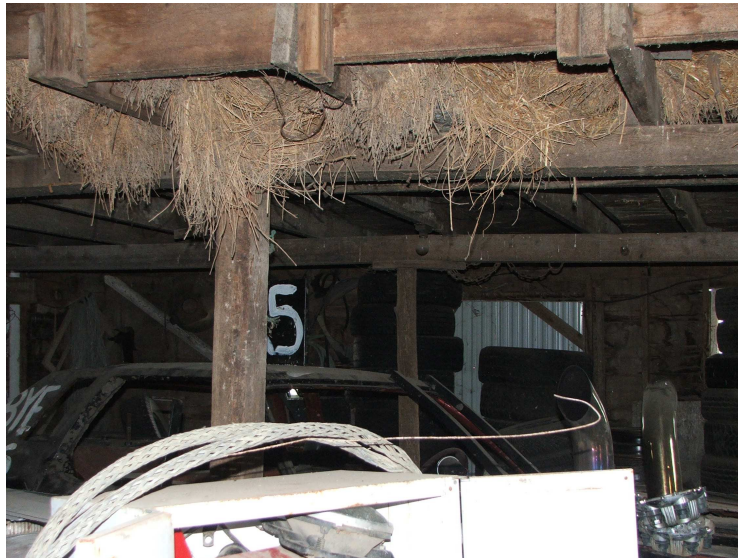
ROLL NUMBER: 6
PHOTO NUMBER: 6

INTERIOR NOTES: Two rows of 4x6 posts with 4x6's for beams support 2x6 joists for hayloft floor. The wall between the barn and lean-to is one of the 4x6 beams with a 4x6 post in the center of the 24'.

CAMERA DIRECTION: First floor, looking SE, 4x6 posts, 4x8 beam, 2x6 floor joists, 2' extension of hayloft into North lean-to
