<b>""SITE INFORMATION</b>								
*SURVEY DATE: March 10,	2014 *ADDRESS:	46116 Riverside Street						
*SURVEYOR: Jim Ston	<del></del>	Clay						
	*CITY:	Centerville						
LOCATION DESCRIPTION: From Vermillion, intersection of South Dakota Highway 50 bi-pass and South Dakota Highway 19, North 15-1/2 miles to Riverside Street, turn left (West) about 7/8 mile, on the right (North) side.								
LEGAL DESCRIPTION: W ½, NW ¼, E	exc 1.48 A, 27 –95 – 52 Rivers	side Twp.						
*QUARTER 1: <u>NW 1/4</u>	OWNER NAME:	Steven & Robin Hansen						
*QUARTER 2:	OWNER ADDRESS:	46140 Riverside Street						
*TOWNSHIP: Riverside	OWNER CITY:	Centerville						
*RANGE: <u>52</u>	OWNER STATE:	South Dakota						
*SECTION:27	OWNER ZIP:	57014						
ACRES: 78.01	QUAD NAME:							
OWNER CODE 1: P								
OWNER CODE 2:								
OWNER CODE 3:								
HISTORIC SIGNIFICANCE								
*DOE:	REGISTER NA	REGISTER NAME:						
*DOE DATE:		MULTIPLE PROPERTY NAME:

#### STRUCTURE DETAILS

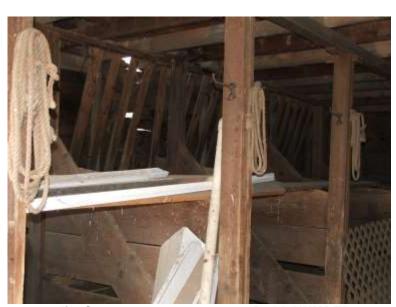
First floor, original barn, looking NW, double 2x6 posts, 4x4 beam and 2x6 floor joists and single horse stalls on West

CAMERA DIRECTION: wall.

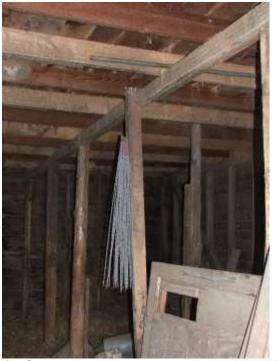
First floor, original barn, looking NE, replaced round posts, 4x4 beam

CAMERA DIRECTION: and 2x6 floor joists.

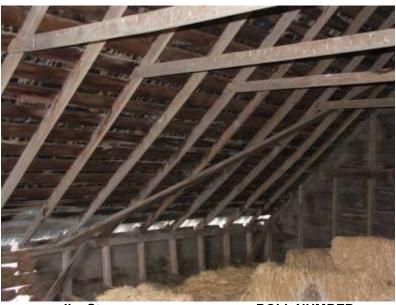
Hayloft, looking NW, 2x4 rafters and 2x4 bracing

CAMERA DIRECTION: 4' O.C.

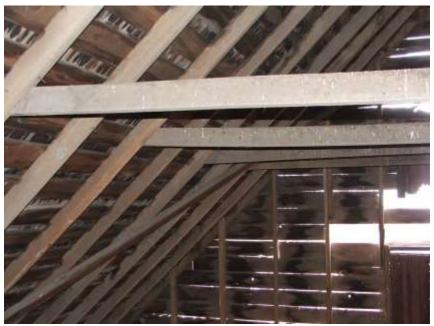
9

Hayloft, looking SE, 2x4 rafters, 2x4 bracing and

CAMERA DIRECTION: South gable wall
