**SOUTH DAKOTA STATE HISTORIC PRESERVATION OFFICE
HISTORIC SITES SURVEY STRUCTURE FORM**

*SURVEY DATE: July 26, 2012 *ADDRESS: 30770 458th Ave. (Vacant)
*SURVEYOR: Jim Stone *COUNTY: Clay
*CITY: Wakonda

HISTORIC FUNCTION: Livestock barn

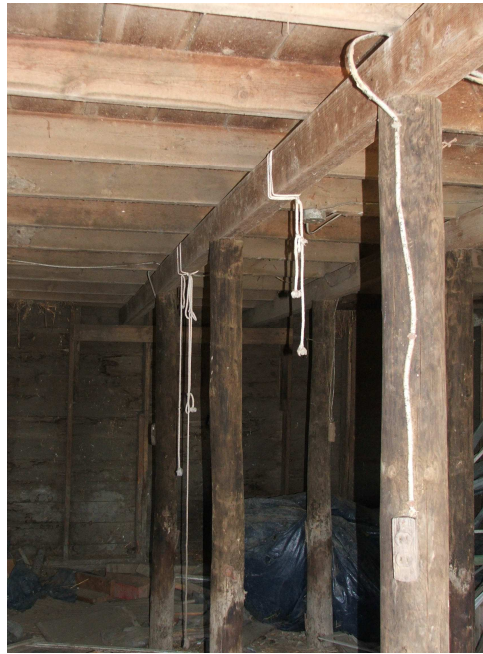
ROLL NUMBER: 5
PHOTO NUMBER: 5

INTERIOR NOTES: Has two rows 6" round creosote posts and (2) 2x6's for a beam to support hayloft floor. Floor joists are 2x6's.

**First floor, looking North,
6" round creosoted
posts and (2) 2x6's for
beam**

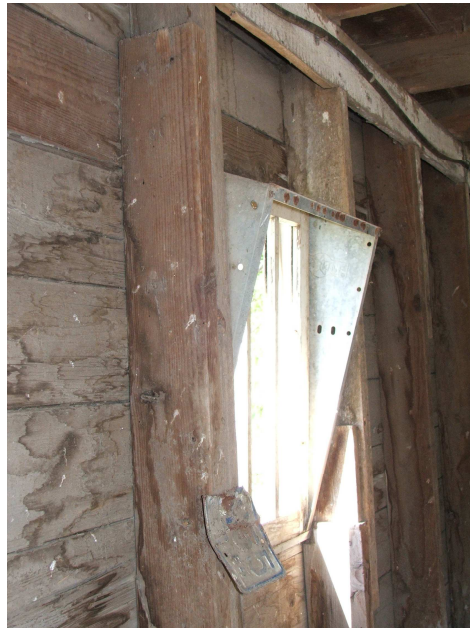
ROLL NUMBER: _____
PHOTO NUMBER: 6

OTHER NOTES: Windows were 4"x24" four light with metal sides for adjustable window ventilation. Tops of windows tilt in to prevent direct drafts and prevent rain from coming into the barn. Walls are 2x6 with 1x8 shiplap sheathing and horizontal galv. corr. steel. Rafters are 2x6's with 2x6 horizontal bracing close to the peak, 4' O.C.

**First floor, looking North,
Special metal sides on
windows for Adj.**

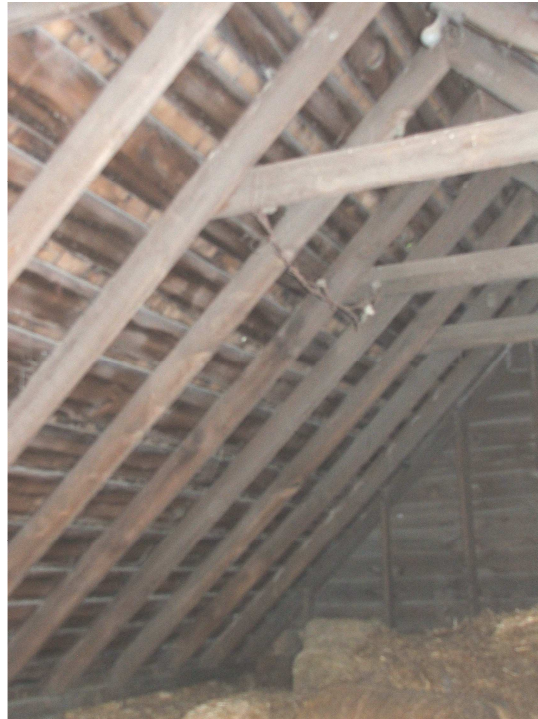
ROLL NUMBER: _____
PHOTO NUMBER: 7
CAMERA DIRECTION: Hayloft, looking NW,
rafters and brace 4' O.C.
