STRUCTURE DETAILS

SOUTH DAKOTA STATE HISTORIC PRESERVATION OFFICE HISTORIC SITES SURVEY STRUCTURE FORM

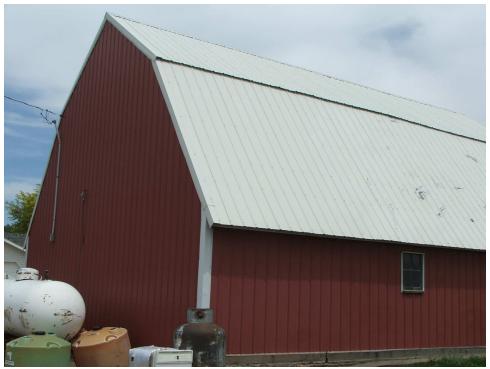
PHOTOGRAPHER: Jim Stone ROLL NUMBER: DATE OF PHOTO: June 5, 2013 PHOTO NUMBER: 1

CAMERA DIRECTION: Looking NE, SW corner

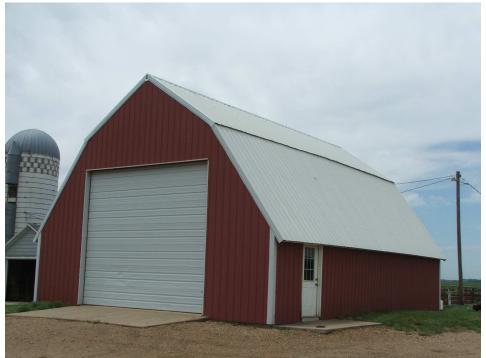
PHOTOGRAPHER: Jim Stone ROLL NUMBER: DATE OF PHOTO: June 5, 2013 PHOTO NUMBER: 3
CAMERA DIRECTION: Looking SW, NE corner

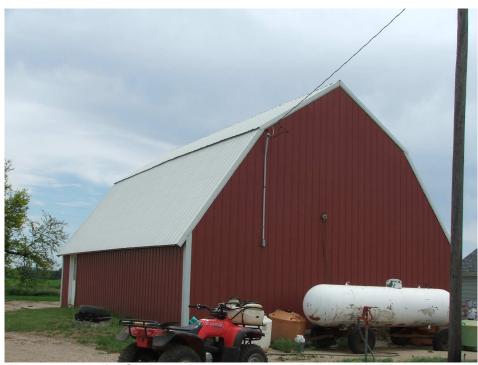
PHOTOGRAPHER: Jim Stone ROLL NUMBER: DATE OF PHOTO: June 5, 2013 PHOTO NUMBER: 4
CAMERA DIRECTION: Looking SE, NW corner
