**SOUTH DAKOTA STATE HISTORIC PRESERVATION OFFICE
HISTORIC SITES SURVEY STRUCTURE FORM**

*SURVEY DATE: October 2, 2012 *ADDRESS: 32115 472nd Ave.
*SURVEYOR: Jim Stone *COUNTY: Union
*CITY: Elk Point

CURRENT SUBFUNCTION: Storage ROOF MATERIAL: _____
 HISTORIC FUNCTION: Livestock barn ROOF SHAPE: Gambrel
 HISTORIC SUBFUNCTION: Hay storage STRUCTURAL SYSTEM: Balloon framing
 OCCUPIED: Yes STYLE: Gambrel roof barn
 TYPE: Livestock barn
2x4 stud with
sheathing & 1/2"x6"
 ACCESSIBLE: Yes with
permission WALLS: cedar lap siding

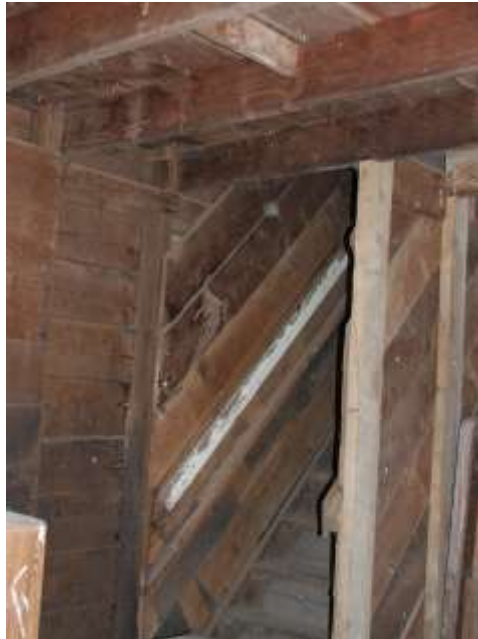
ROLL NUMBER: _____
PHOTO NUMBER: 5

CAMERA DIRECTION: First floor, looking NW,
stairs to hayloft, note
hand rails

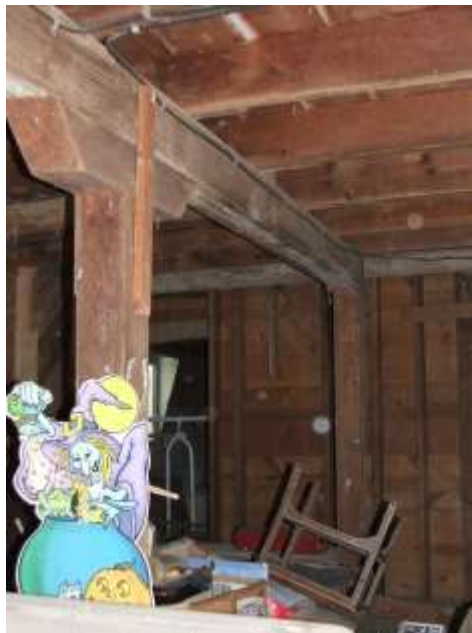
ROLL NUMBER: _____
PHOTO NUMBER: 6

INTERIOR NOTES: Has two rows 6x6 posts and three 2x8's and one 1x8 laminated for a beam. 2x8 floor joists. All evidence of horse stalls is gone. Eight milk cow stanchions are still in place in the North 17' of the barn. There is a 2x6 solid wall dividing that area from the South side of the barn.

CAMERA DIRECTION: First floor , looking
North, 6x6 posts with (3)
2x8's and (1) 1x8
laminated into a beam

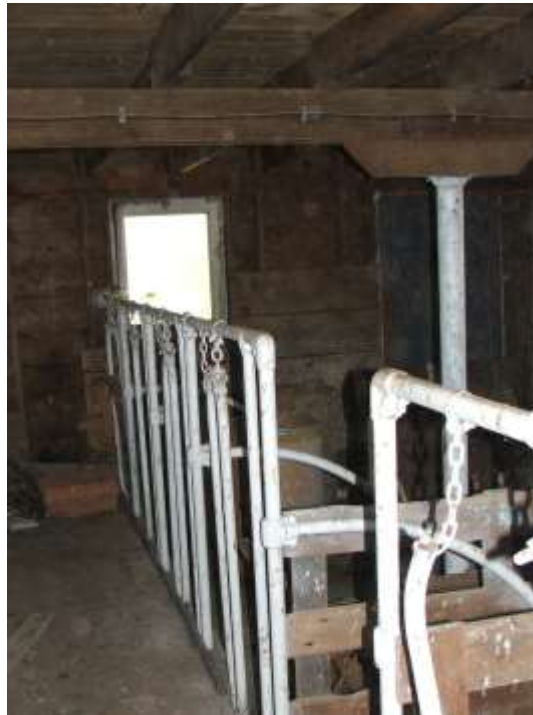
ROLL NUMBER: _____
PHOTO NUMBER: 7

CAMERA DIRECTION: First floor, looking West, milk cow stanchions

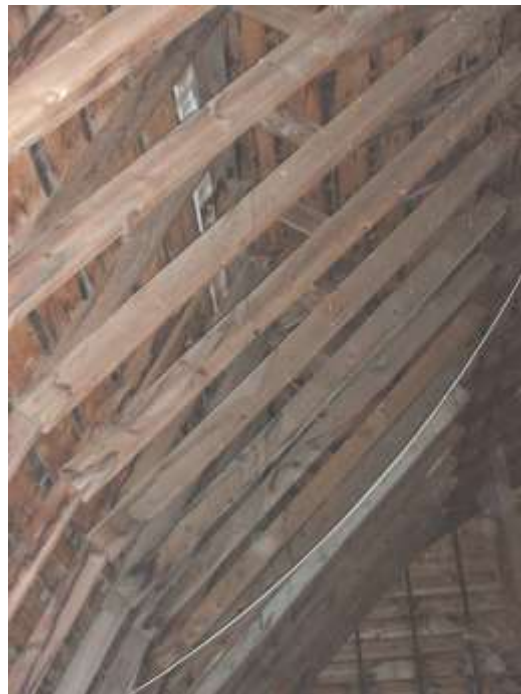
ROLL NUMBER: _____
PHOTO NUMBER: 8

CAMERA DIRECTION: Hayloft, looking North, (2) 2x6's bracing on rafter hip

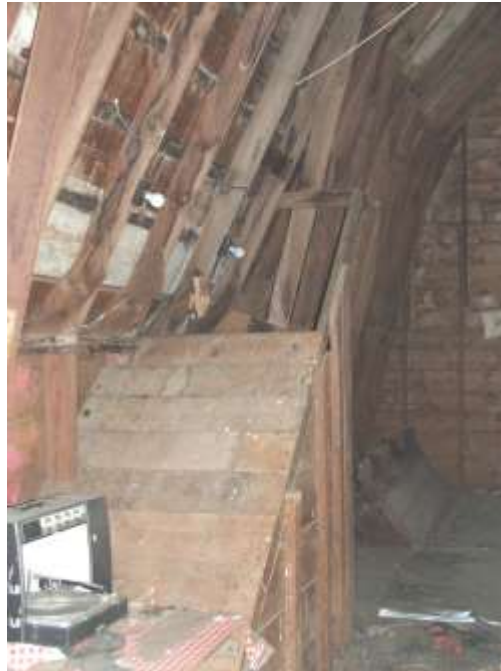
ROLL NUMBER: _____
PHOTO NUMBER: 9
CAMERA DIRECTION: Hayloft, enclosed stairs up into hayloft

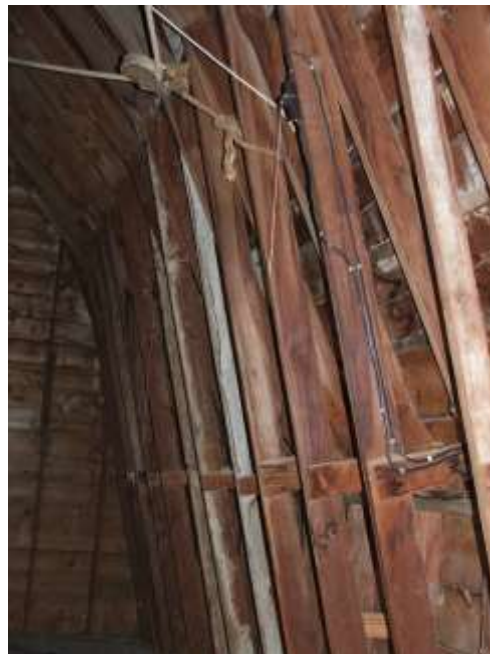
ROLL NUMBER: _____
PHOTO NUMBER: 10
CAMERA DIRECTION: Hayloft, looking North, 2x6 brace from lower rafter down to floor
