**SOUTH DAKOTA STATE HISTORIC PRESERVATION OFFICE  
HISTORIC SITES SURVEY STRUCTURE FORM**

\*SURVEY DATE: February 1, 2013 \*ADDRESS: 46882 311<sup>th</sup> Street  
\*SURVEYOR: Jim Stone \*COUNTY: Clay  
\*CITY: Beresford

CURRENT FUNCTION: <u>Storage</u>	FOUNDATION: <u>Poured concrete foundation</u>
CURRENT SUBFUNCTION: <u>Storage</u>	ROOF MATERIAL: <u>Asphalt shingles over cedar shingles</u>
HISTORIC FUNCTION: <u>Livestock barn</u>	ROOF SHAPE: <u>Gambrel</u>
HISTORIC SUBFUNCTION: <u>Hay storage</u>	STRUCTURAL SYSTEM: <u>Balloon framing</u>
OCCUPIED: <u>Yes</u>	STYLE: <u>Gambrel roof barn</u>
ACCESSIBLE: <u>Yes with permission</u>	TYPE: <u>Livestock barn</u>
STORIES: <u>2</u>	WALLS: _____
*DATE OF CONSTRUCTION: <u>1894</u>	SIGNIFICANT PERSON: <u>Maren Jacobson</u>
	CULTURAL AFFILIATION: <u>Danish</u>

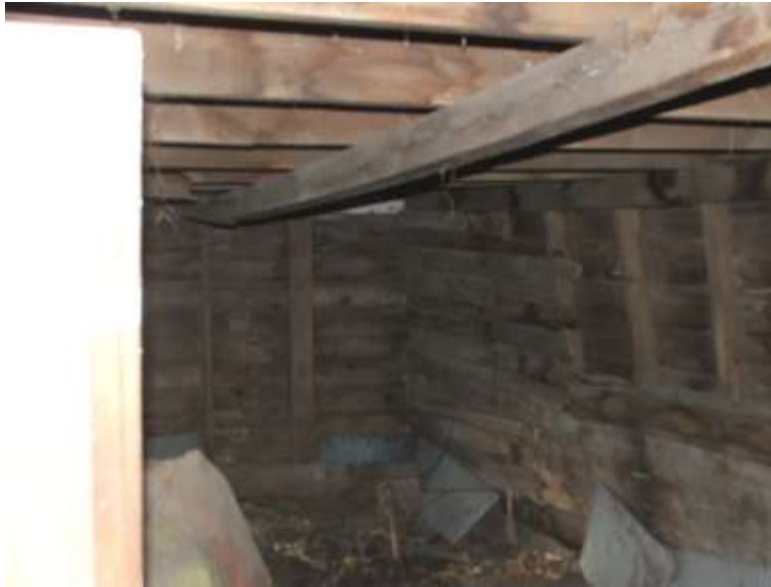
**ROLL NUMBER:** \_\_\_\_\_  
**PHOTO NUMBER:** 5

\*PHYSICAL NOTES: Barn is in poor condition. 4x4 beams are sagging after the 2x4 posts were removed. Wind has torn off some of the steel roofing.

**CAMERA DIRECTION:** First floor, looking NW,  
4x4 beam sagging after  
2x4 posts were removed.

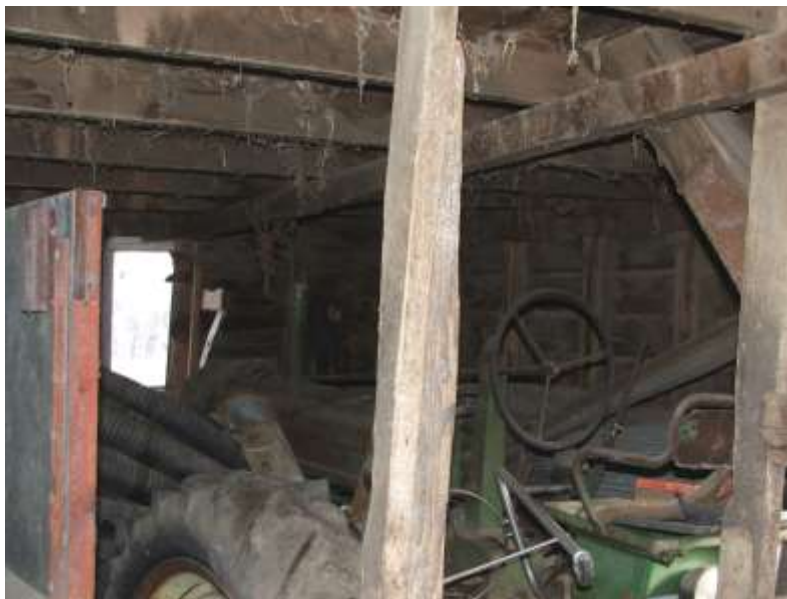
**ROLL NUMBER:** \_\_\_\_\_  
**PHOTO NUMBER:** 6

**CAMERA DIRECTION:** First floor, looking SE,  
where the single horse  
stalls were located.

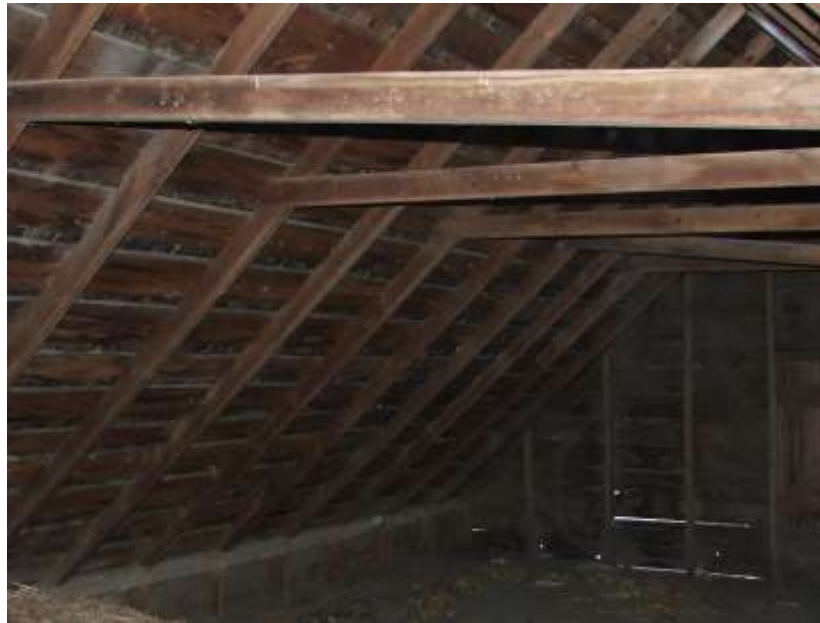
**ROLL NUMBER:** \_\_\_\_\_  
**PHOTO NUMBER:** 7

**CAMERA DIRECTION:** Hayloft, looking SW, 2x6  
rafters with 2x6 cross  
brace, note 12" wall.

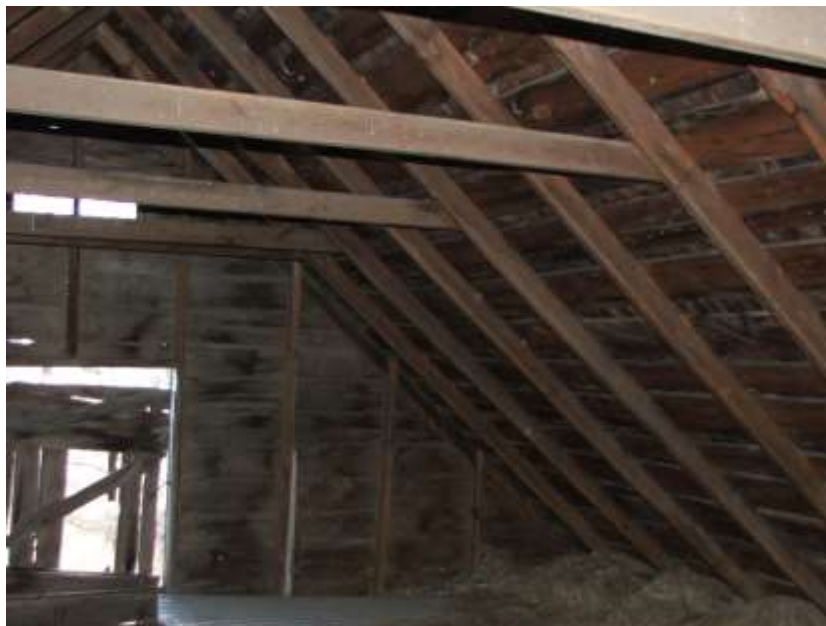
**ROLL NUMBER:** \_\_\_\_\_  
**PHOTO NUMBER:** 8

**CAMERA DIRECTION:** Hayloft, looking SE, 2x6  
rafters with 2x6 cross  
brace.
