**SOUTH DAKOTA STATE HISTORIC PRESERVATION OFFICE
HISTORIC SITES SURVEY STRUCTURE FORM**

*SURVEY DATE: March 15, 2013 *ADDRESS: 46973 298th Street
*SURVEYOR: Jim Stone *COUNTY: Clay
*CITY: Beresford

CURRENT FUNCTION: Storage FOUNDATION: Poured concrete
 CURRENT SUBFUNCTION: Storage ROOF MATERIAL: Steel over cedar shingles
 HISTORIC FUNCTION: Livestock barn ROOF SHAPE: Gable and Gambrel
 HISTORIC SUBFUNCTION: Hay & grain storage STRUCTURAL SYSTEM: Balloon framing
 STYLE: Gable/ gambrel roof barn
 OCCUPIED: Yes TYPE: Livestock barn
 Yes with 2x6 studs, 1x6
 ACCESSIBLE: permission WALLS: #106 drop siding

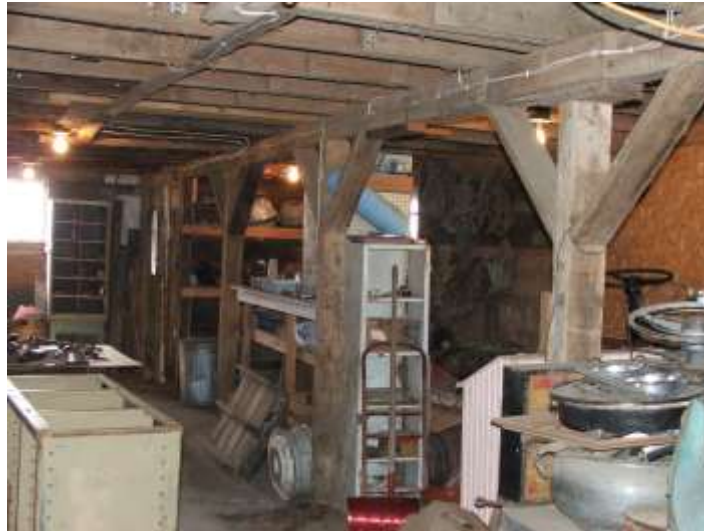
ROLL NUMBER: _____
PHOTO NUMBER: 5

CAMERA DIRECTION: First floor, looking SW in original barn, 4x6 posts, 4x6 beam, 2x8 floor joists

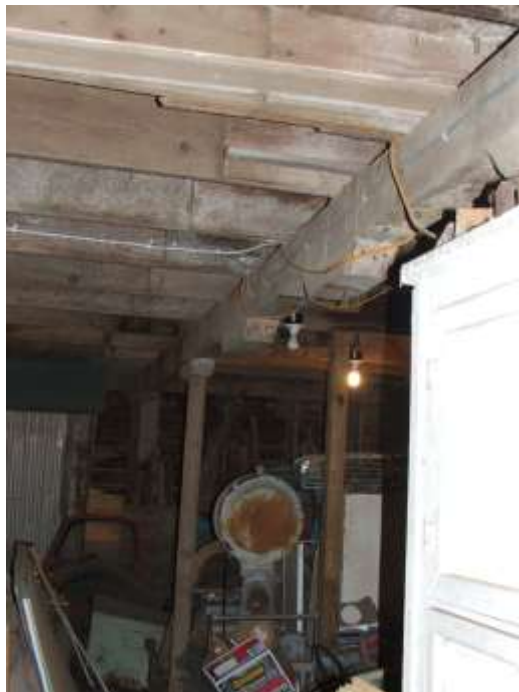
ROLL NUMBER: _____
PHOTO NUMBER: 6

CAMERA DIRECTION: First floor, looking SW, in East barn, 6x6 posts, 6x8 beam and 2x10 floor joists

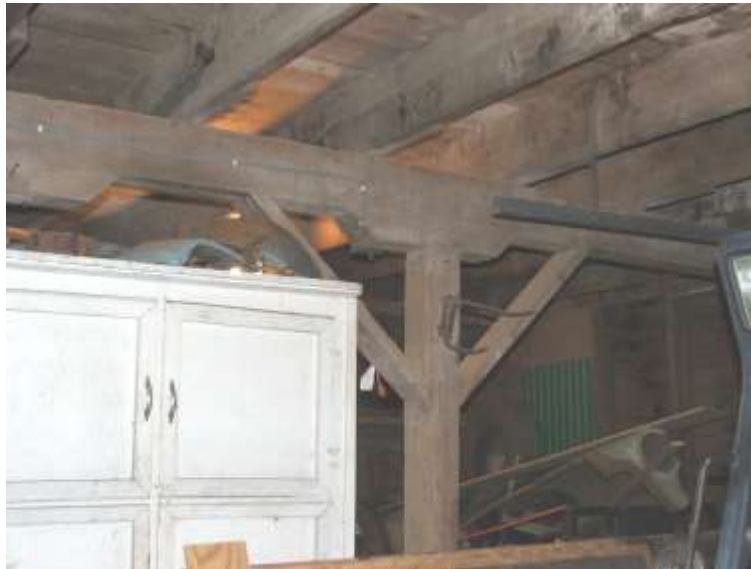
ROLL NUMBER: _____
PHOTO NUMBER: 7

CAMERA DIRECTION: First floor, looking West in East barn, note 4x4 bracing on 6x6 posts up to 6x8 beam

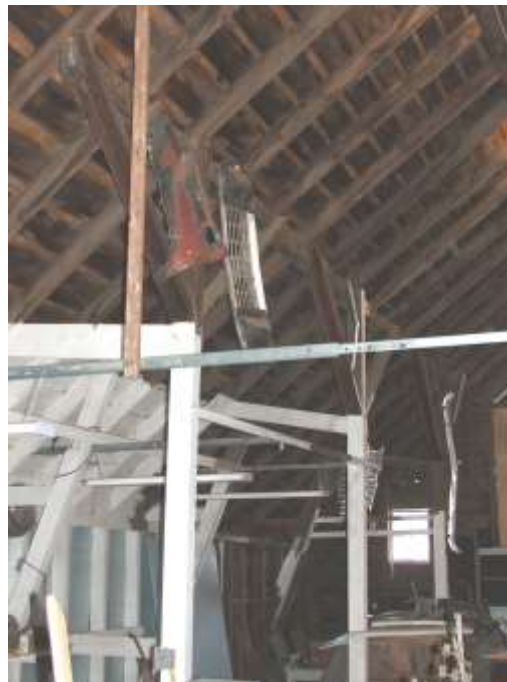
ROLL NUMBER: _____
PHOTO NUMBER: 8

ALTERED/MOVED NOTES: Original site. Any evidence of horse stalls and milk cow stanchions has been removed. Gambrel roof barn added on East side later. Roof has been covered with steel roofing. Three 4x6 posts and a 4x6 beam were added in the hayloft to help support the West side of the roof in the original barn when the gambrel roof barn was added on the East side. Metal cupola is gone. Large granary added in the NE corner in hayloft above 6'x8' granary on first floor. 6'x8' hayloft floor cut out to allow grain to flow down to lower granary.

CAMERA DIRECTION: Hayloft, looking NW in original barn, 4x6 posts and 4x6 beam to support West rafters, when East barn was added.

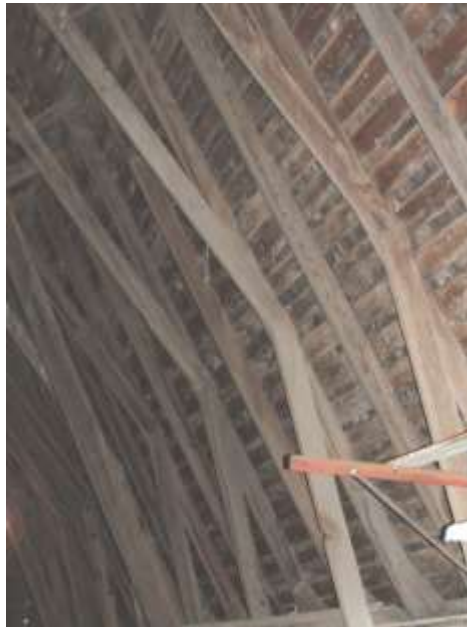
ROLL NUMBER: _____
PHOTO NUMBER: 9

**Hayloft, looking SE, 2x6
rafters, 2x6 bracing 4'
O.C. 2x8 bracing from
peak to floor 12' O. C.**

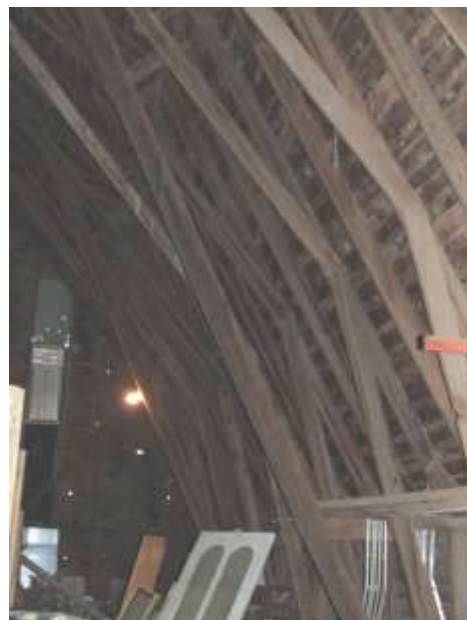
ROLL NUMBER: _____
PHOTO NUMBER: 10

**Hayloft, looking SE in
East barn, 2x6 rafters,
2x6 bracing 4' O. C. and
2x8 bracing from peak to
the floor 12' O. C.**

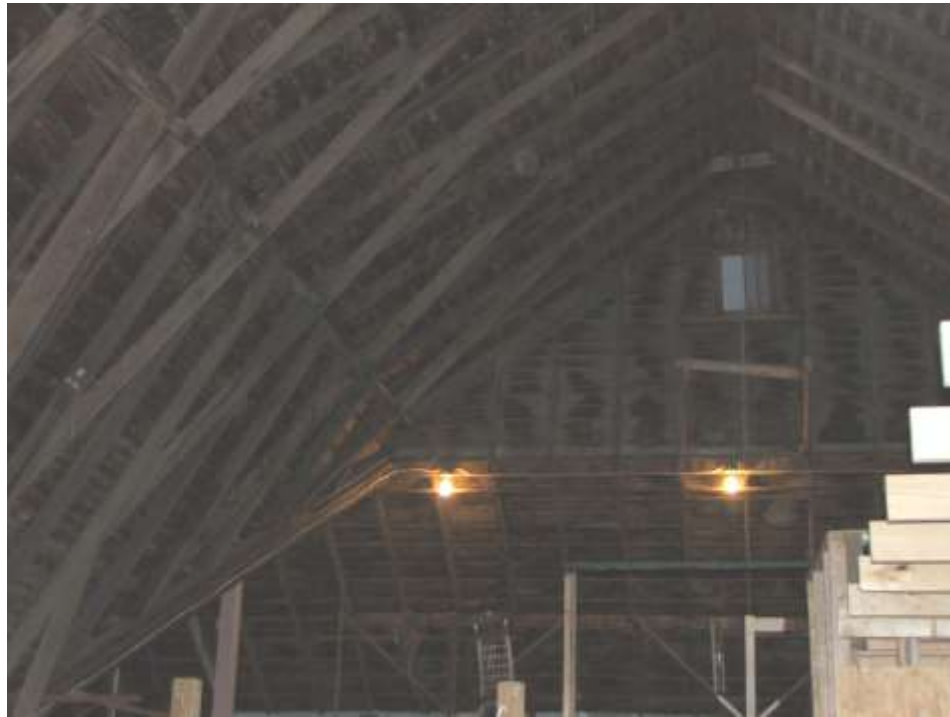
ROLL NUMBER: _____
PHOTO NUMBER: 11

CAMERA DIRECTION: Hayloft, looking West into West original barn, great engineering project.
