**SOUTH DAKOTA STATE HISTORIC PRESERVATION OFFICE
HISTORIC SITES SURVEY STRUCTURE FORM**

*SURVEY DATE: November 20, 2012 *ADDRESS: 30512 University Ave.
*SURVEYOR: Jim Stone *COUNTY: Clay
*CITY: Centerville

CURRENT FUNCTION: <u>Calving and cattle</u>	FOUNDATION: <u>Poured concrete foundation</u>
CURRENT SUBFUNCTION: <u>Storage</u>	ROOF MATERIAL: <u>Steel roofing over cedar shingles</u>
HISTORIC FUNCTION: <u>Livestock barn</u>	ROOF SHAPE: <u>Gothic round</u>
HISTORIC SUBFUNCTION: <u>Hay storage</u>	STRUCTURAL SYSTEM: <u>Balloon framing</u>
	STYLE: <u>Wisconsin dairy barn</u>
OCCUPIED: <u>Yes</u>	TYPE: <u>Livestock barn</u>
	<u>2x6 studs with 1x6 #106 drop siding</u>
ACCESSIBLE: <u>Yes with permission</u>	WALLS: <u>and steel siding</u>
STORIES: <u>2</u>	SIGNIFICANT PERSON: <u>Martin Swedling</u>
*DATE OF CONSTRUCTION: <u>1920 to 1940</u>	CULTURAL AFFILIATION: <u>?</u>

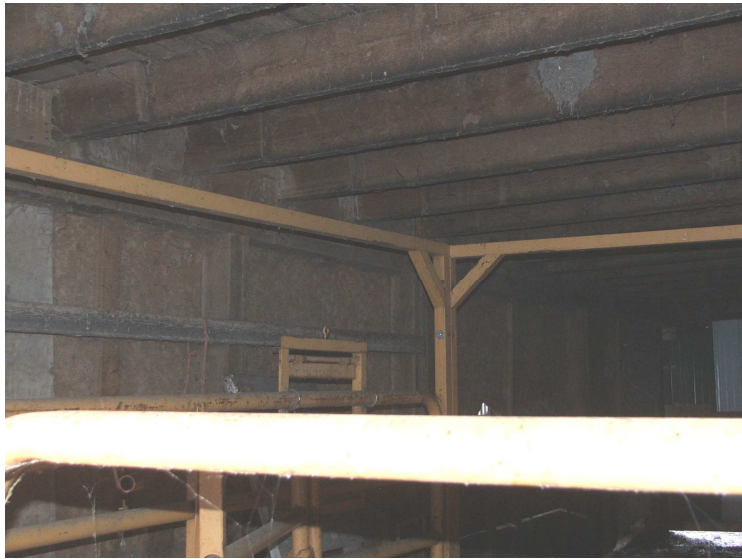
ROLL NUMBER: _____
PHOTO NUMBER: 5

CAMERA DIRECTION: First floor, looking North,
Solid wall dividing East
13' from the West side

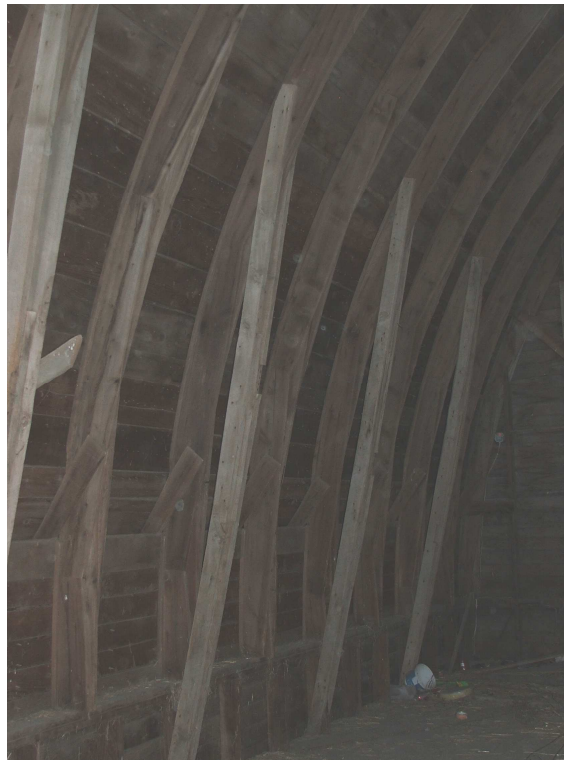
ROLL NUMBER: _____
PHOTO NUMBER: 6

CAMERA DIRECTION: Hayloft, looking North, 3
ply 1x8 rafters 3' O.C.
and (2) 2x4 bracing 6'
O.C.

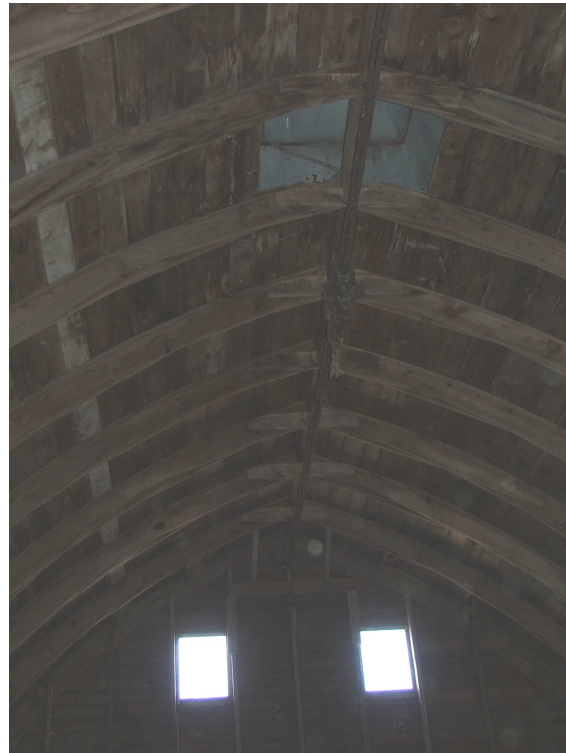
ROLL NUMBER: _____
PHOTO NUMBER: 7

CAMERA DIRECTION: Hayloft, looking North
gothic round rafters and
North gable wall

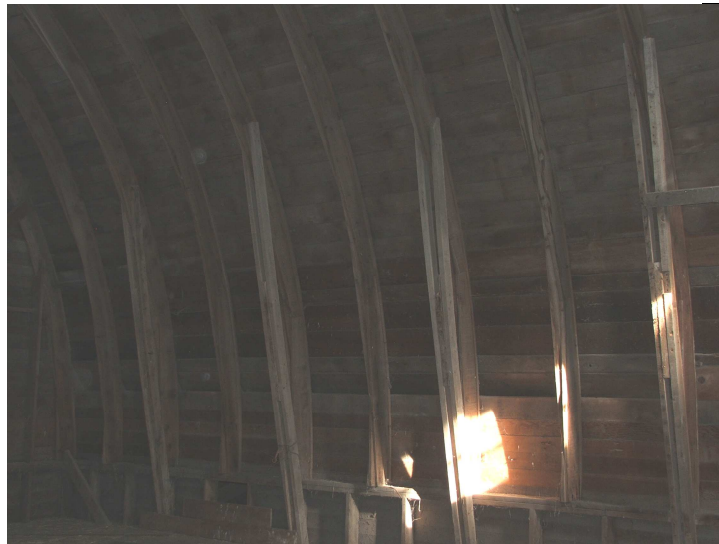
ROLL NUMBER: _____
PHOTO NUMBER: 8

CAMERA DIRECTION: Hayloft, looking East,
3ply 1x8 rafters 3' O. C.
and (2) 2x4 bracing 6'
O.C.
